Location: Site 004 – A414 jw M11 Harlow (Hastingwood Rd)
District: Epping Forest
Collision Investigation Period: 01/01/2017 and 31/12/2019
Site Ranking: 004 (Rural Site)

EXECUTIVE SUMMARY

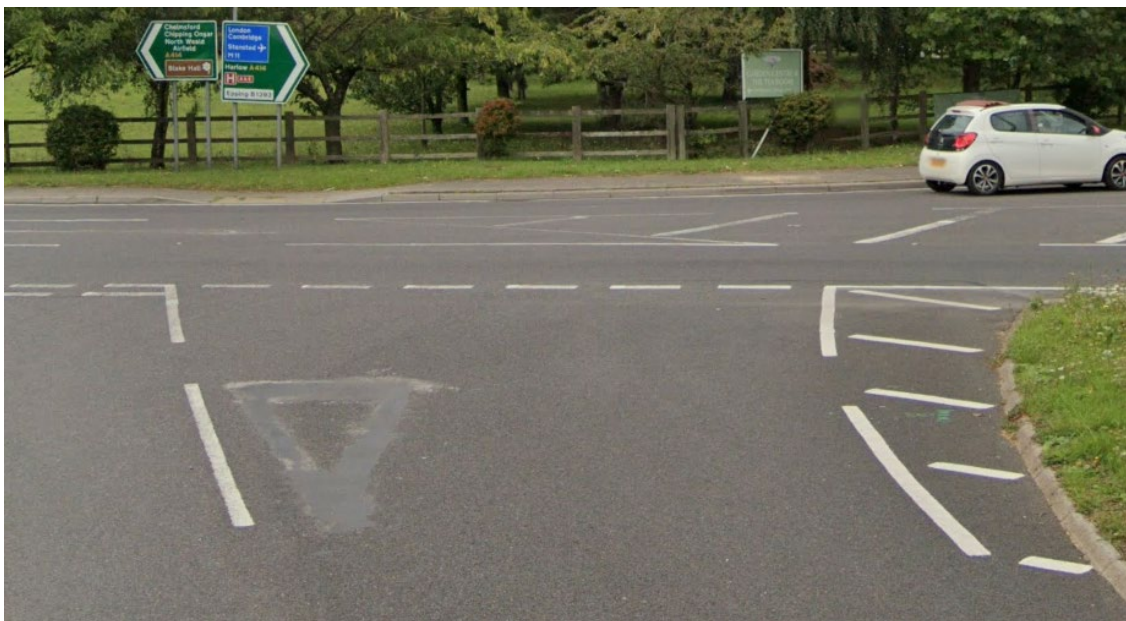
Image 4 – Area of junction to be reconfigured

- 1) It is recommended that a right turn facility within the centre hatching on the A414 northbound approach to the roundabout, to enable traffic turning right from Hastingwood Rd to perform the manoeuvre in two stages.

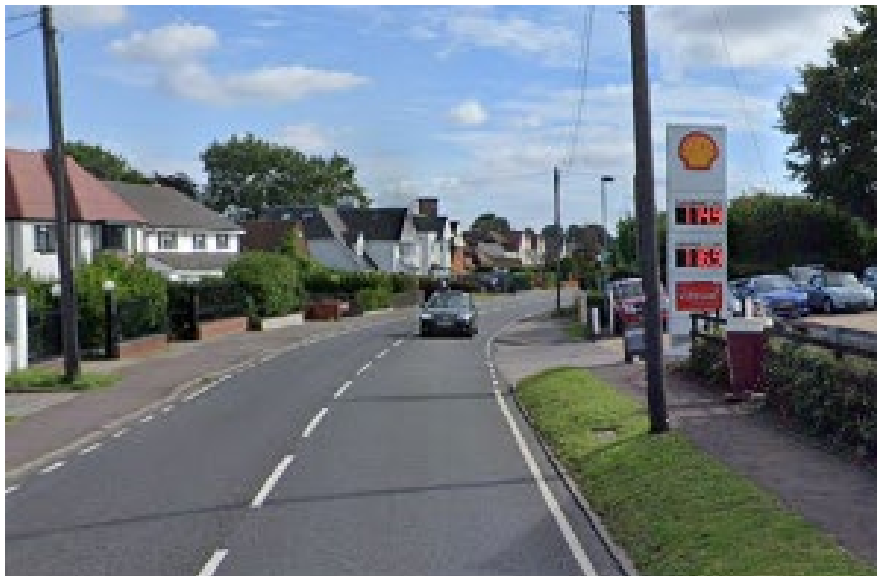
Image 3 – Approach to filling station access

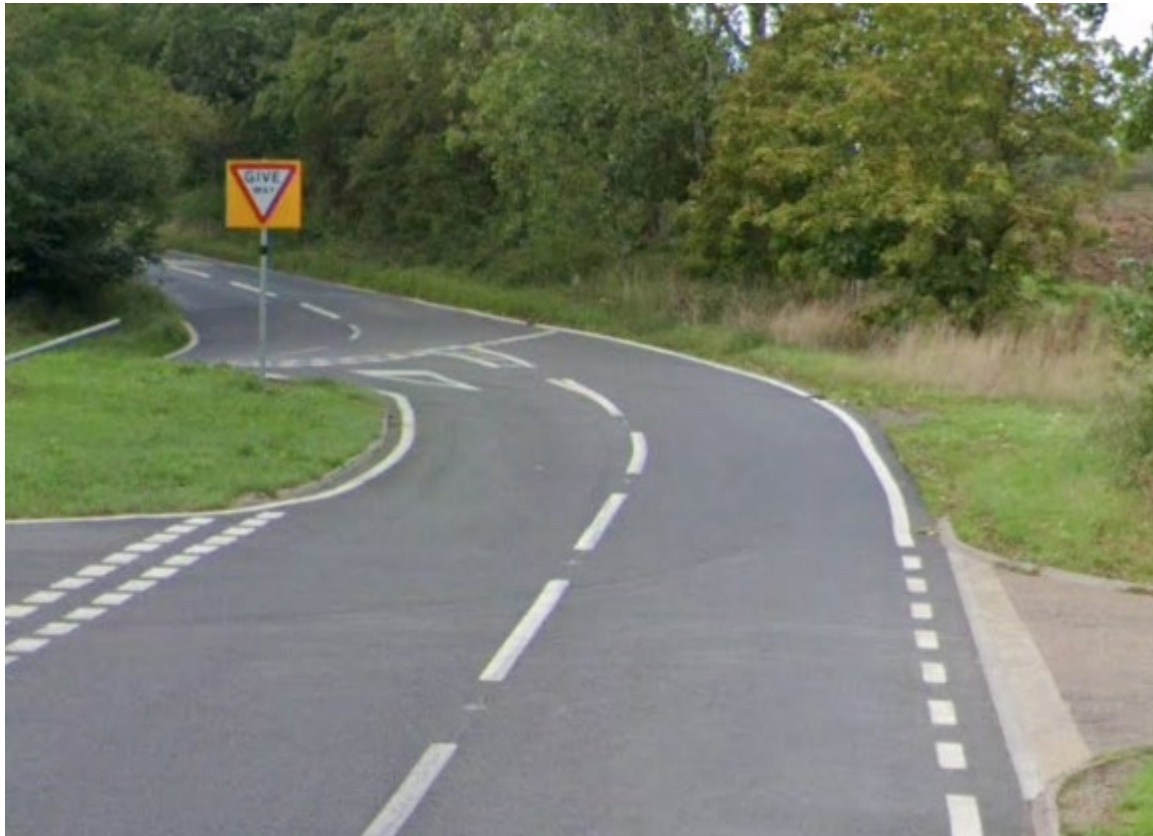
Image 3 – B182 (Bury Lane) North-east bound approach to junction

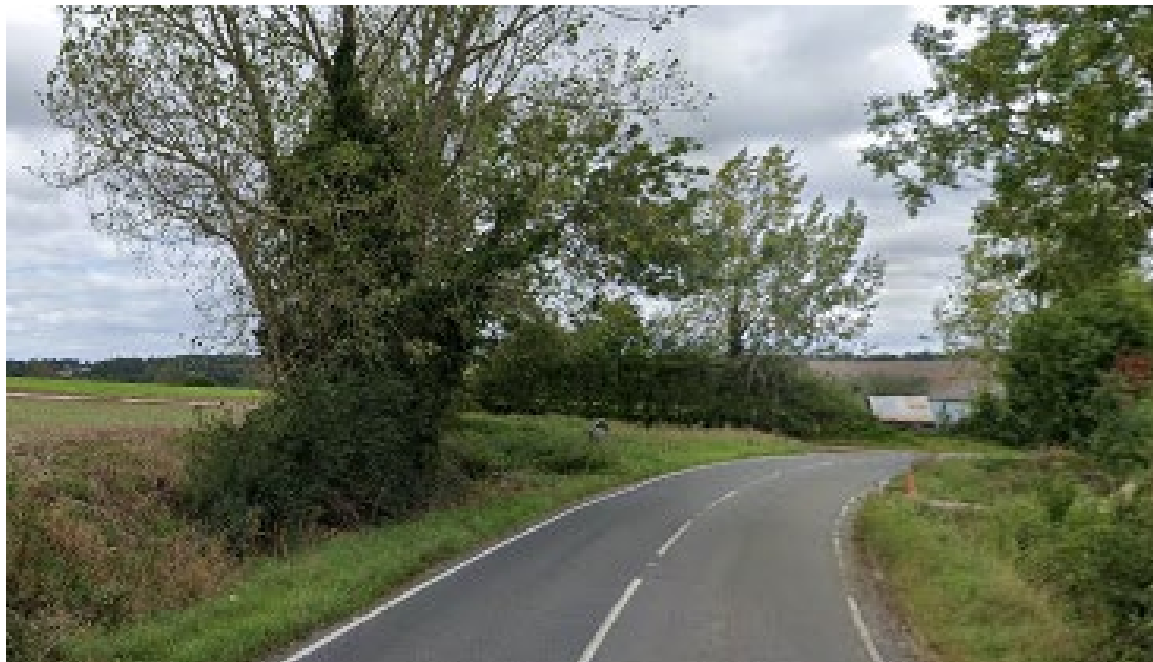
Image 4 – B182 (Bury Lane) North bound approach to bend

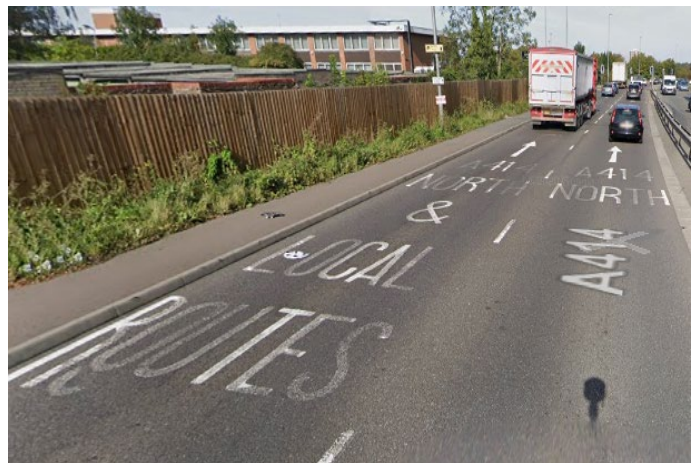
Image 4 – A414 northbound approach to roundabout showing destination carriageway markings

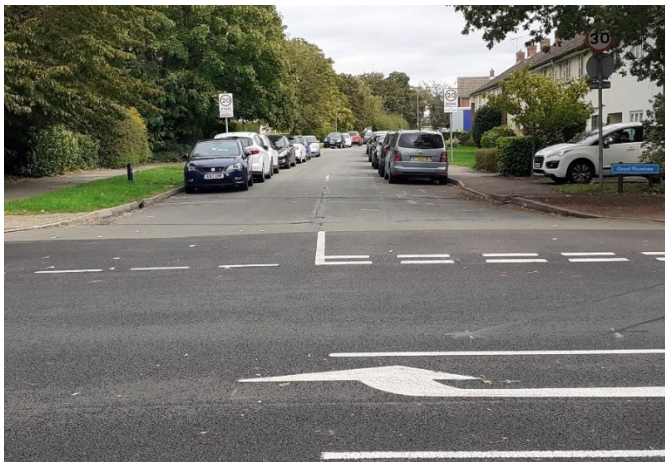
Image 3 – View of Mowbray Road from Howard Way

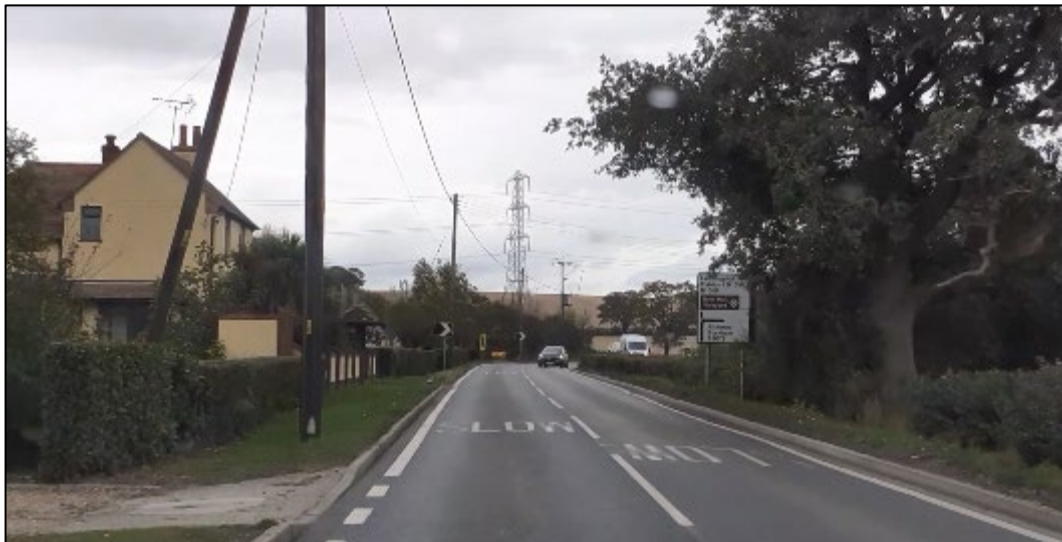
Image 1 – B1012 Lower Burnham Road, eastbound (northwards) approach to bend/junction

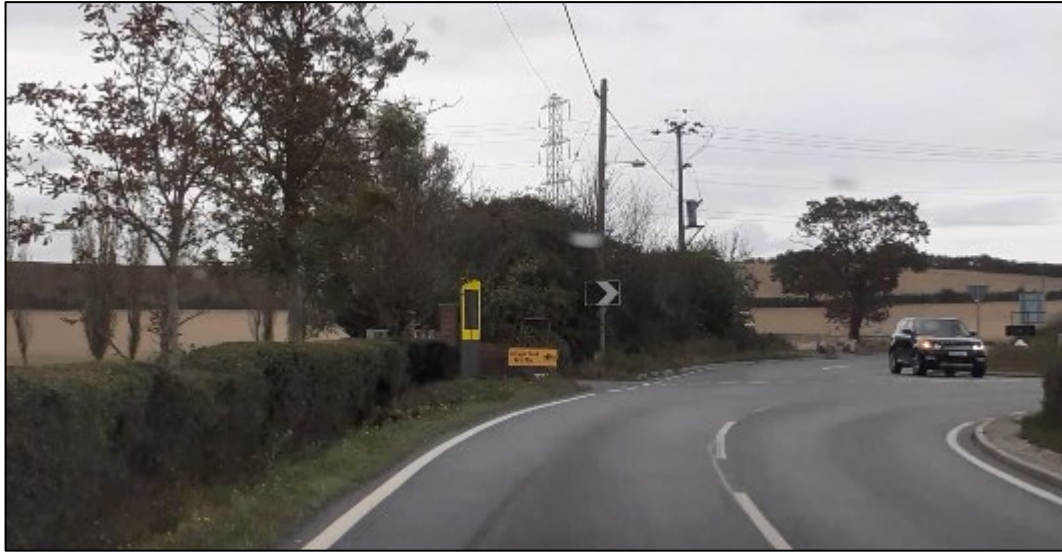
Image 2 – B1012 Lower Burnham Road, eastbound (northwards) approach to bend/junction.
Note absence of entry deflection into Fambridge Road (towards Kits Hill)

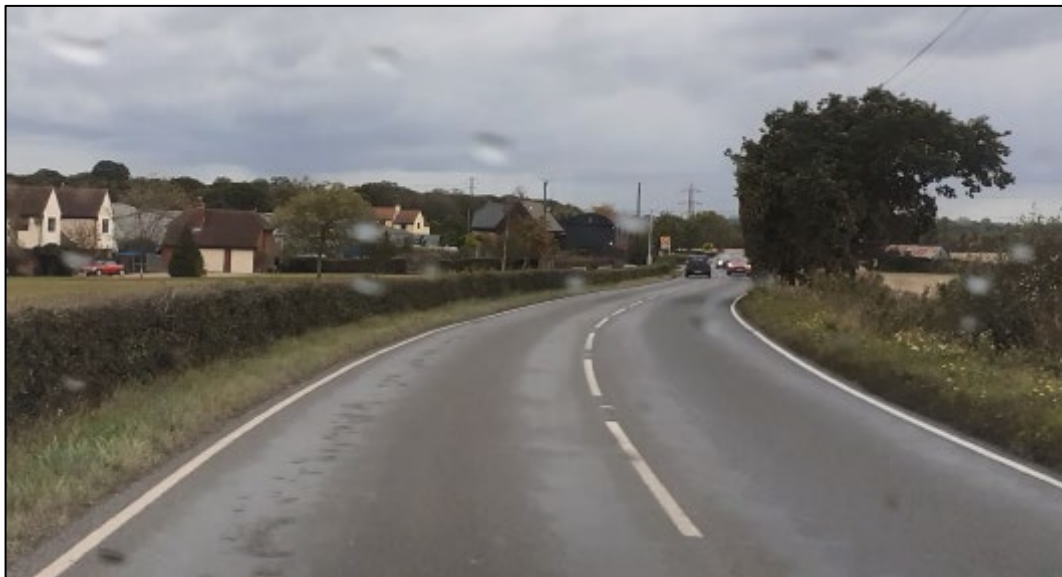
Image 3 – B1010 Lower Burnham Road, westbound, approximate location at which the
bend/junction ahead first comes into view

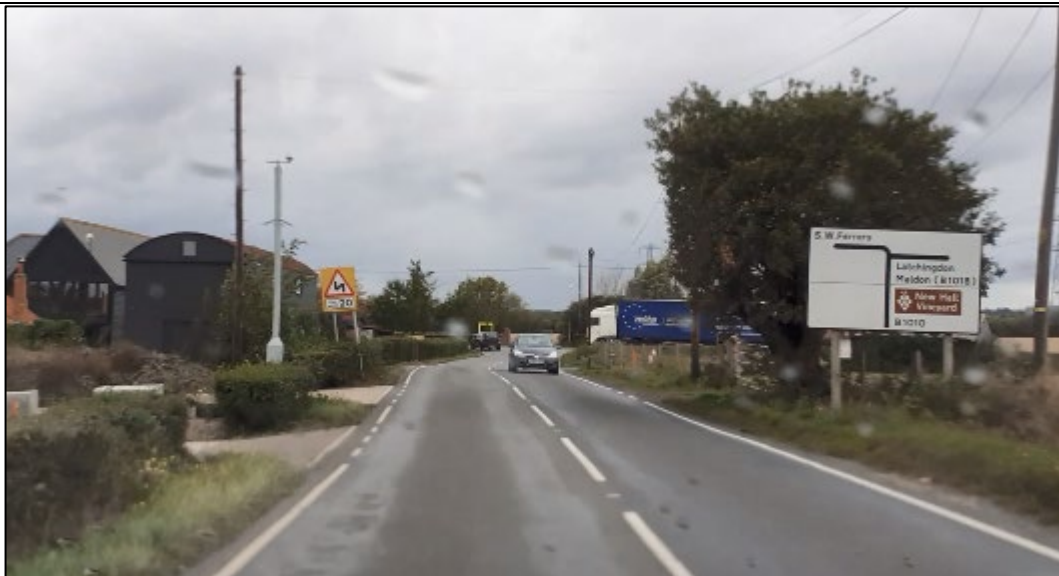
Image 4 – B1010 Lower Burnham Road, westbound, approaching the bend/junction

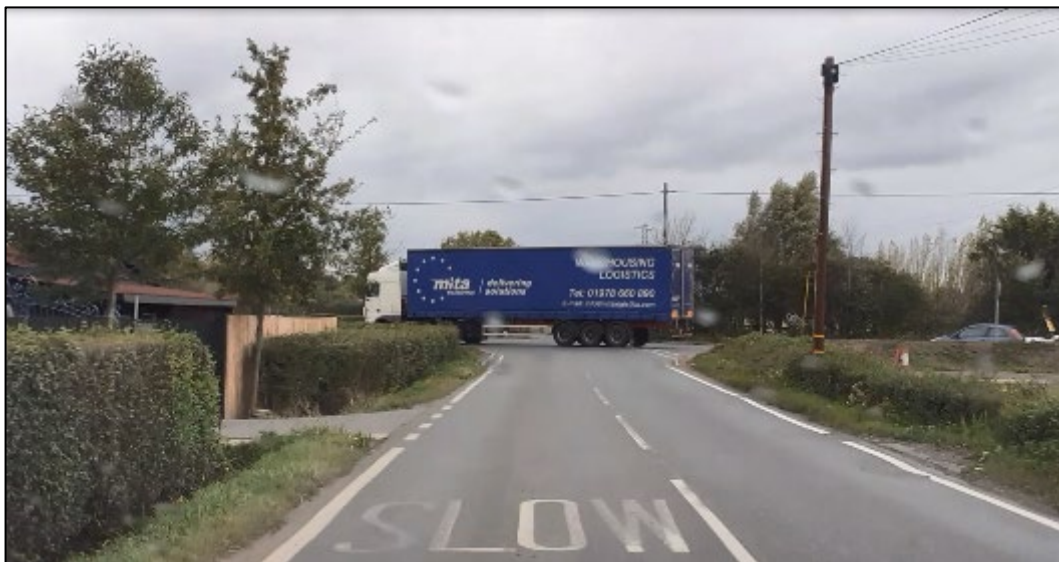
Image 5 – B1010 Lower Burnham Road, westbound approach
(NB – the grey car after the lorry also emerged before the video car reached the junction)

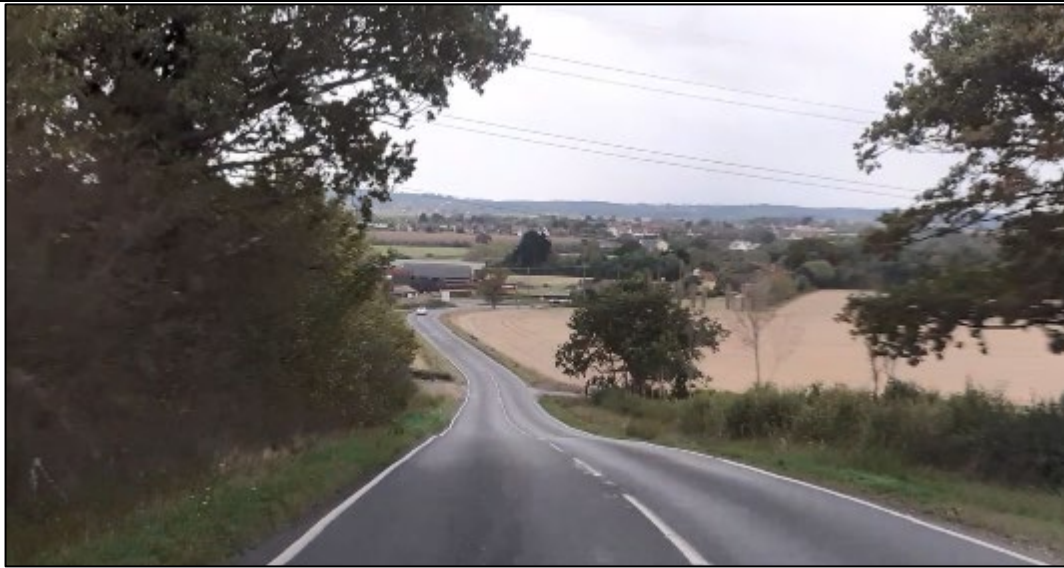
Image 6 – B1010 Fambridge Road (Kits Hill) southbound
Illustrating the extensive forward view from the brow of Kits Hill

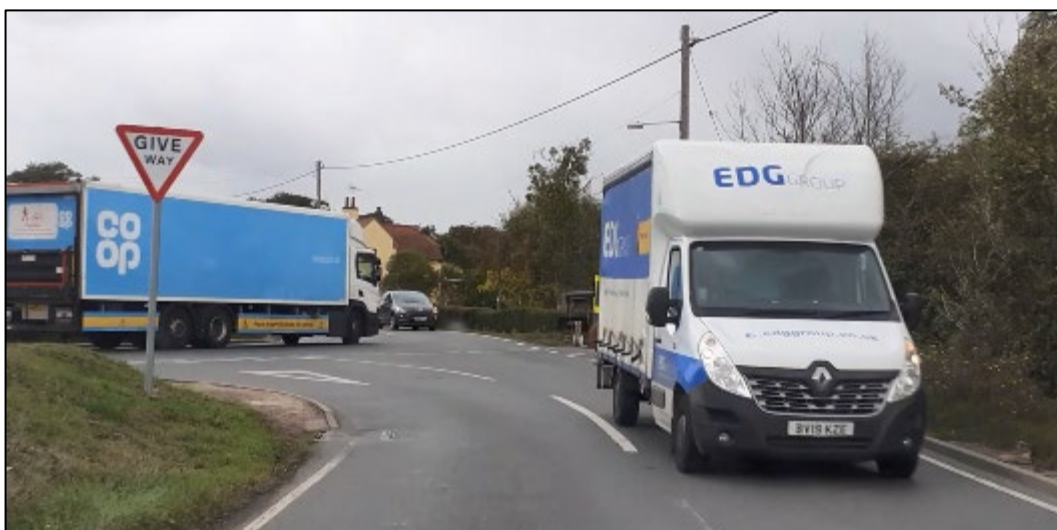
Image 9 – Fambridge Road (Kits Hill) southbound – at ‘Give Way’ line at junction.
Illustrating offset alignment of ‘Give Way’ line and limited visibility due to other road users.

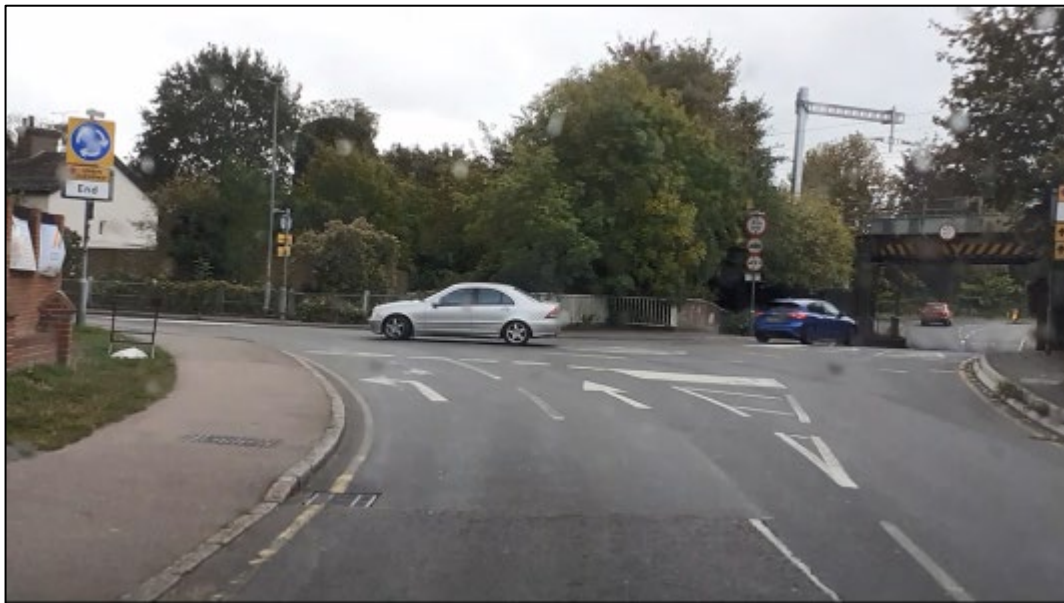
Image 8 – Ashington Road (southbound) at mini-roundabout

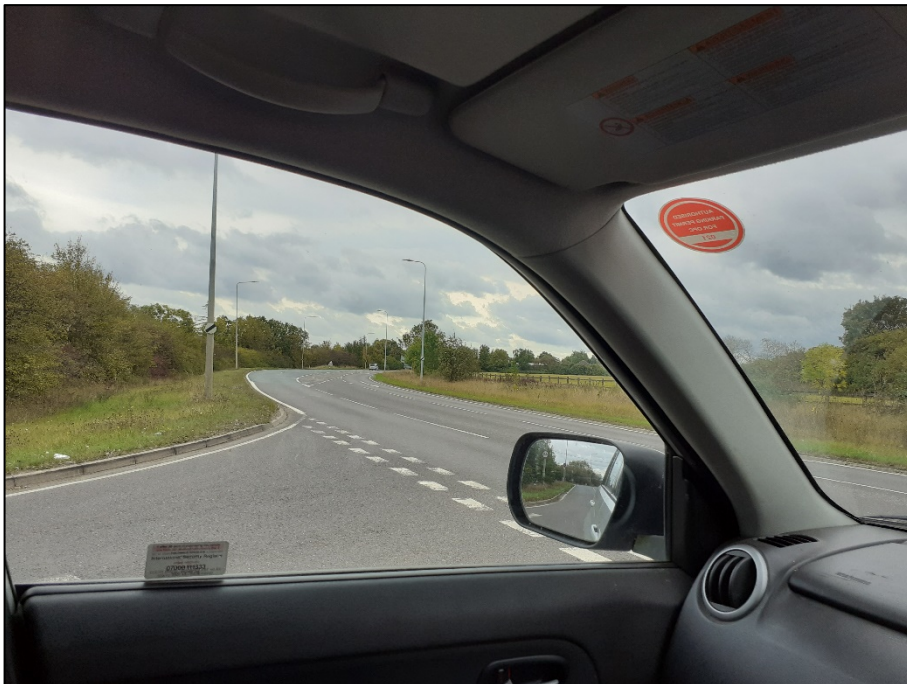
Image 4 – looking south from Chelmsford Road, northbound vehicles approaching

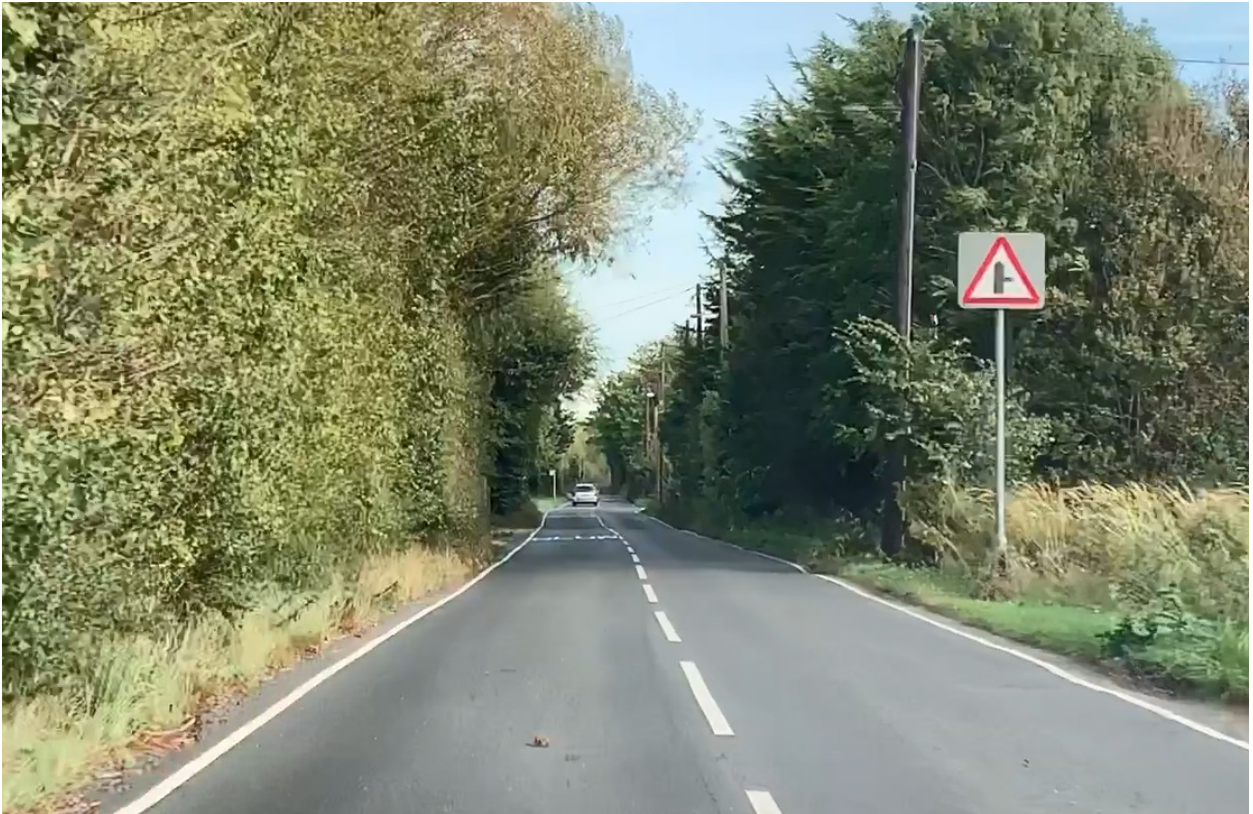
Image 1 – Poynters Lane eastbound approach to junction.

Updated 03/03/2021 – following intervention work study the following measures are to be implemented. Poynters Lane eastbound Vehicle Activated sign with junction ahead warning sign and reduce speed subplate. Give-way lining and signing is to be removed and replaced with a physical 'STOP' sign and marking.

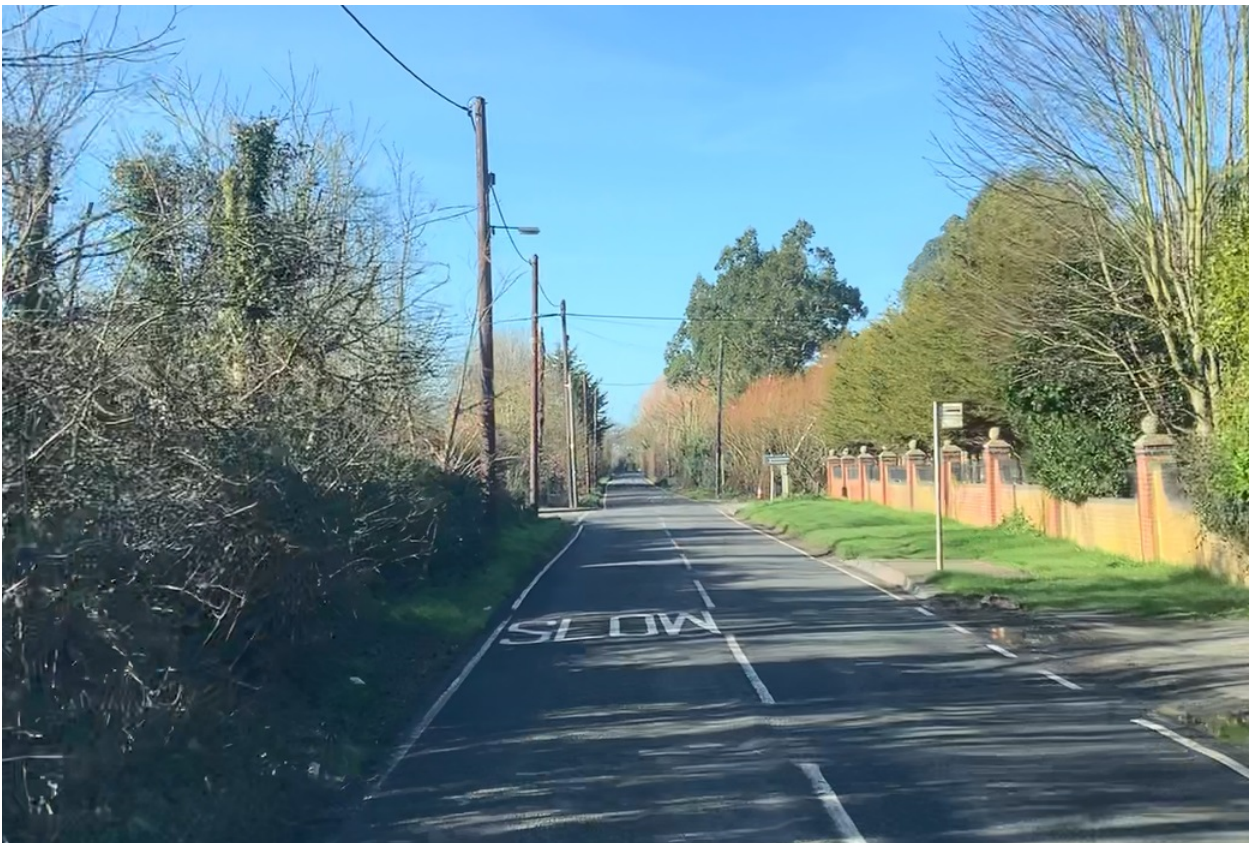
Image 2 – Poynters Lane westbound approach to junction

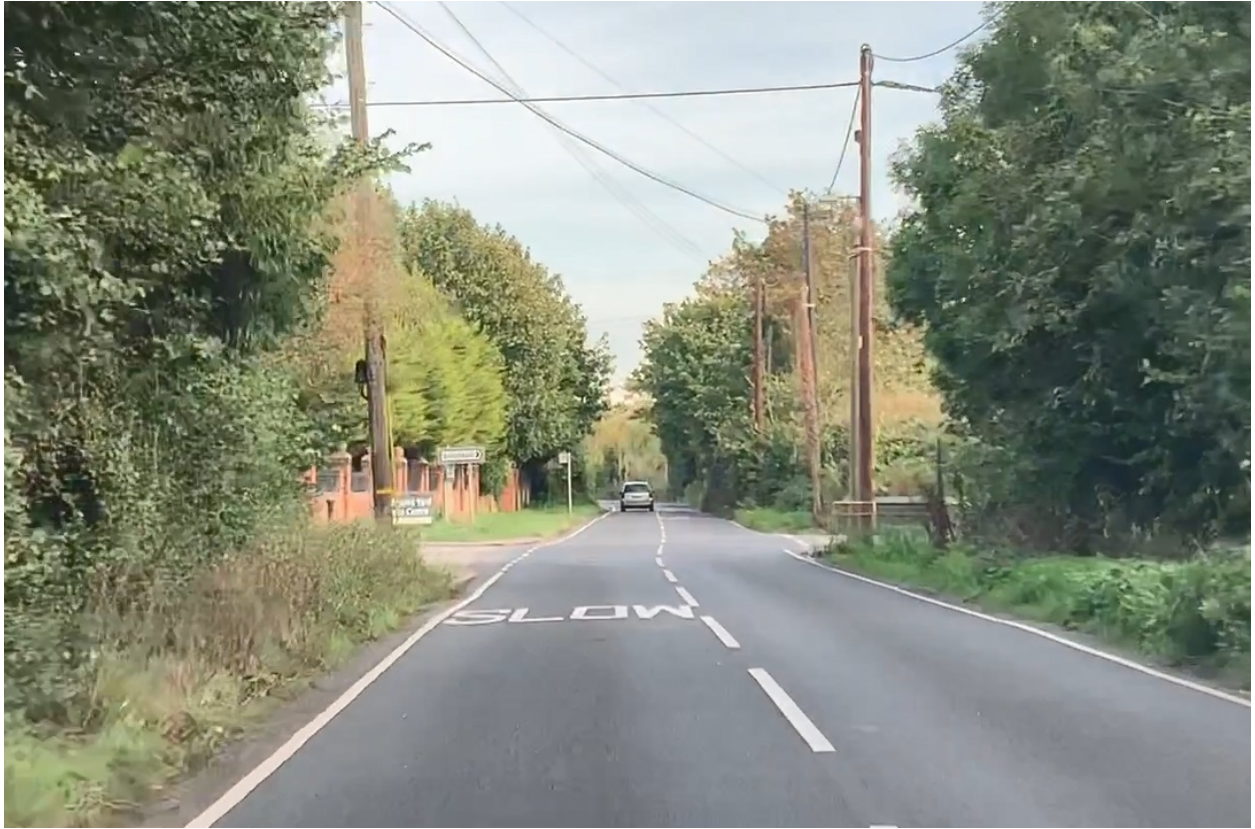
Image 3 – Sudden 'kink' in the alignment of Poynters Lane at the junction.

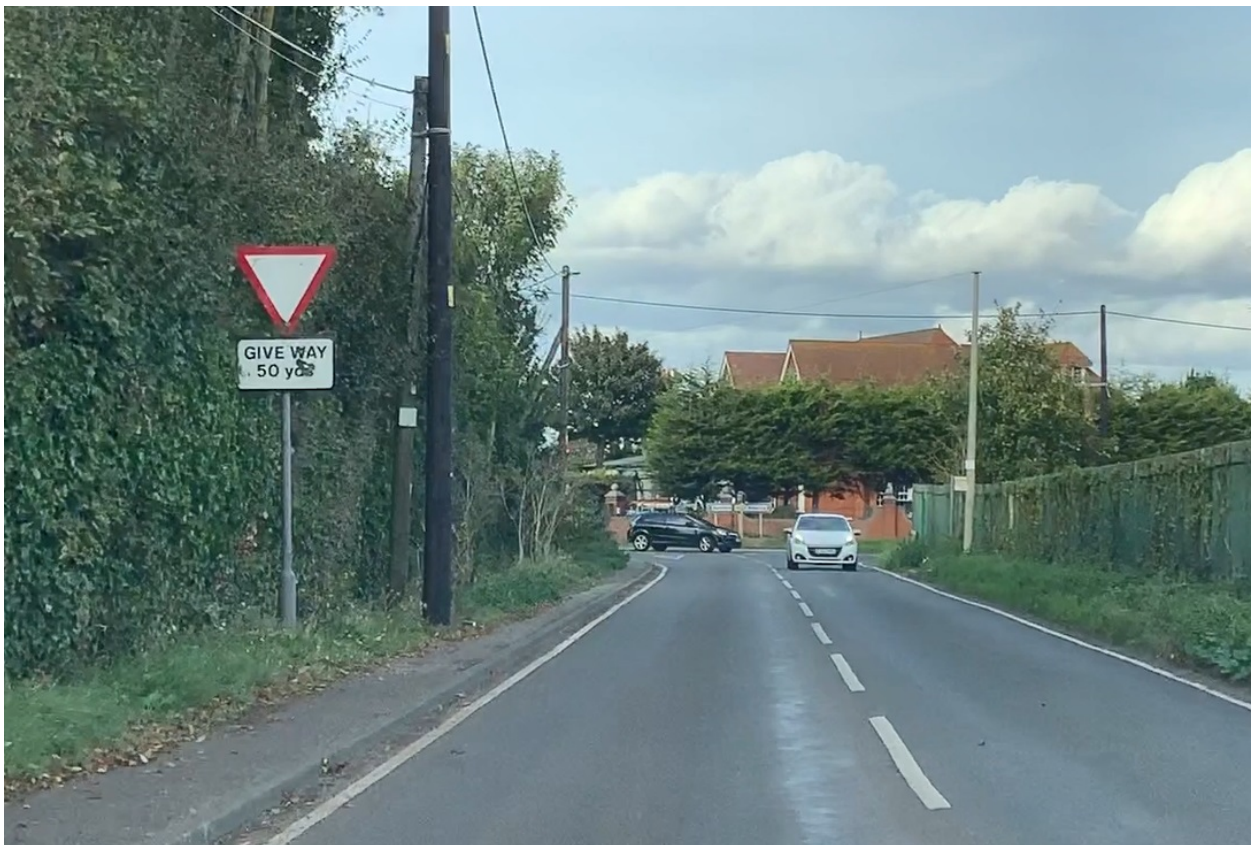
Image 4 – Waking Road northbound approach to junction.

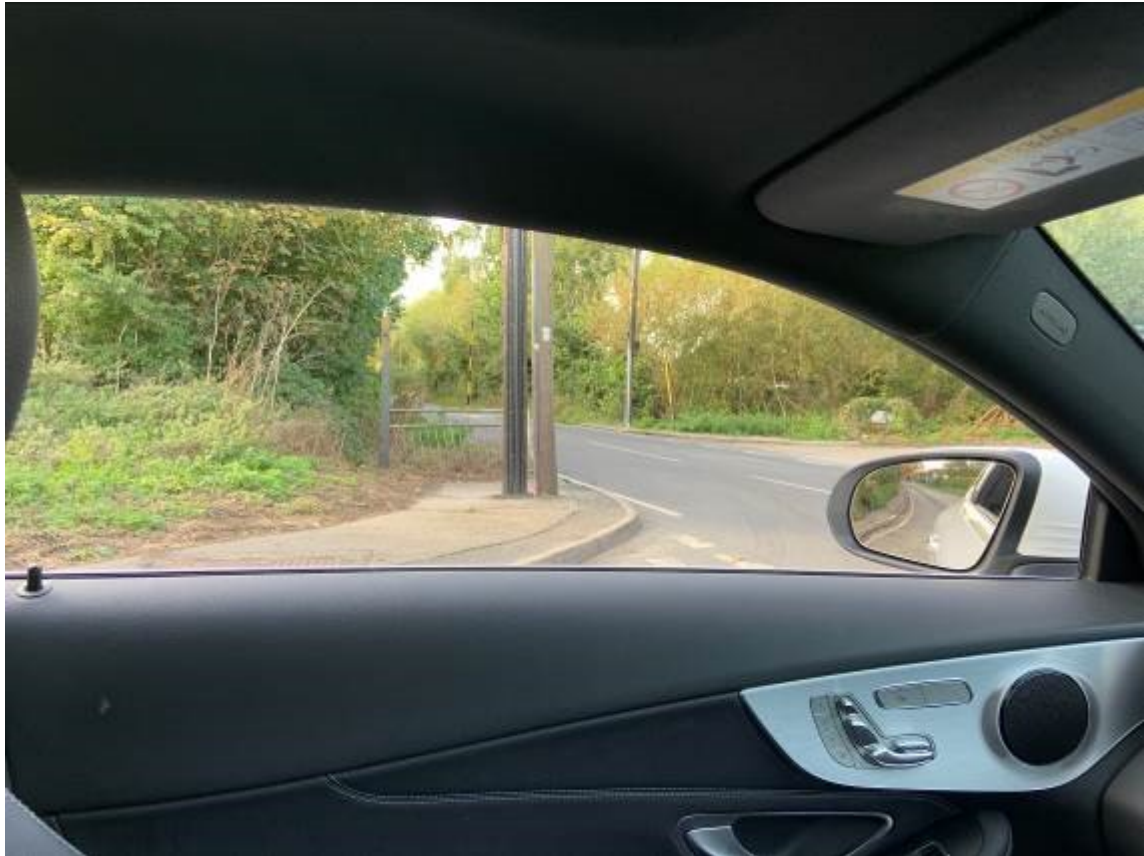
Image 5 – Visibility splay to the left (West) when waiting at the give way lines on Waking Rd

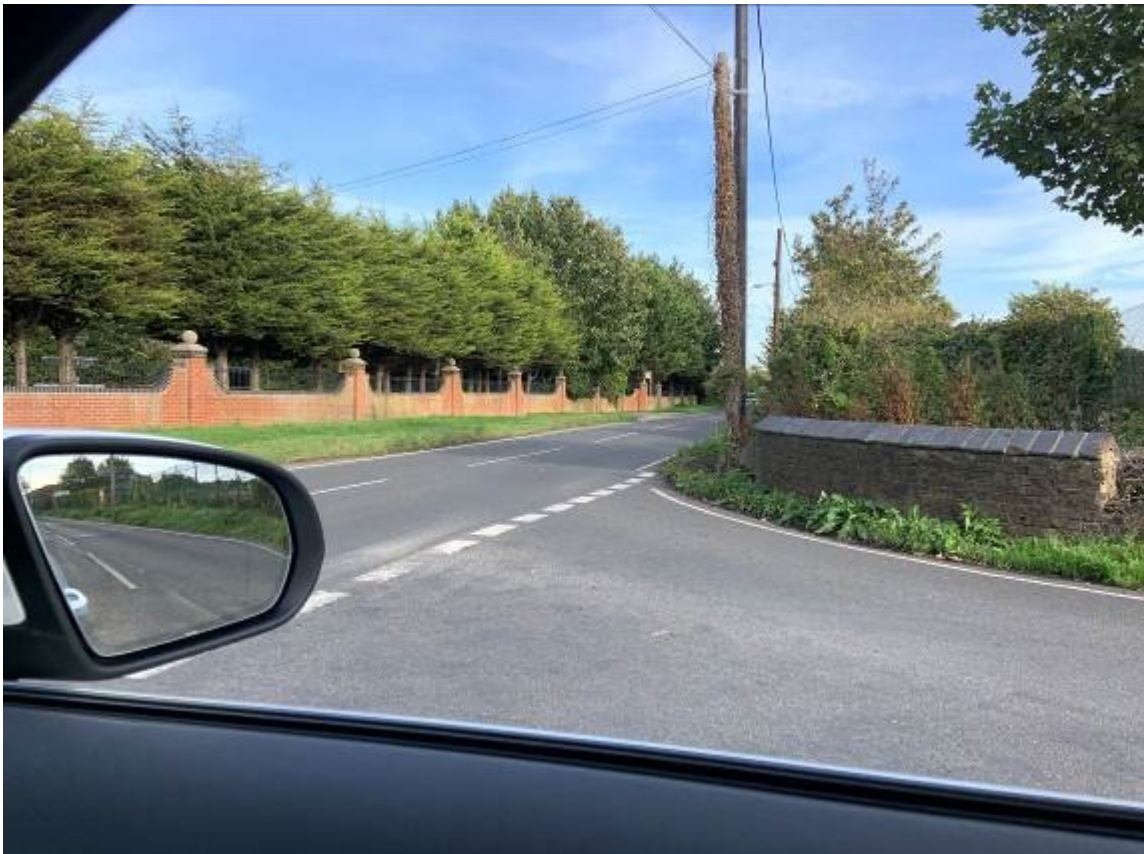
Image 6 – Visibility splay to the right (East) when waiting at the give way lines on Waking Rd

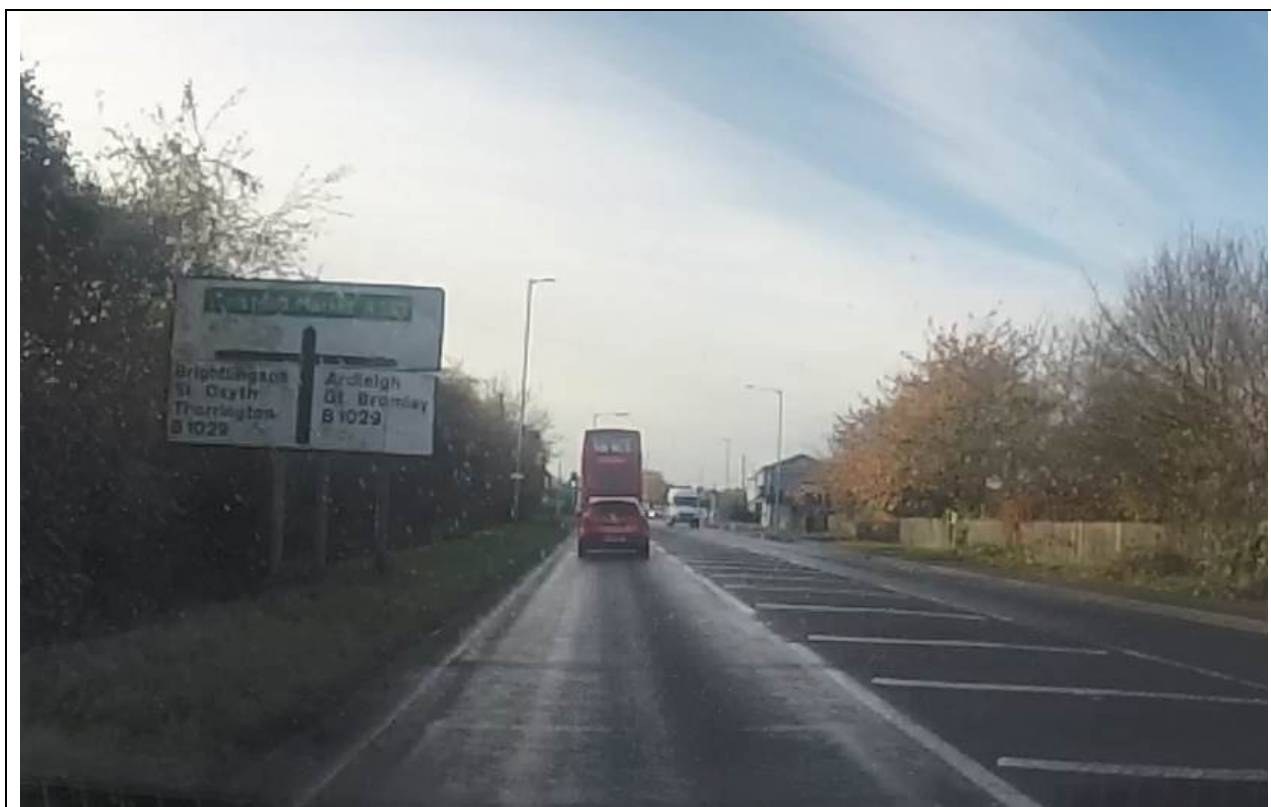
Image 1 – A133 Westbound approach to signalised junction

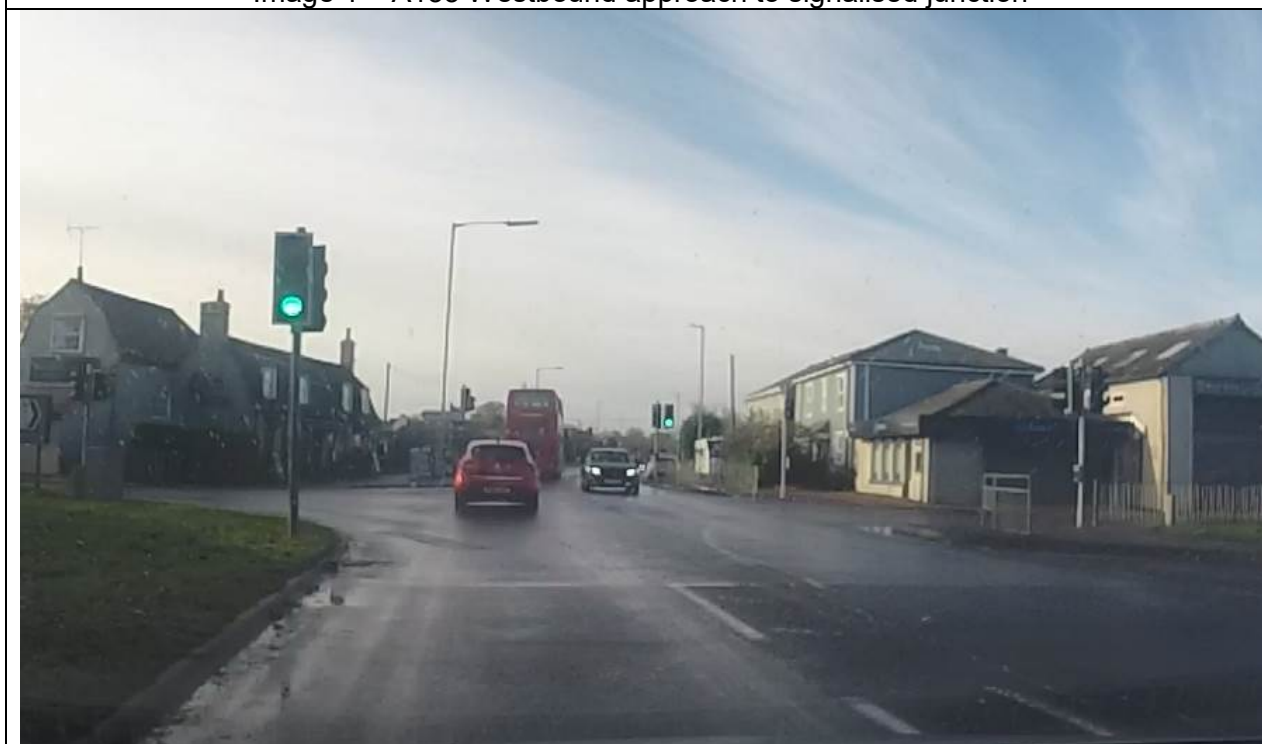
Road Markings	On A133, centre of carriageway hatch markings are provided on both approaches to the junction. The stop lines at the junction are worn. On the Bromley Road southbound approach to the junction, a centre line marking and parking restriction markings are provided. The centre line and signals stop line are worn On Great Bentley Road northbound approach to the junction, centre line markings and edge of carriageway markings are provided. The centre line and signals stop line are worn in the vicinity of the junction. There are no "guidance markings within the junction for vehicles waiting to turn.		
Visibility	Forward visibility to the traffic signals on all approaches, is considered good for a route subject to a 40mph speed limit. The collision data implies a possible visibility issue for road users from B1029 Great Bentley Road turning right on to A133 Main Street eastbound. This is likely due to vehicles traveling from A1029 Bromley Road waiting to turn right within the junction, masking north/south bound straight ahead road users.

Image 2 – A133 Westbound at signalised junction

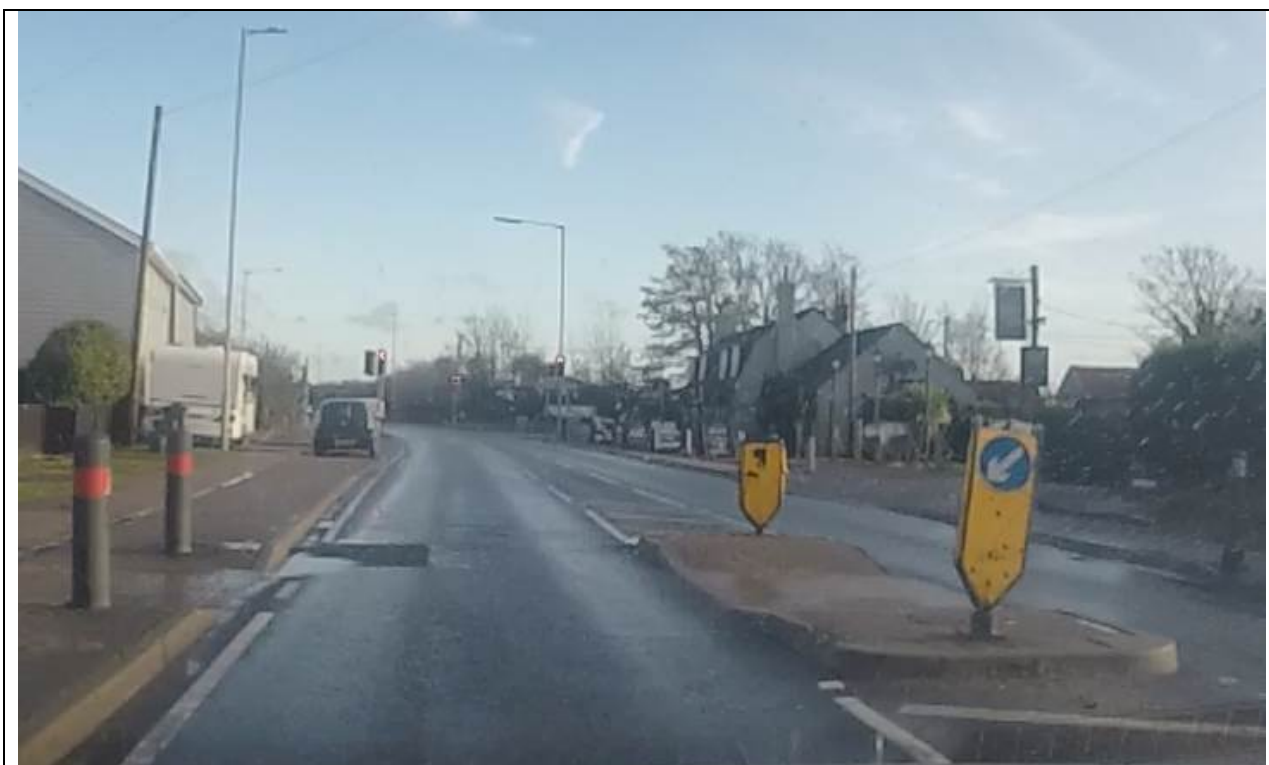
Image 3 – A133 Eastbound approach to signalised junction

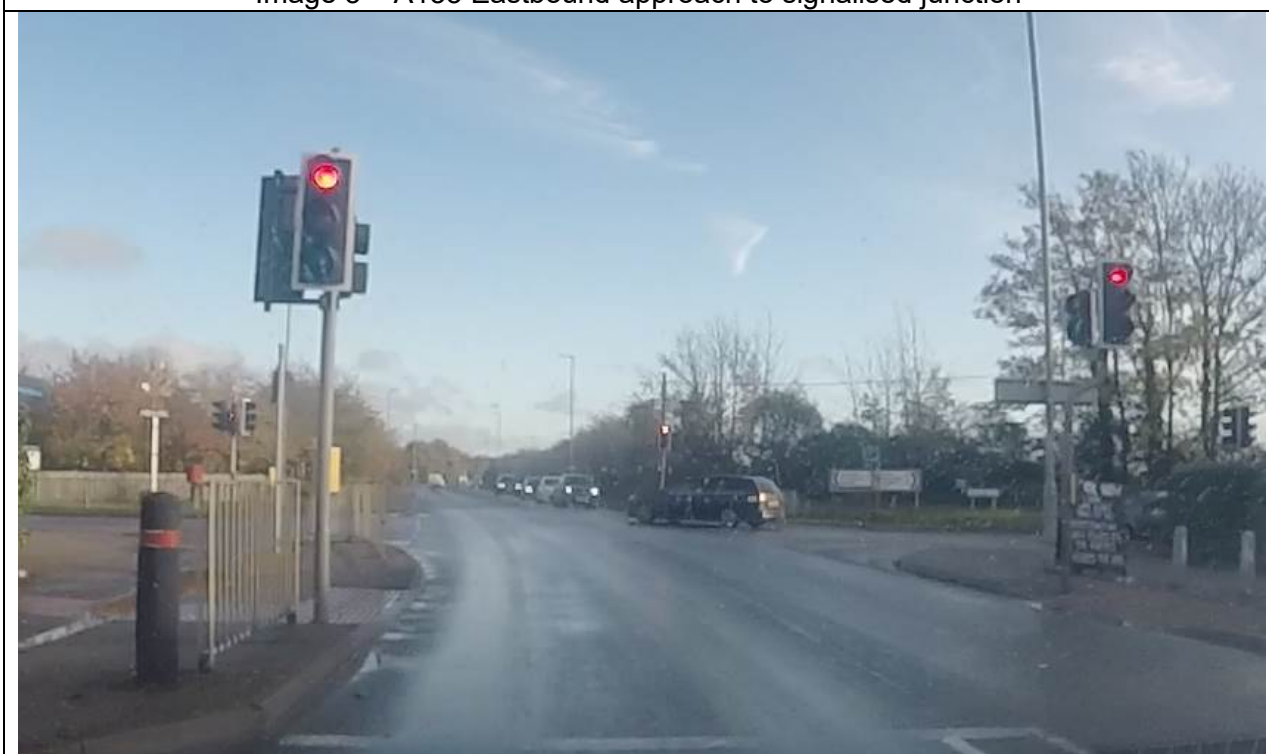
Image 4 – A133 Eastbound at signalised junction

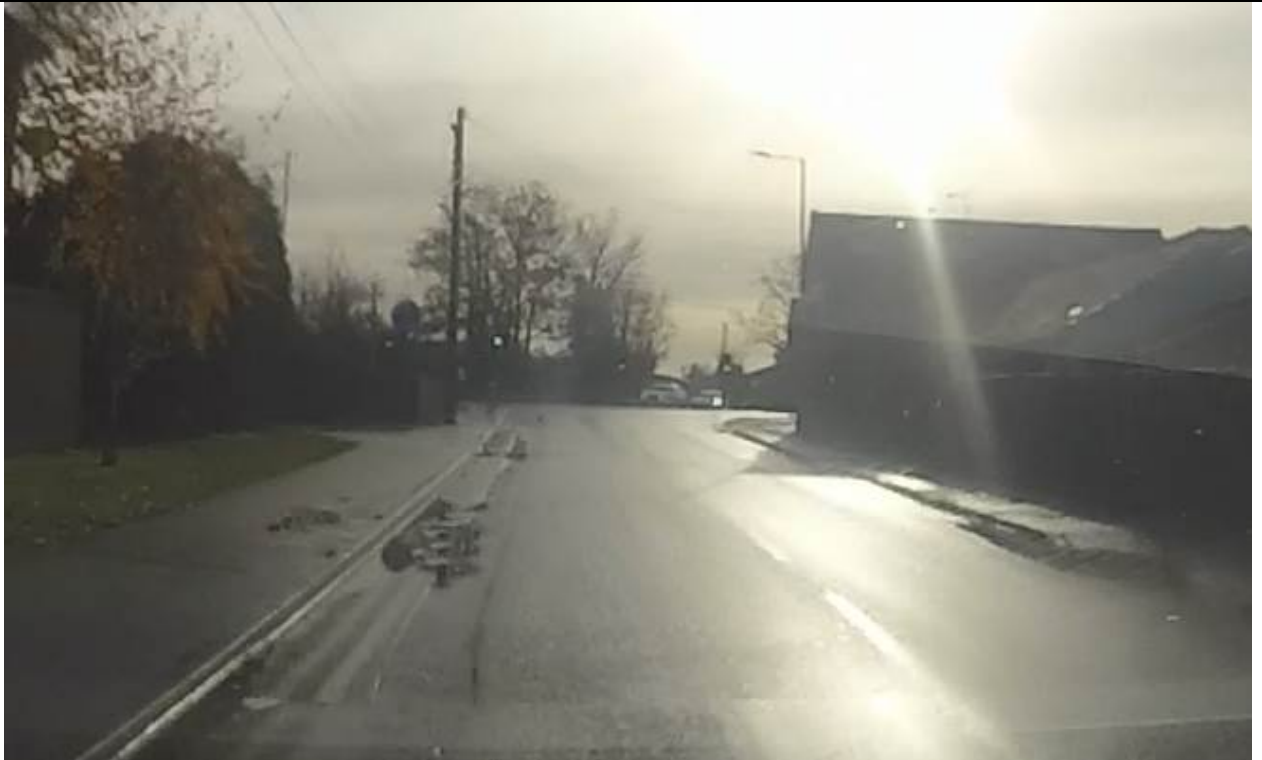
Image 5 – B1029 Bromley Road southbound approach to signalised junction

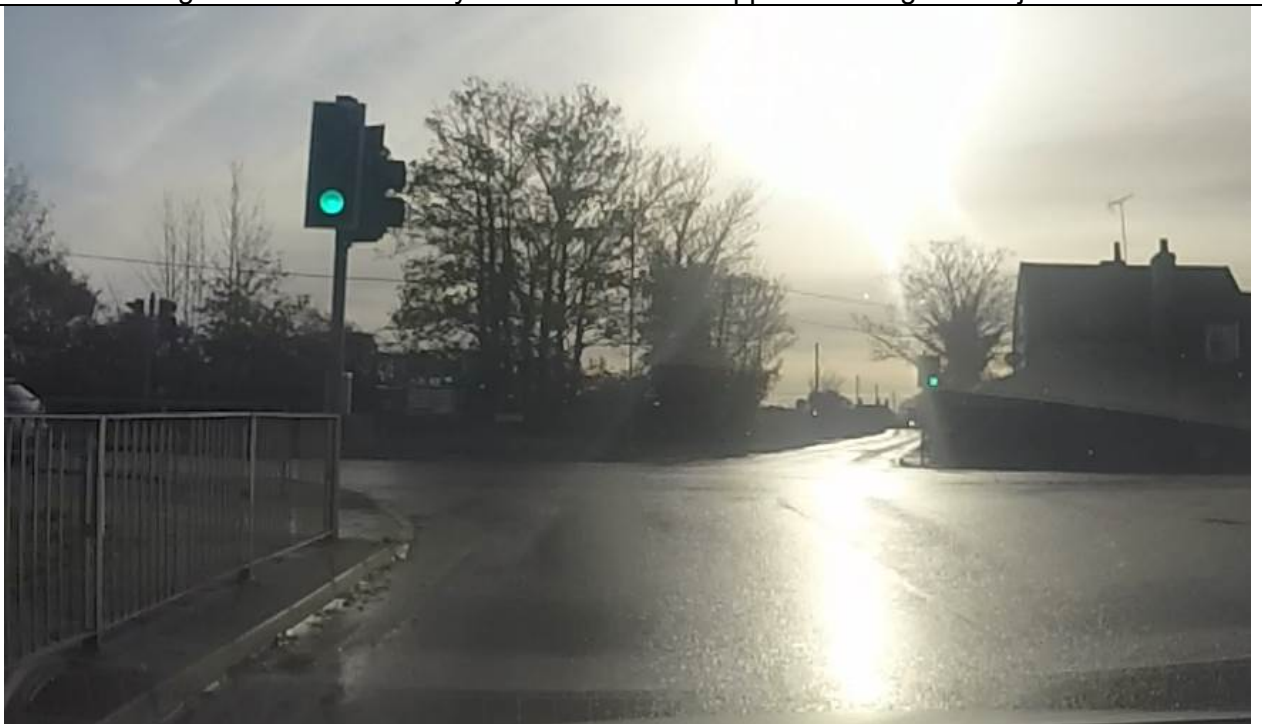
Image 6 – B1029 Bromley Road southbound at signalised junction

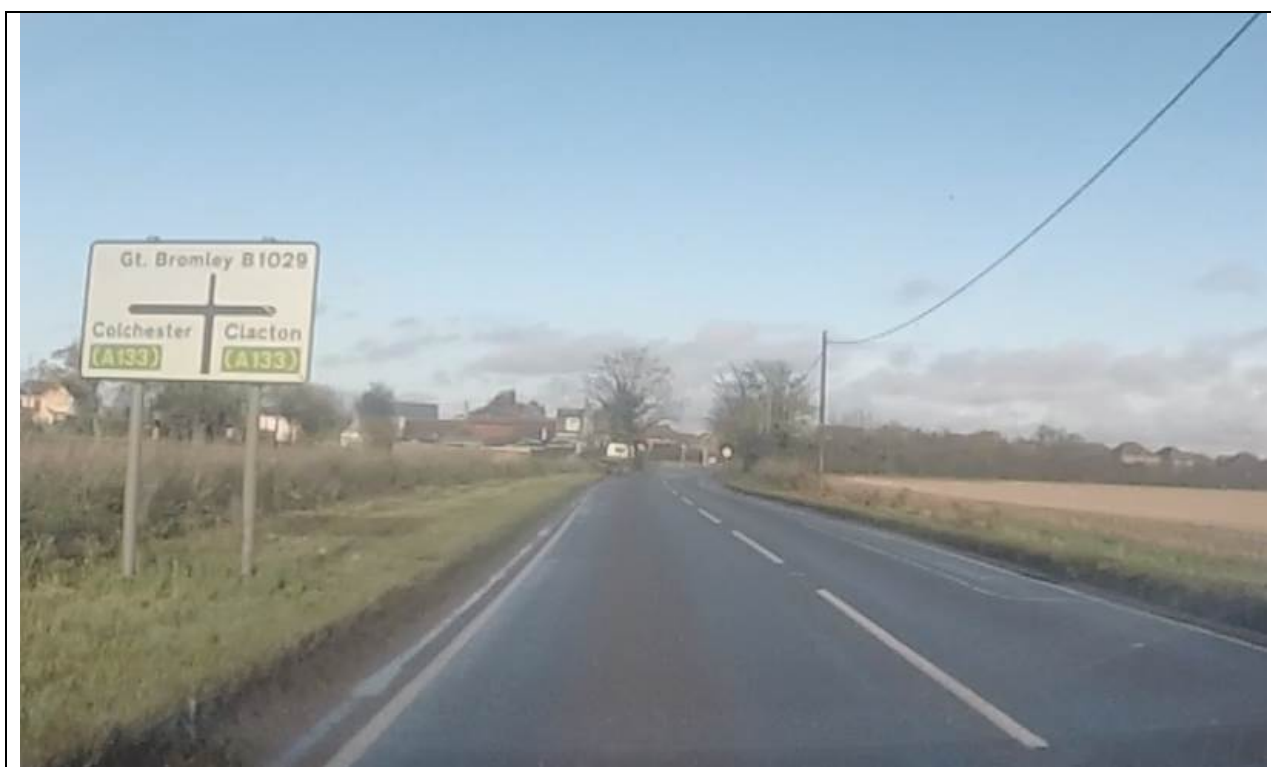
Image 7 – B1029 Great Bentley Road northbound approach to signalised junction
