Location: Site 004 – A414 jw M11 Harlow (Hastingwood Rd)
District: Epping Forest
Collision Investigation Period: 01/01/2017 and 31/12/2019
Site Ranking: 004 (Rural Site)

EXECUTIVE SUMMARY

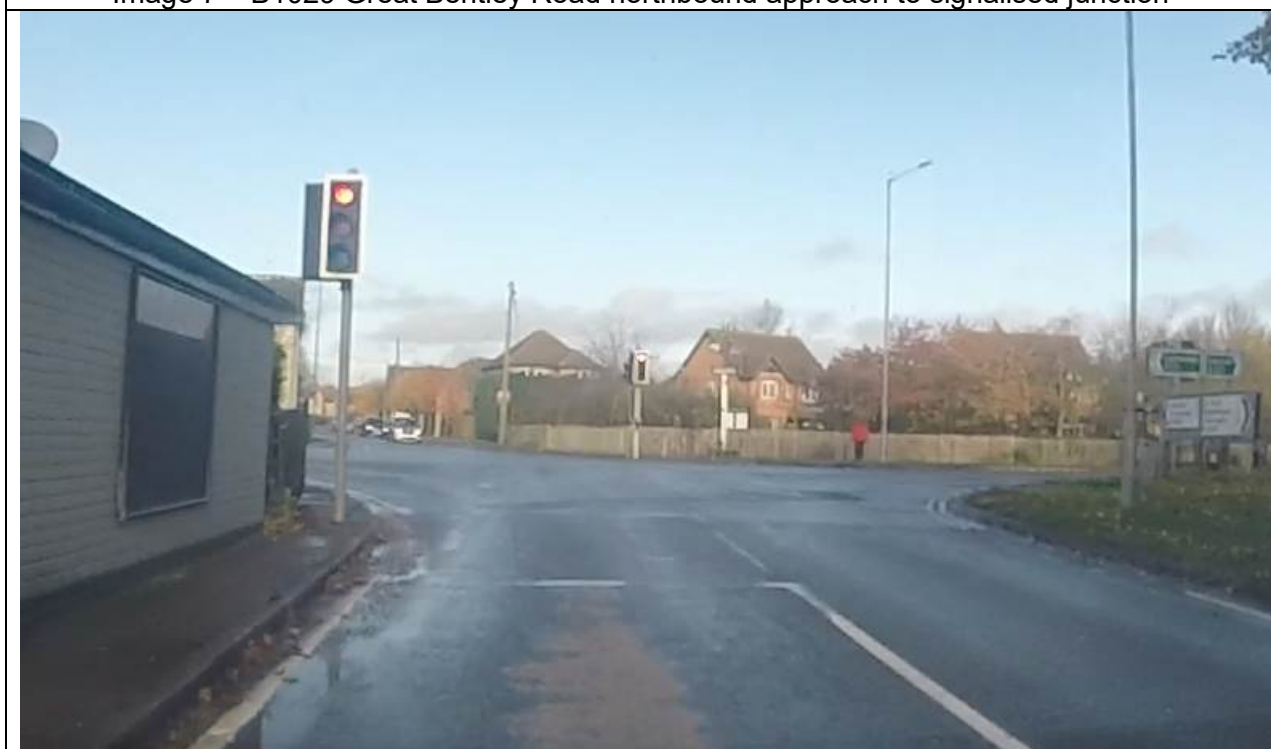
Image 8 - B1029 Great Bentley Road northbound at signalised junction

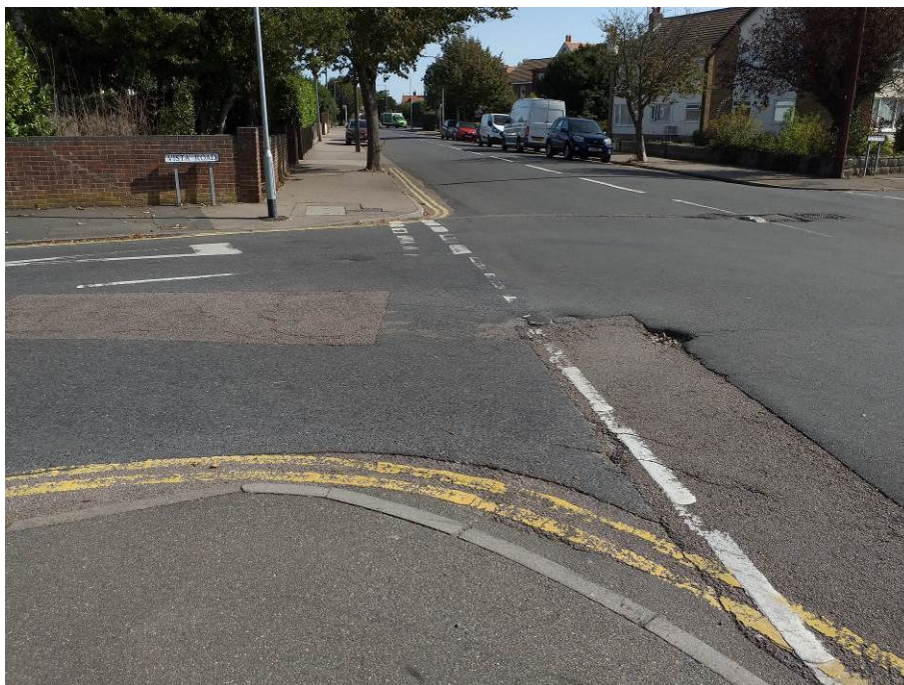
Details	Description/Observations
Road Name (s)	Skelmersdale Road jw Vista Road, Clacton-on-Sea
Grid Reference	618020, 215340
Speed Limit	30mph
Street Lit	Yes
Carriageway type	Skelmersdale Road is a wide 2 way single carriageway in a residential area. Vista Road is a 2 way single carriageway in a residential area.
Gradient	Level Gradient
Traffic Management / Existing Traffic Calming	Existing crossroads junction
Utilities Present	Potentially
Existing TRO's	None
Road Surface	Carriageway surface at the junction appears in poor condition (refer to Image 5)

Image 5: Carriageway condition at junction

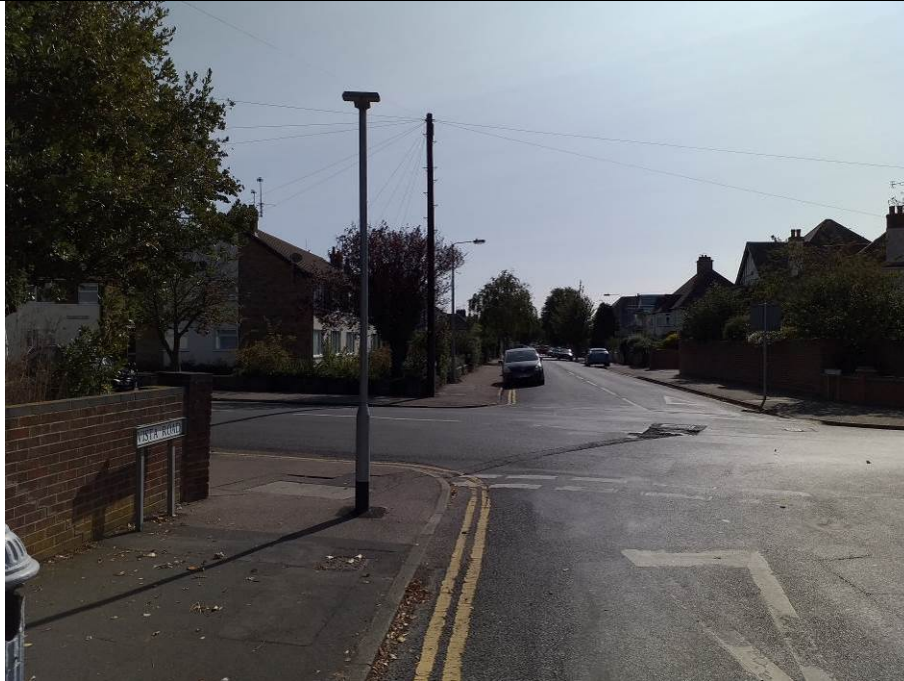
Signing	Crossroads warning signs on yellow backing boards located on Skelmersdale Road in both directions in advance of crossroads junction. Give Way post (sign missing) on Vista Road (north) at junction (refer to Image 6).		
Road Markings	Skelmersdale Road: <ul style="list-style-type: none"> 5 No centre line markings on eastbound approach to junction. The centre line continues eastward after the junction to B1032 Holland Road Vista Road (north): <ul style="list-style-type: none"> Centre line on approach to junction (badly faded) Give Way markings at junction (badly faded) Double yellow parking restrictions at junction to maintain visibility 		
Visibility	.Visibility to the right from Vista Road is good. Visibility to the left is partially obscured by sign post and existing tree in footway.		
Vegetation	N/A		
Highway Boundary / Land & Ownership Check?		Is the scheme within Highway boundary or on land owned by ECC(*)	Yes (*if the land is not highway the scheme should only proceed to feasibility design & land acquisition/dedication stage)

Image 6: Missing Give Way sign

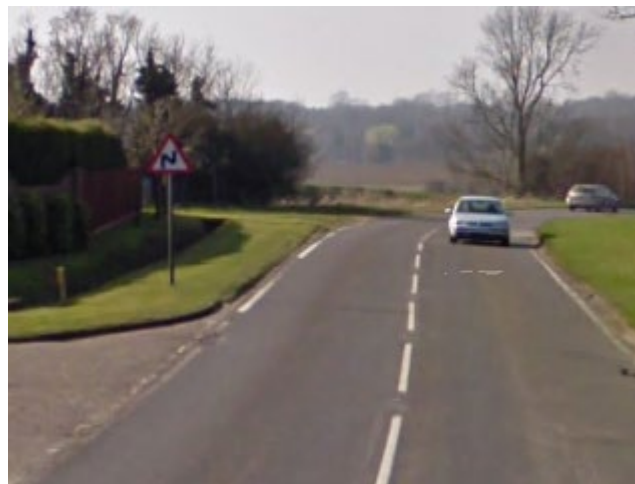
Image 4 – Westbound approach to bends showing 'Series of bends' warning sign

Intervention works: Provide enhanced (yellow backing boards) advanced 'Series of Bends Ahead' warning signs on both approaches, a (right hand) bend warning sign with an advisory 40mph speed limit sub-plate on the eastbound approach to this section of Chelmsford Road A1060. The existing chevron signs to be replaced with yellow backed chevron signs to improve conspicuity.
