Site Report Essex Highways Casualty Reduction Site Report 2019/20

Location: A176 Uppermayne Roundabout Junction with A176 Noak Hill Road, South Wash Road & A127 Eastbound Off-slip, Noak Bridge

Collision Investigation Period: 01/01/2015 – 31/12/2017

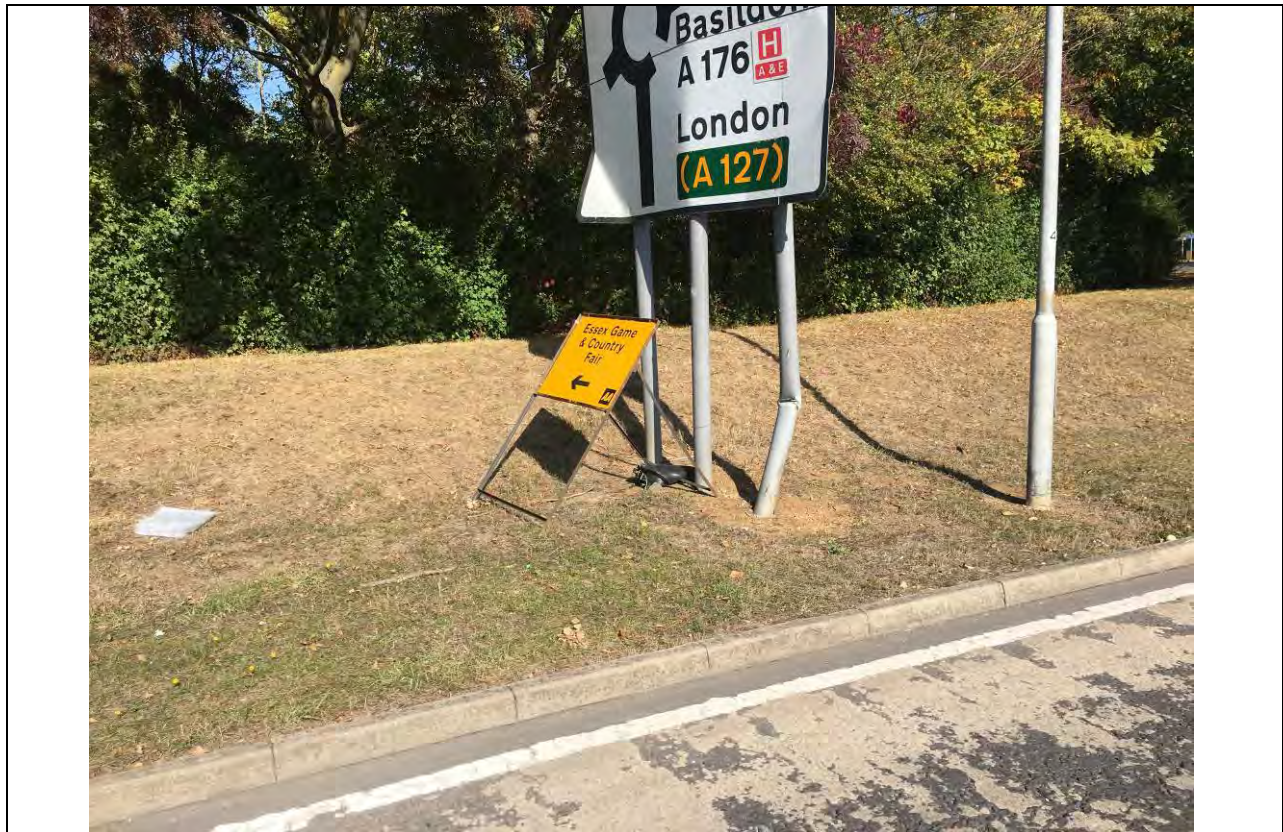
Image 1 – Damaged ADS sign on eastbound approach

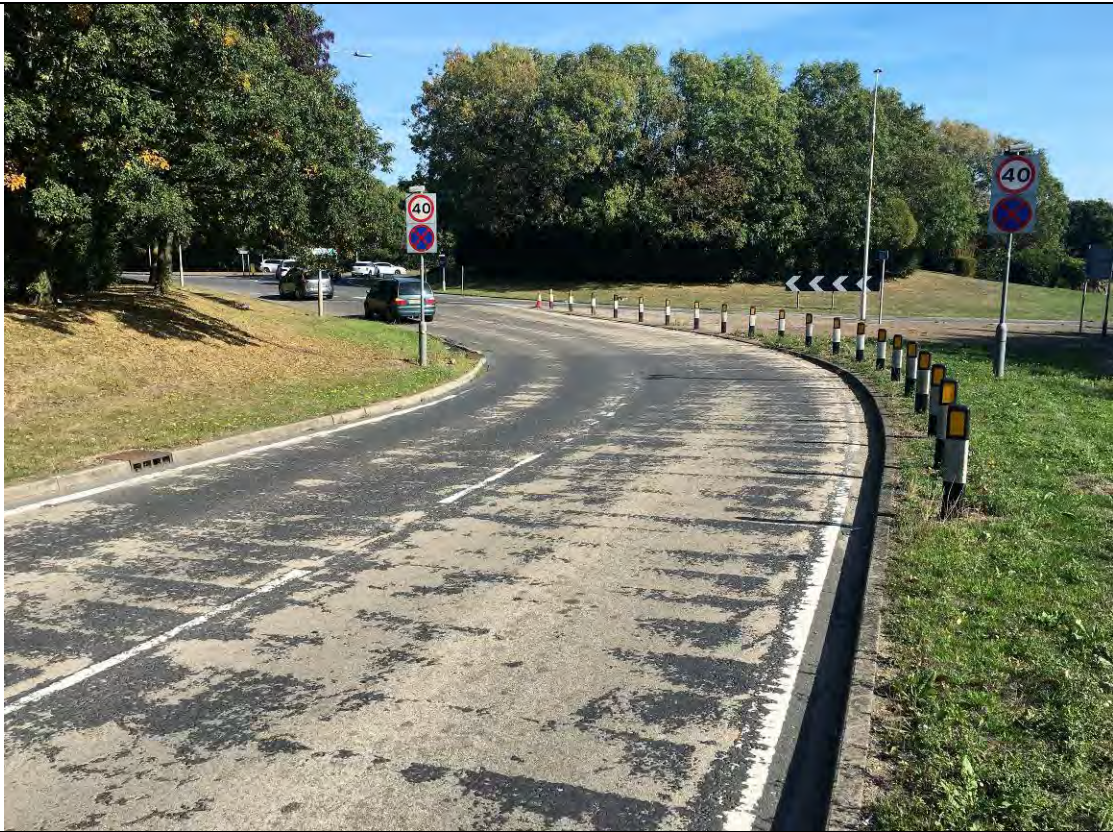
Image 2 – 40mph speed limit signs & clearway signs on the eastbound approach.
Worn edge of carriageway and centre line road markings.

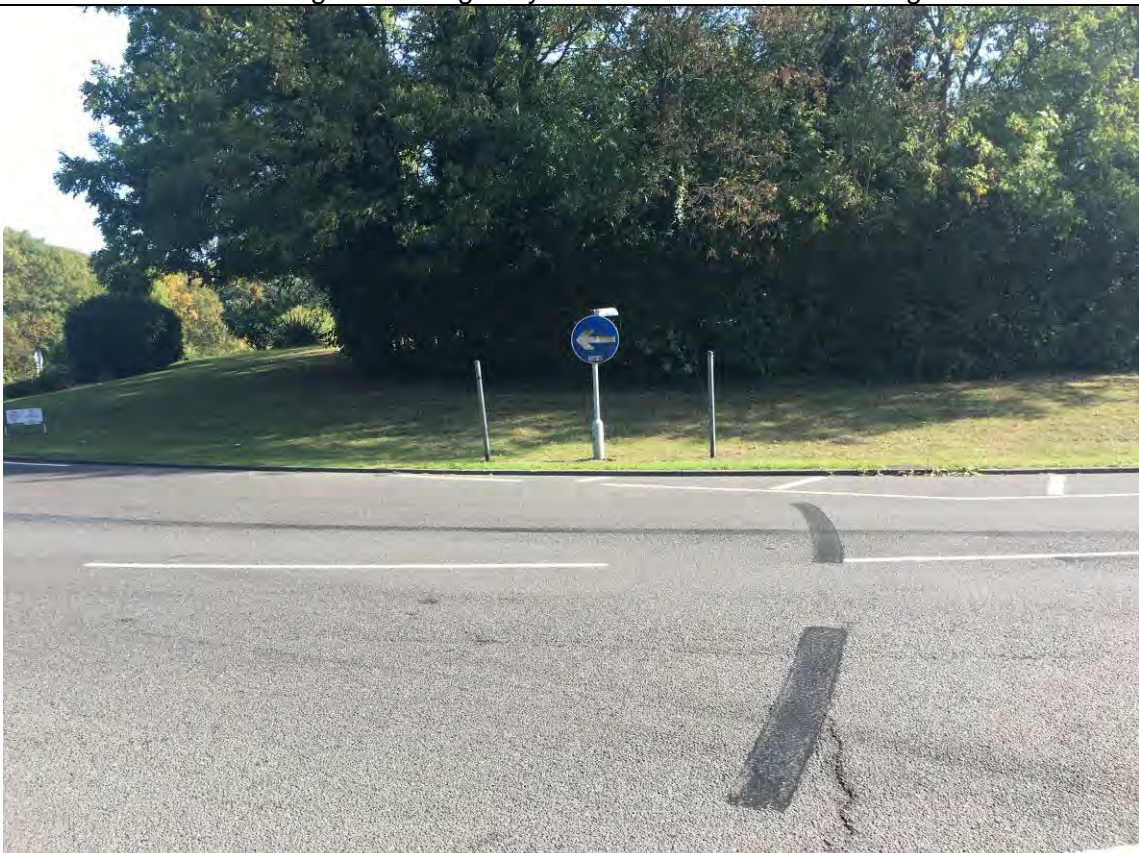
Image 3 – Chevron sign is missing from sign posts on the eastbound approach

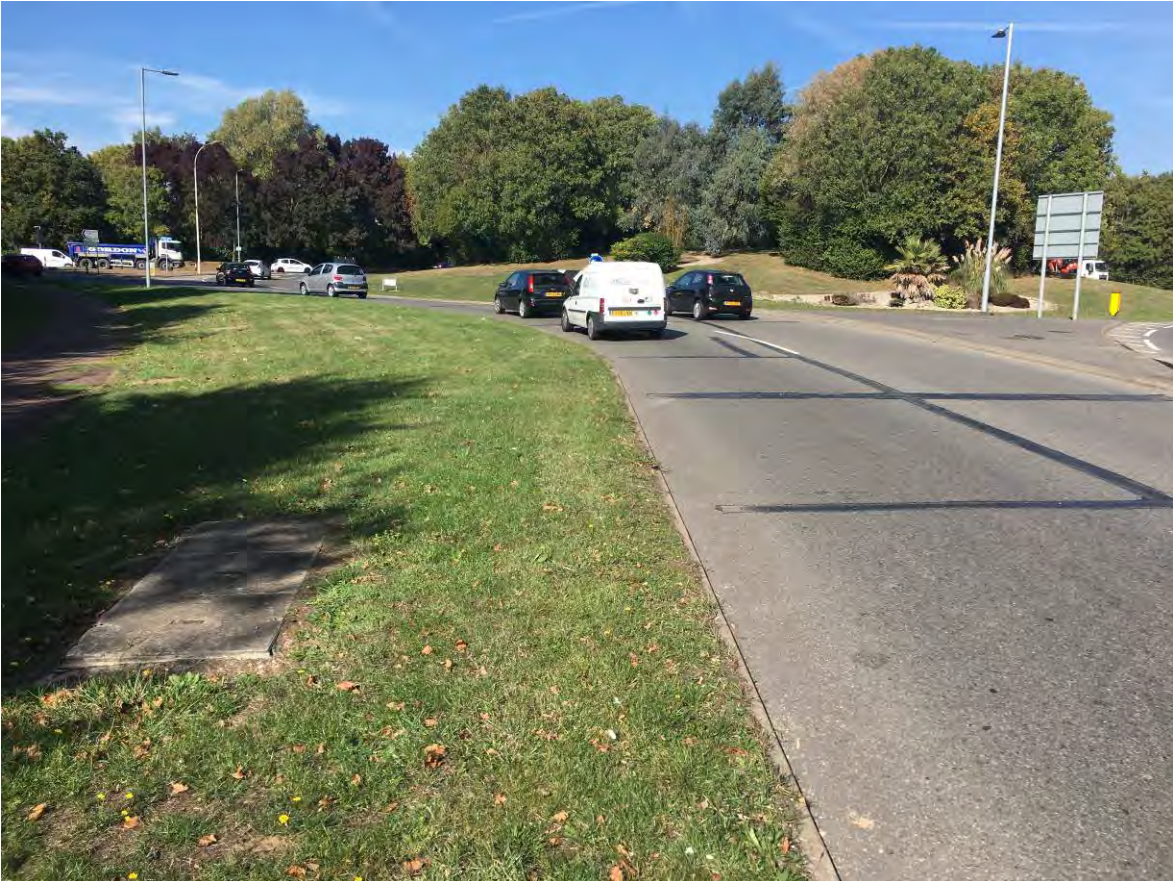
Image 6 – Lane line road marking obscured by joint repairs on northbound approach

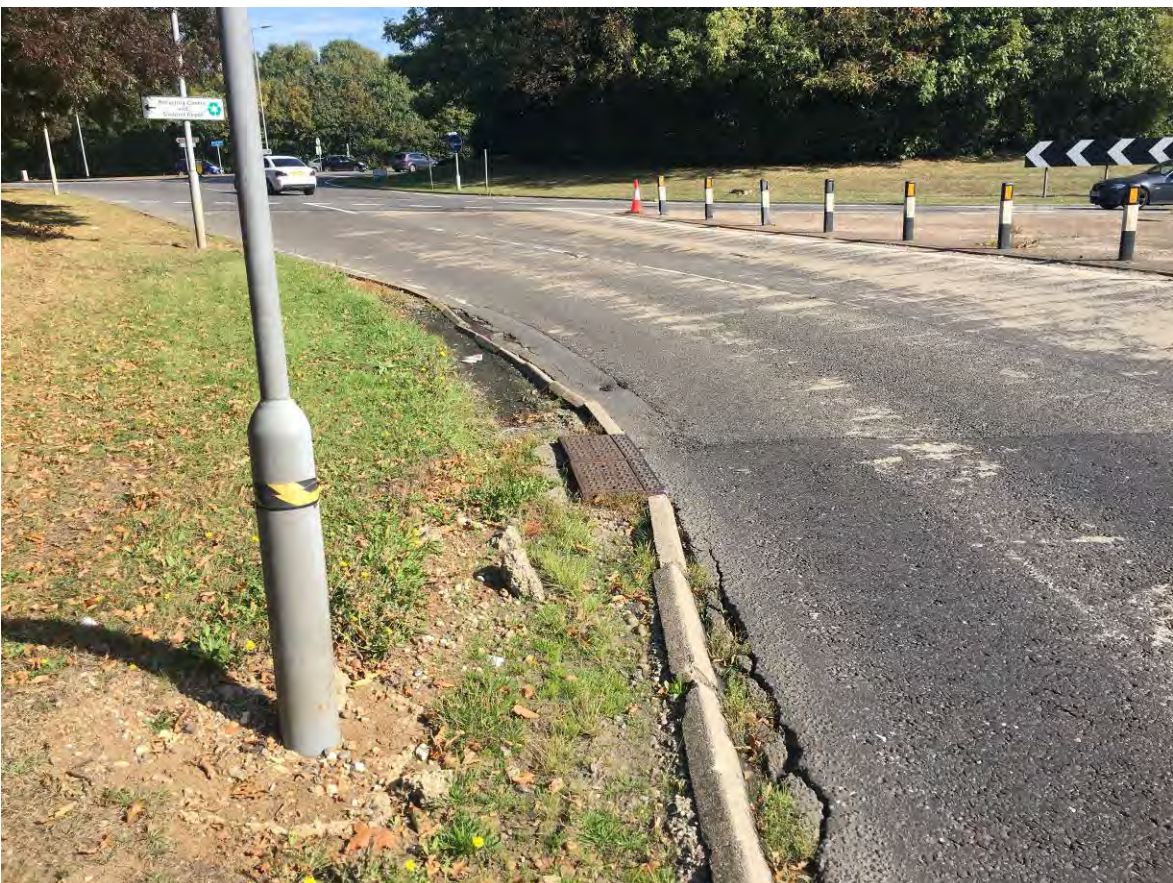
Image 7 – Nearside kerbing & verge on the eastbound approach has been over run

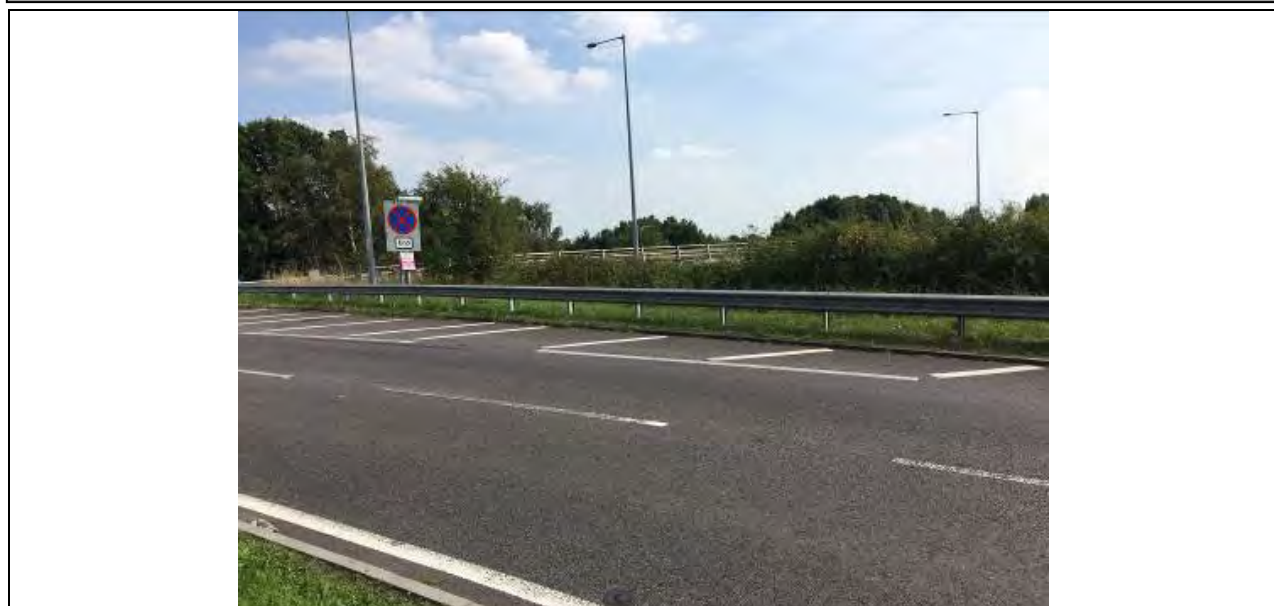
Image 1 – Excessive visibility to the right on the approach to the roundabout junction

- 1) It is recommended that 'approach screening' be provided to the offside of the eastbound off-slip to a point 15m in advance of the give way line. This is proposed in order to reduce excessive visibility of other vehicles on the northbound overbridge over the A127 in order to reduce approach speeds on the off-slip.
- 2) It is recommended that all vegetation is removed from the area to the offside of the off-slip within 15m of the give way lines, and this be made an area of hardstanding in order to reduce the potential for future growth and the need for ongoing maintenance.

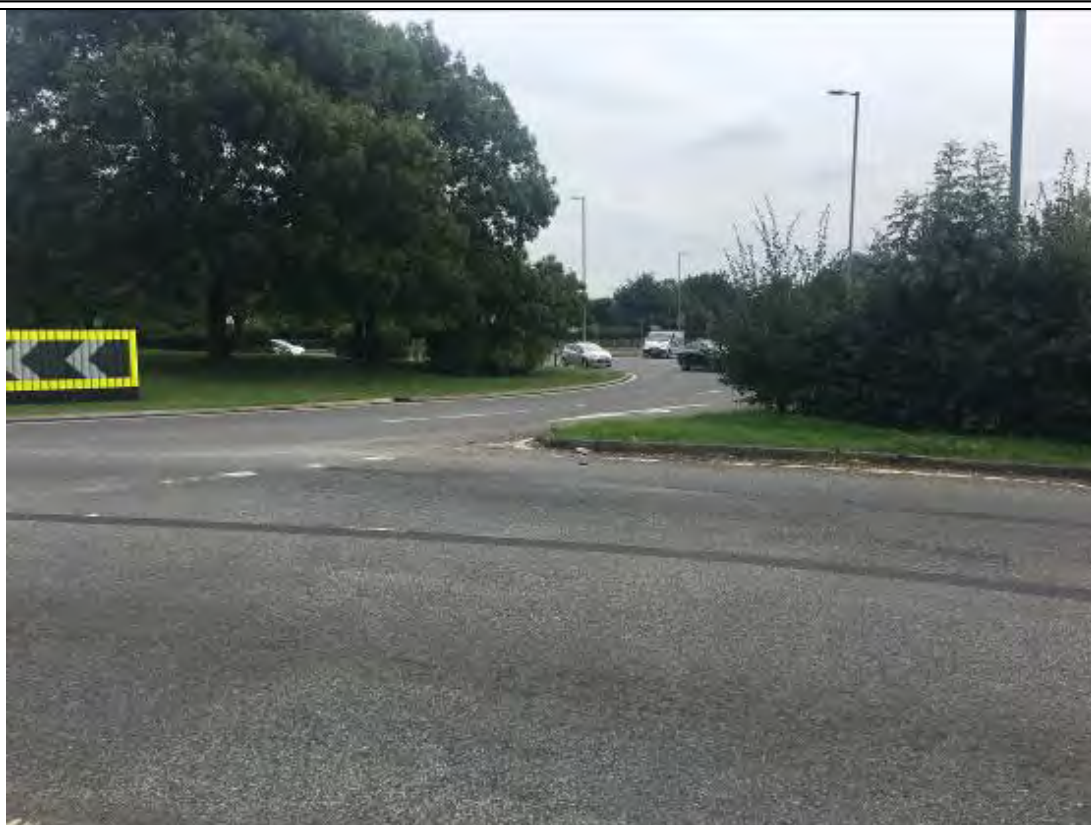
Image 1 – Existing highway screening / hedgerow terminates immediately adjacent the give way lines, impeding the visibility splay for eastbound motorists

- 1) It is recommended that the existing highway screening / hedgerow should be amended so that it terminates 15m in advance of the give way lines in order to improve the visibility splay of motorists on the roundabout circulatory.

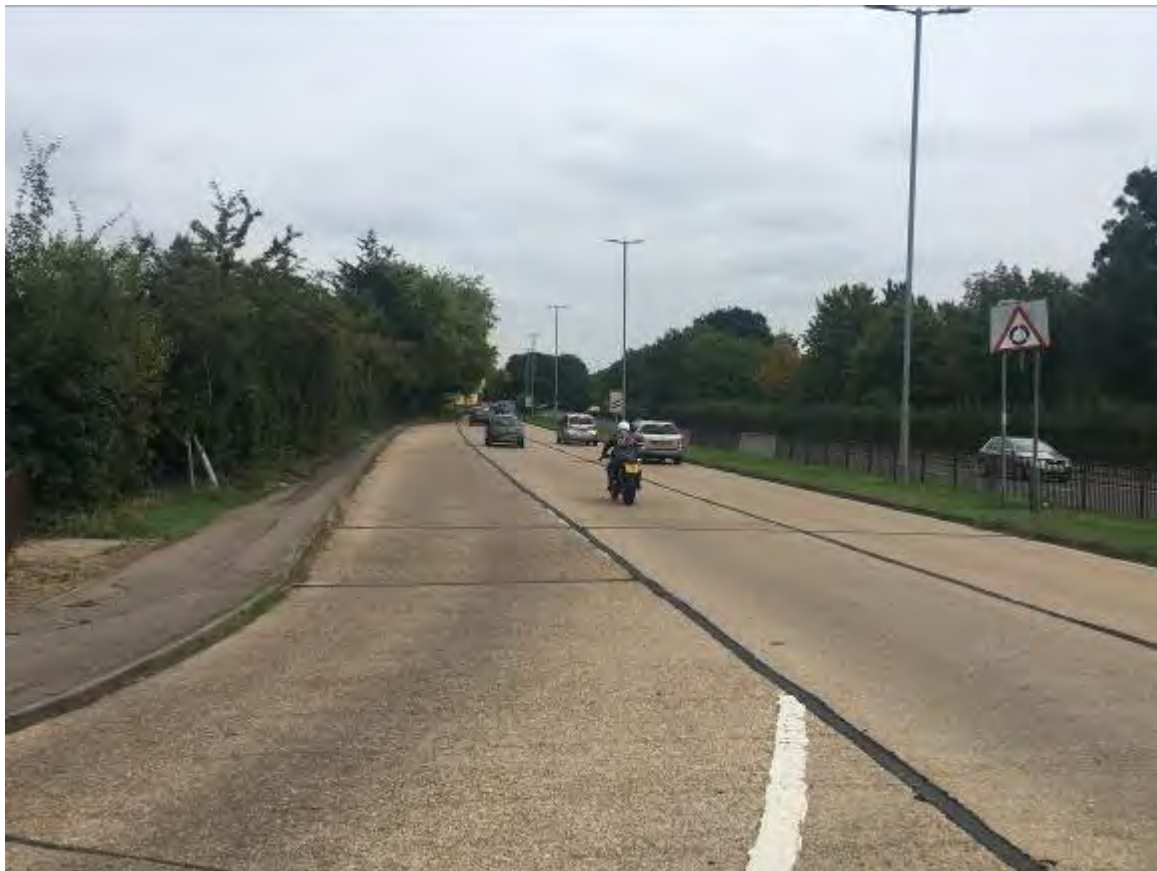
Image 3 – Existing 'Roundabout ahead' warning signs are damaged / partially missing

- 4) It is recommended that the existing damaged / partially missing nearside & offside 'Roundabout ahead' warning signs should be repaired / replaced with yellow backed versions with 'Reduce speed now' supplementary plates.

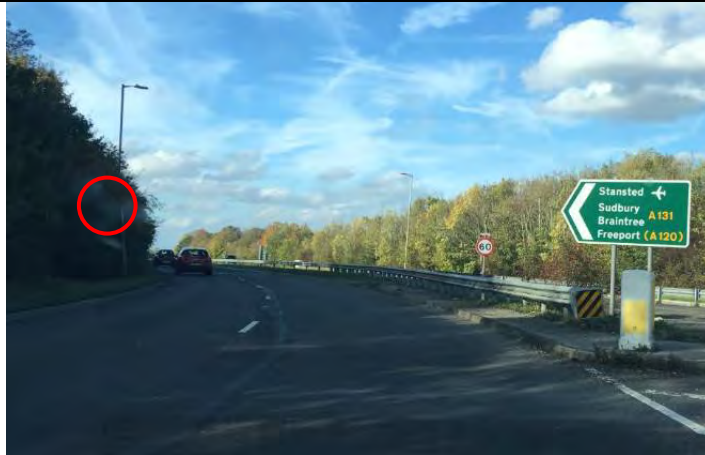
Image 2 – View looking at the circulatory for A131 northern arm when heading south. Image shows motorist not indicating to head north on the A131

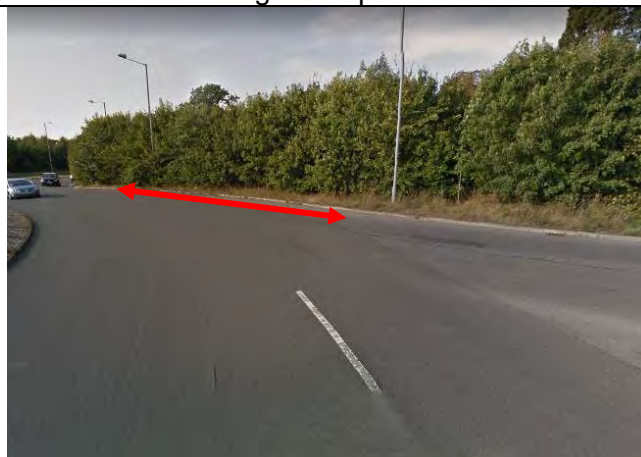
Image 5 – View looking south west on circulatory of the roundabout, image showing area to be hatched out to reduce lane widths.

- 4) It is recommended that the nearside of the roundabout circulatory for the western arm to northern arm is partially hatched out to help narrow the road and reduce speeds on the circulatory. It may also be necessary to provide a hatched section on the circulatory between the lanes 1 and 2 for motorists heading towards London Road. It is recommended that this is drawn up to establish if this is achievable.

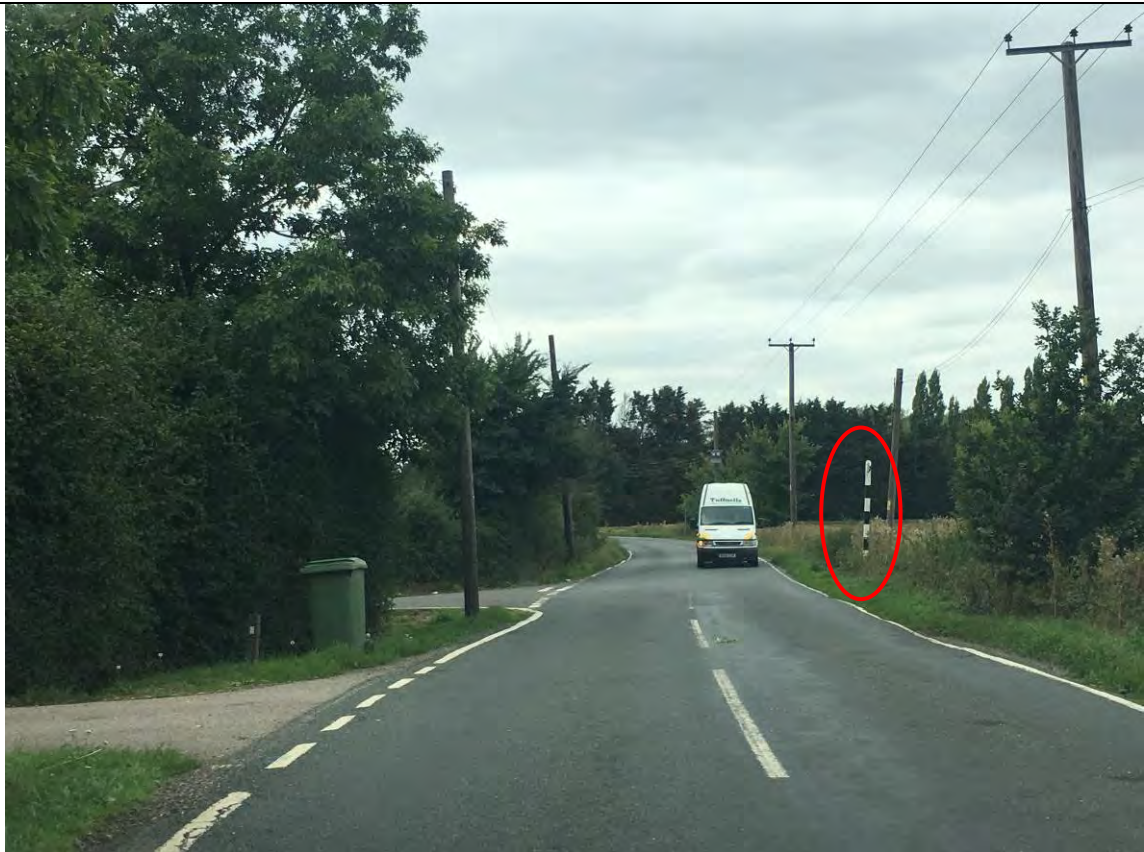
Image 4 – Existing finger post directional sign with sign facing into St Annes Road missing

- 3) It is recommended that a new yellow backed 'Side road ahead' warning sign should be provided on the Thoby Lane westbound approach.
- 4) It is recommended that the existing finger post directional sign located opposite the junction should be replaced with a more substantial flag type sign to improve conspicuity of the junction.

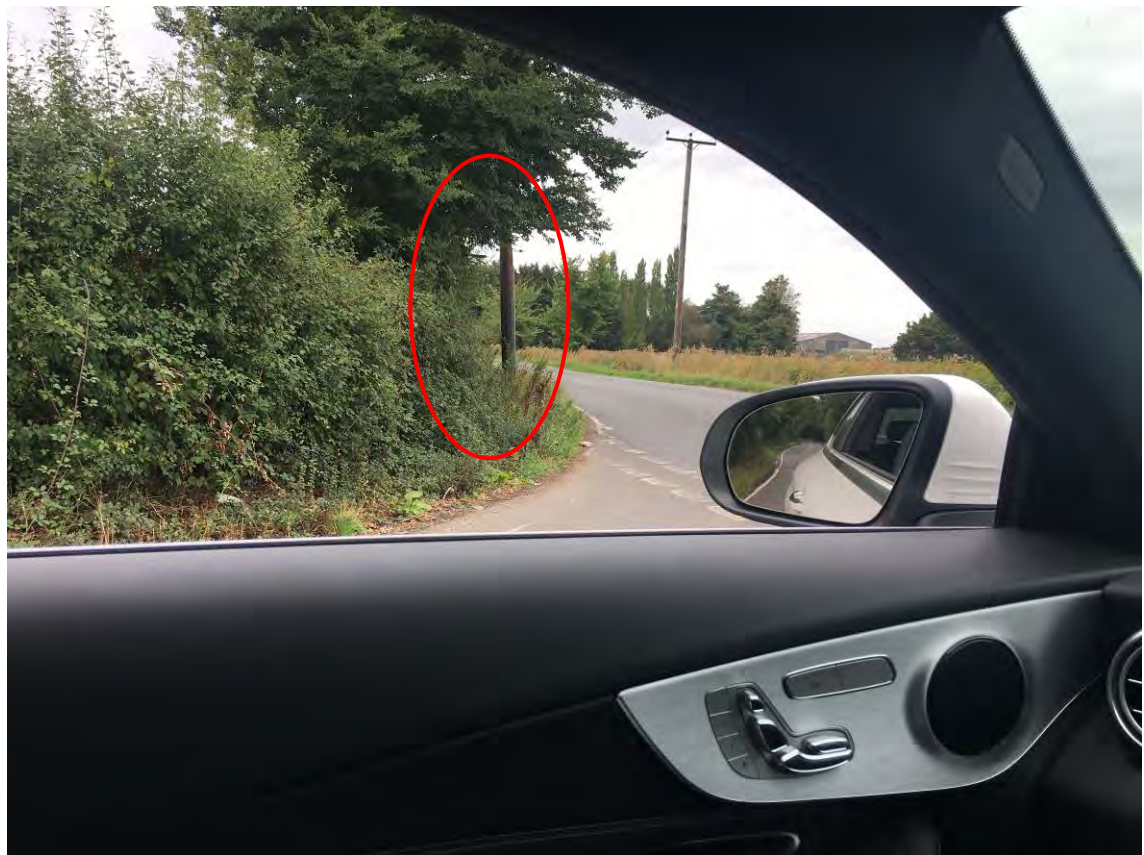
Image 5 – Telegraph pole and overgrown vegetation located the within visibility splay to the left when sitting in at the give way lines on St Annes Road

- 1) It is recommended that any overgrown vegetation located within the visibility splay should be cut back and maintained on a regular basis.
- 2) It is recommended that the existing 'Side road ahead' warning sign on the Thoby Lane eastbound approach should be replaced with a new yellow backed version and overgrown vegetation should be cut back and maintained on a regular basis, or the sign should be relocated to an area without adjacent vegetation.

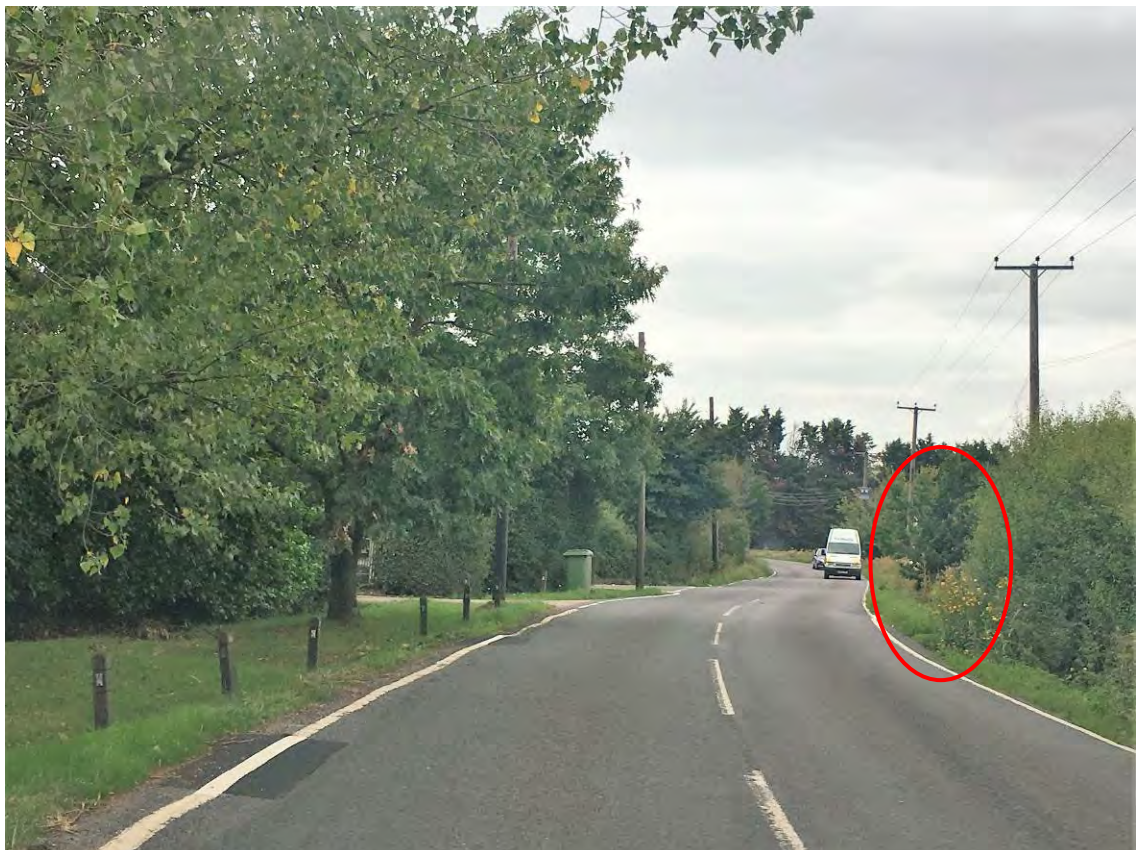
Image 7 – Overgrown vegetation to the northern side of Thoby Lane restricts forward visibility to the existing finger post directional sign opposite St Annes Road

- 5) It is recommended that the area of overgrown vegetation located along the northern side of Thoby Lane to the east of the junction should be cut back and maintained on a regular basis in order to improve forward visibility to the new flag type sign.

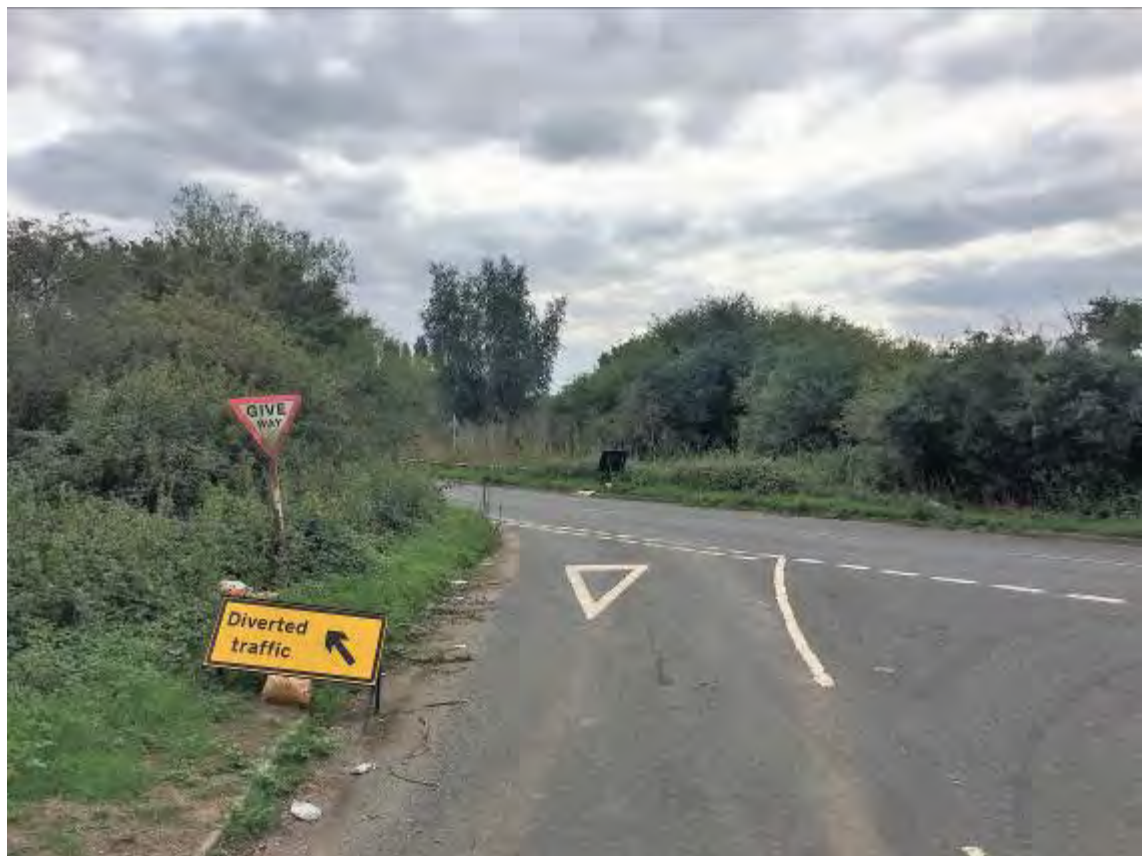
Image 5 – Existing 'Give way' sign on Old Church Lane westbound approach (Southern section) is partially soiled / dirty and the sign post appears to be rusty.

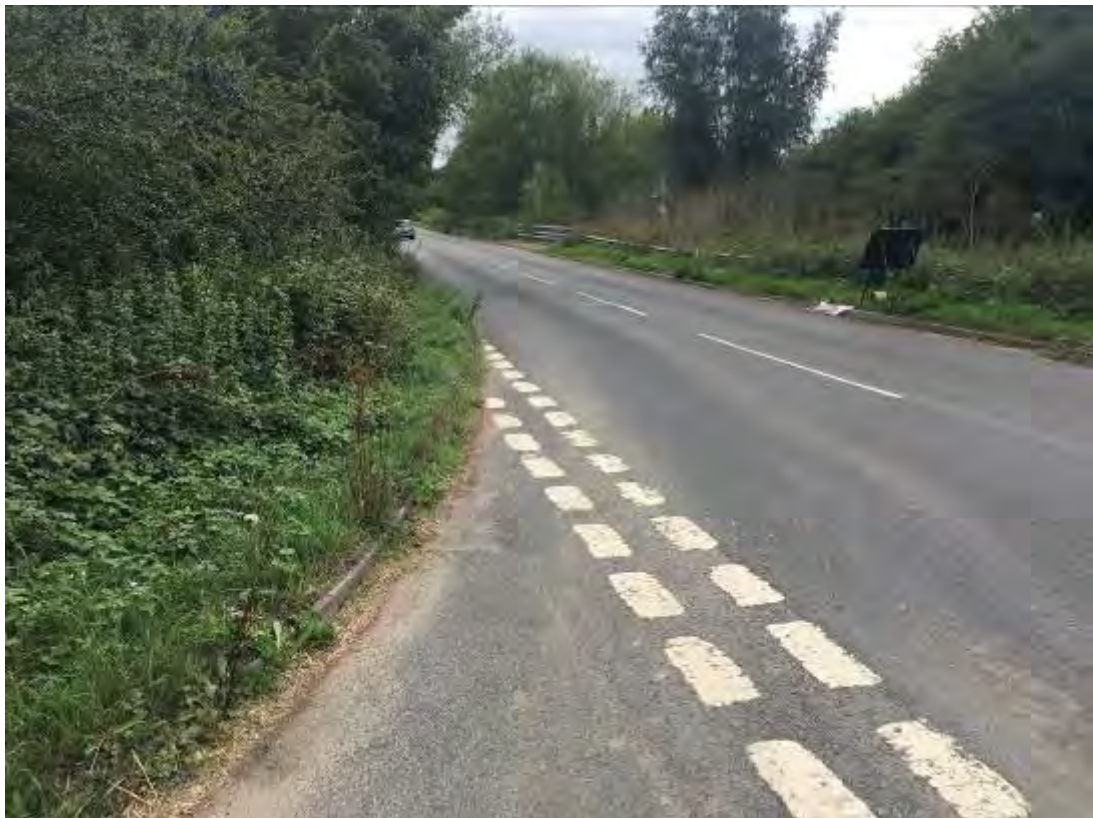
Image 7 – Visibility to the left from give way lines on Old Church Lane westbound approach (Southern Section) is partially obscured by overgrown vegetation.

- 1) It is recommended that any overgrown vegetation located within the visibility splays should be cut back and maintained on a regular basis, including the area to the inside of the sharp bend (Subject to highway boundary). Overgrown areas of vegetation surrounding and/or obscuring existing chevron signs should also be cut back and maintained on a regular basis.
- 2) It is recommended that the existing 'Side road on bend ahead' warning signs on both Wash Road / Widvale Road approaches should be replaced with new yellow backed versions.
- 3) It is recommended that a new 'Give way' sign assembly should be provided on the Old Church Lane westbound approach (Southern section).

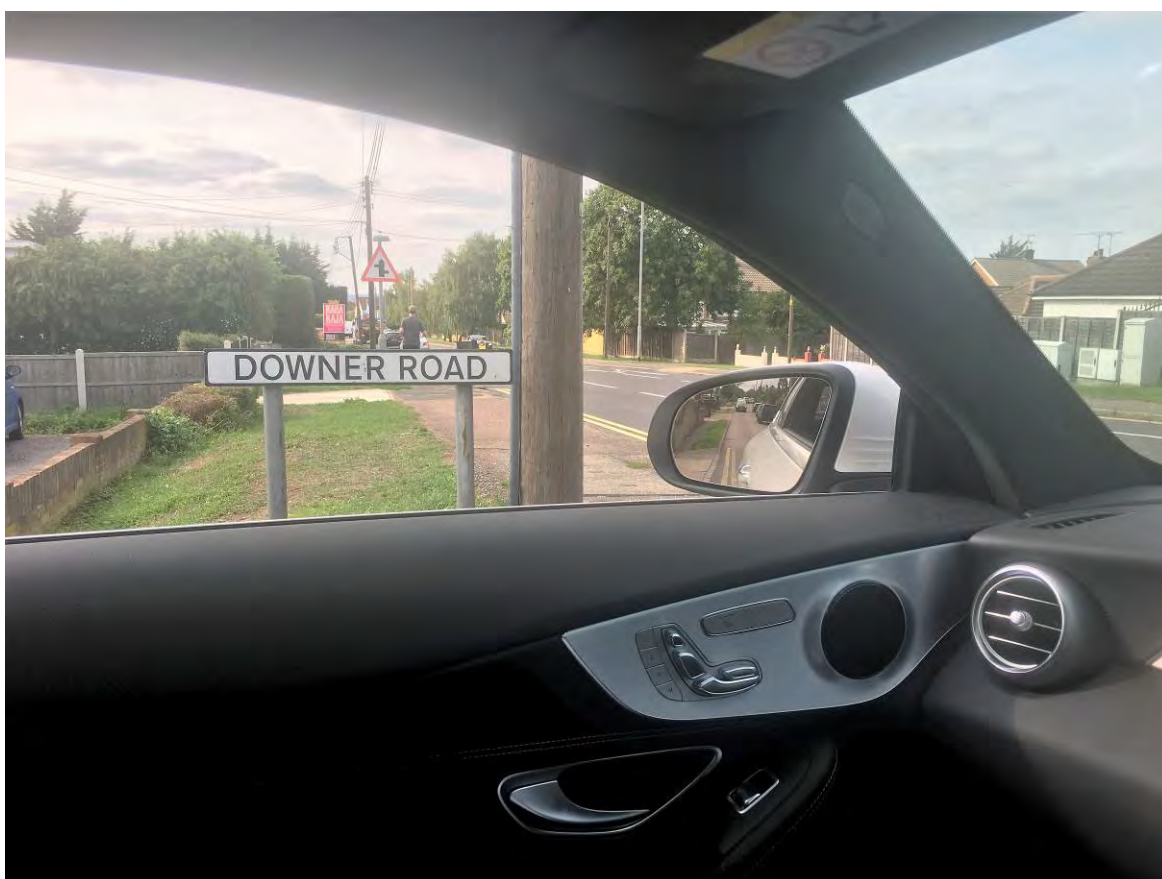
Image 3 – Visibility to the left obscured by a telegraph pole and street name sign

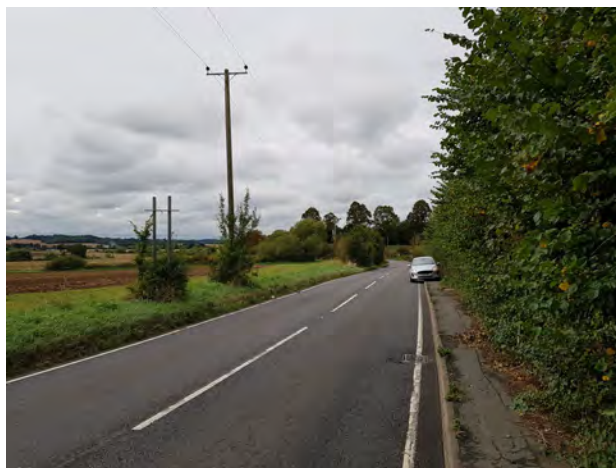
Image 2 – Romford Rd south bound approach to bends (sign missing)

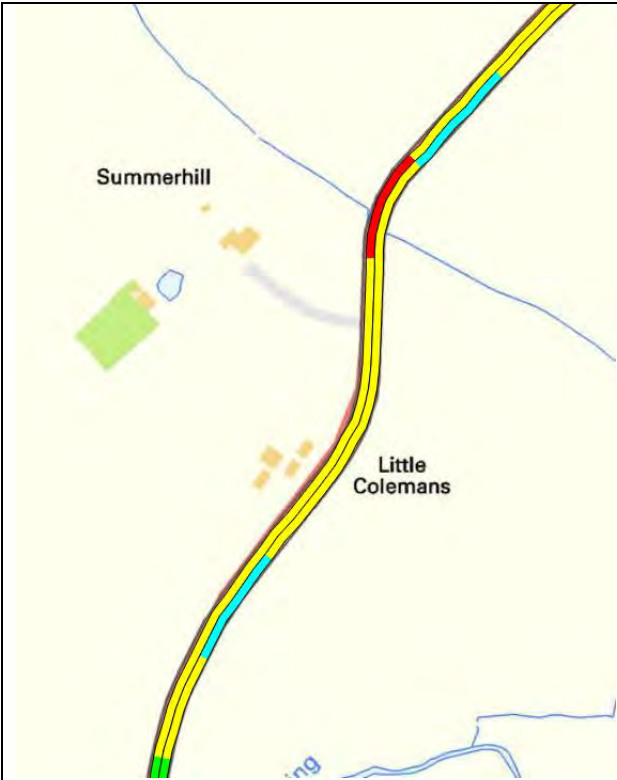
Image 3 – SCRIM Data 2017
Yellow = Below Investigatory Level
Red = Critical Level

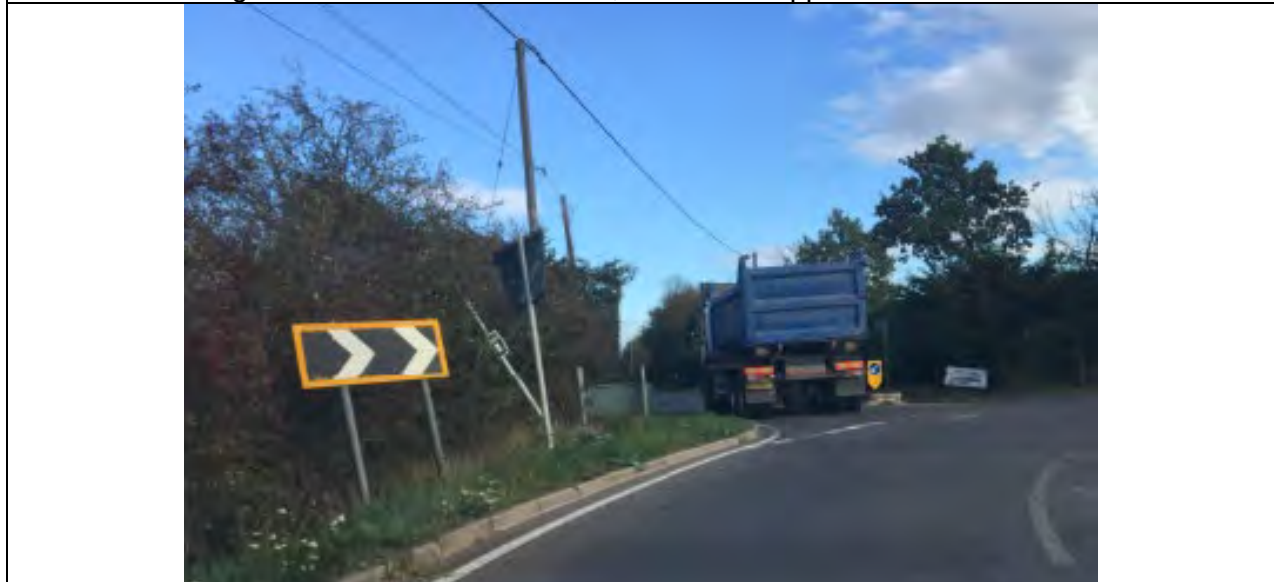
Image 2 – B1018 Burnham Road; damaged signing at bend in road and junction

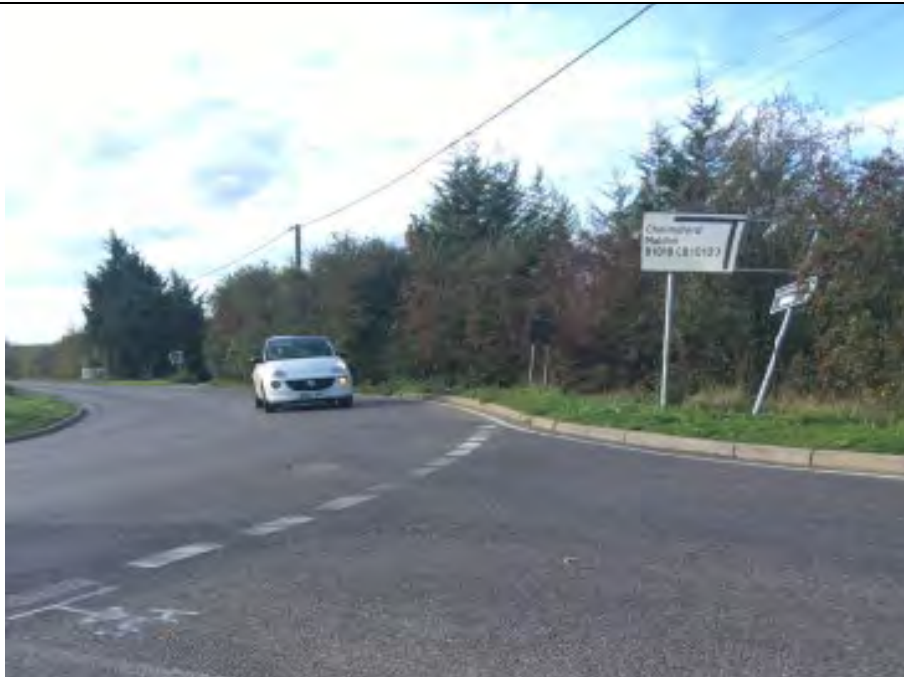
Image 3 – Green Road; damaged signing at junction (looking towards Burnham Road)

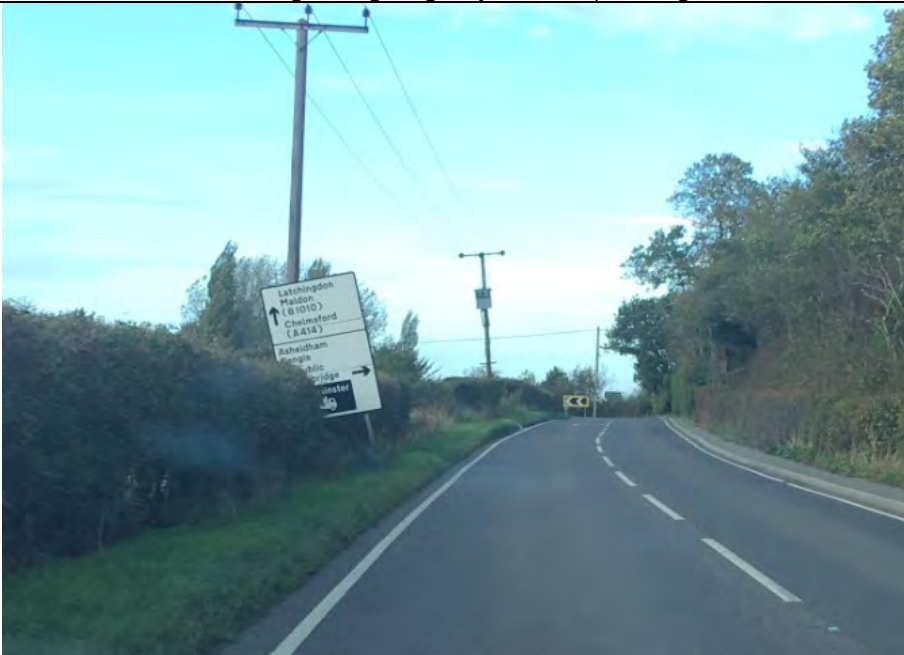
Image 4 – B1018 Burnham Road; damaged direction sign along northbound approach to bend
