BRAINTREE FLAGSHIP CYCLE ROUTE

STAGE 1 ROAD SAFETY AUDIT

Dated	24 th June 2019
Registration Code:	8145
Replicon Code:	E08-084N-007

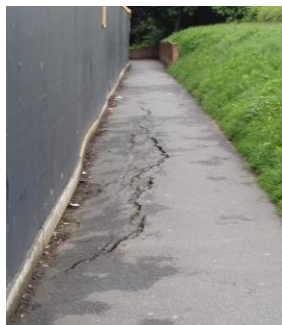
During the site visit it was observed that the surface of the existing shared use facility is in poor condition and appears to be subsiding (See RSA1 Image 1 below). Further deterioration of the surface could lead to cyclists losing control and colliding with pedestrians and/or other cyclists.

RSA1 Image 1 – Existing shared facility surface

It is recommended that improvements are made to these facilities as part of these proposed to provide a suitable surface.

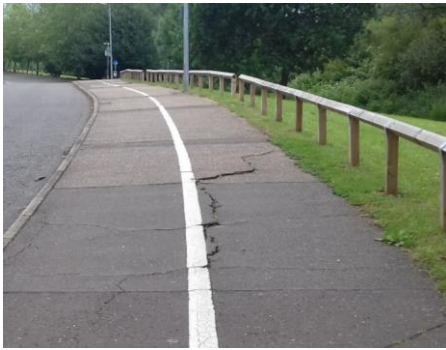
RSA1 Image 2

During the site visit it was observed that the surface of the existing segregated facility on Tortoiseshell Way is in poor condition (See RSA1 Images 2 and 3 below). Further deterioration of the surface could lead to cyclists losing control and colliding with pedestrians and/or other cyclists. It could also present a trip hazard to pedestrians particularly those with mobility or visual impairment.

It is recommended that improvements are made to these surfaces as part of the proposed scheme.

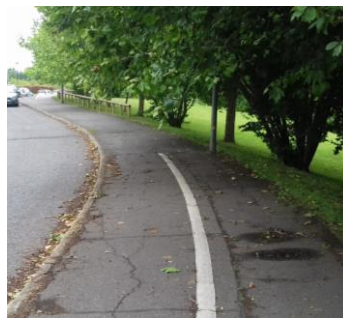
It was noted at the time of the site visit that there is low hanging vegetation obstructing the existing segregated facility on Tortoiseshell Way (see RSA1 Image 4 below). If not removed the vegetation cyclists may make sudden deviations in order to avoid striking the branches. This could lead to collisions with other cyclists or pedestrians.

RSA1 Image 4 – low hanging vegetation.

It is recommended that the vegetation is cut back/removed and maintained on a regular basis.

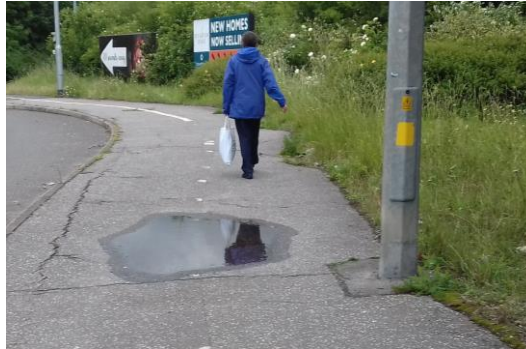
During the site visit it was noted that there was a low area with standing water within the existing segregated facility adjacent to the roundabout at the junction of the B1256 and London Rd. (See RSA1 Image 5 below). In conditions of freezing weather this standing water could form to ice and present a hazard for both cyclists and pedestrians.

RSA1 Image 5 – Standing water within existing facility

It is recommended that improvements are made to these facilities as part of the proposed scheme.

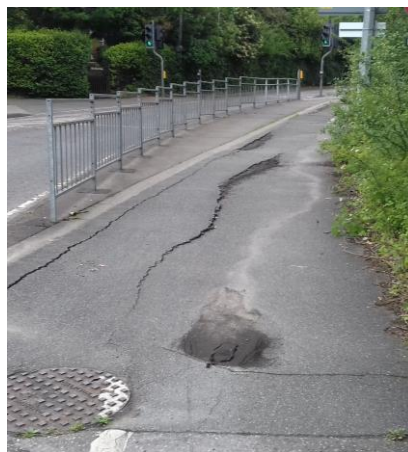
It was noted at the time of the site visit that the surface of the existing shared use facility to south of B1256 London Rd Rbt. is poor condition (See RSA1 Image 6) Further deterioration of the surface could lead to cyclists losing control and colliding with pedestrians and/or other cyclists. It could also present a trip hazard to pedestrians particularly those with mobility or visual impairment.

RSA1 Image 5 – Surface in poor condition

It is recommended that improvements are made to these facilities as part of the proposed scheme.

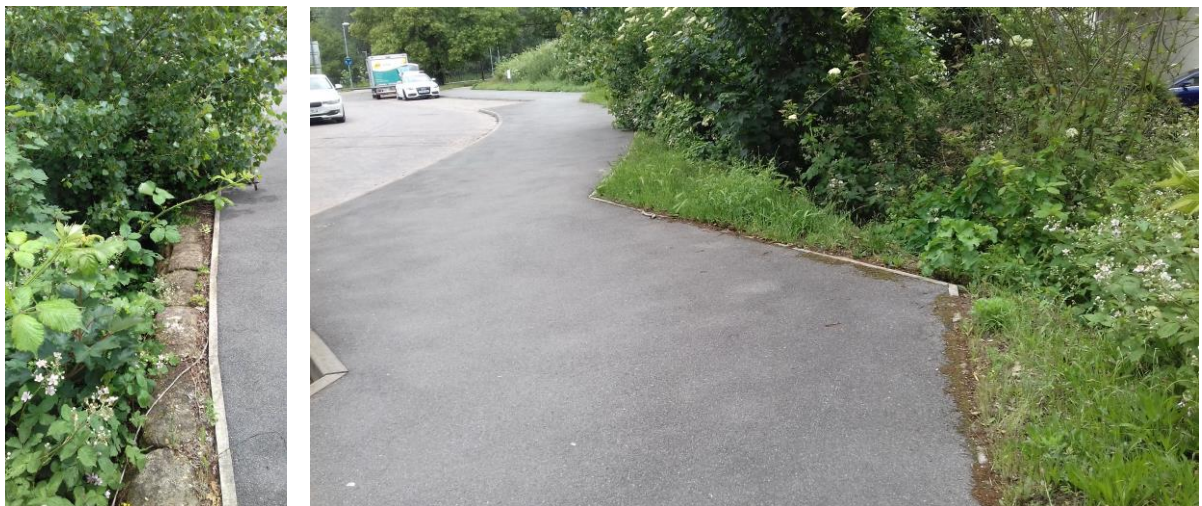
During the site visit it was observed that the existing shared use facility in St Johns Avenue is immediately adjacent to an extremely steep embankment to an adjacent watercourse (see RSA1 Images 6 & 7 below). The Audit Team have concerns that cyclists or pedestrians, particularly young children, moving close to the edge of the shared facility may not be aware of the steep embankment and could fall leading to serious injuries.

RSA1 – Images 6 & 7 – Steep embankment close very to shared use facility

It is recommended that a pedestrian barrier is provided along this section of the cycle route.

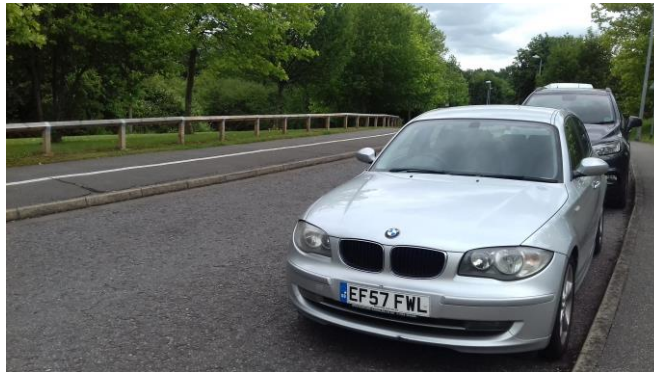
During the site visit it was observed that there were a number of vehicles parked immediately adjacent to the crossing point on Tortoiseshell Way (See RSA1 Image 8 below). These parked vehicles present an obstruction to inter-visibility between cyclists/pedestrians and approaching motorists. This could lead to cyclists/pedestrian entering the carriageway and into the path of oncoming vehicles leading to injury.

RSA1 Image 8 – Vehicles parked close to crossing point

It is recommended that Waiting Restrictions are implemented in the vicinity of the crossing point to ensure that suitable inter-visibility between cyclists/pedestrians and motorists is provided.

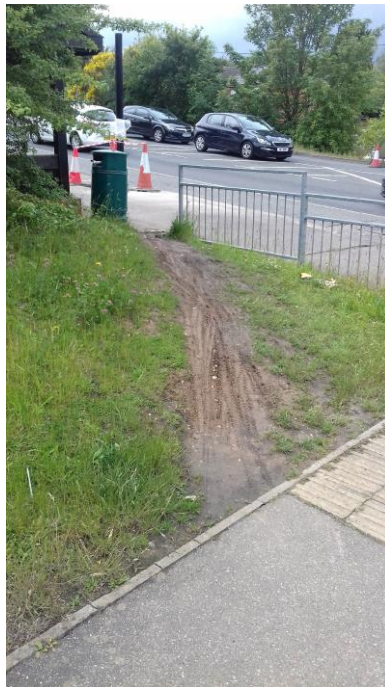
It was noted during the site visit that there is a worn track which circumvents the pedestrian guard rail at the junction of the existing shared use facility at Tortoiseshell Way and London Rd. (See RSA1 Image 9 below). Whilst there are no reported incidents at this location if the route is to be promoted to pedestrians and cyclists, there is likely to be an increase in the number of users. This could increase the likelihood of conflict and collisions between south-west bound cyclists and pedestrians at the bus stop area.

RSA1 Image 9 – Worn track adjacent to Bus Stop

It is recommended that additional panels of Pedestrian Guard Rail are installed to prevent the circumnavigation of the existing railings.

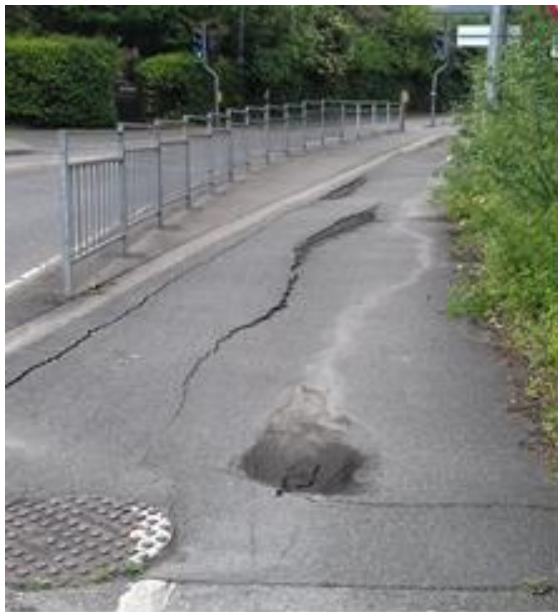
Drawing B355376A-11-00-004 shows a note stating “*Short Term: Remove existing pedestrian guardrail. Remove lining, tactiles and signing associated with segregation and replace with unsegregated equivalents. Trim back vegetation to improve visibility. Provide toucan crossing*”. The Audit Team are concerned that if the Pedestrian Guard Rail is removed, pedestrians/cyclists wishing to travel onward to Great Notley High School or the Black Notley cycle route may choose a direct route across London Road and into the path of oncoming traffic (See RSA1 Image 10 below). It should also be noted that there is already an existing Toucan Crossing facility at this location (See RSA1 Image 11 below).

It is recommended that the existing pedestrian guard rail and Toucan crossing are retained.

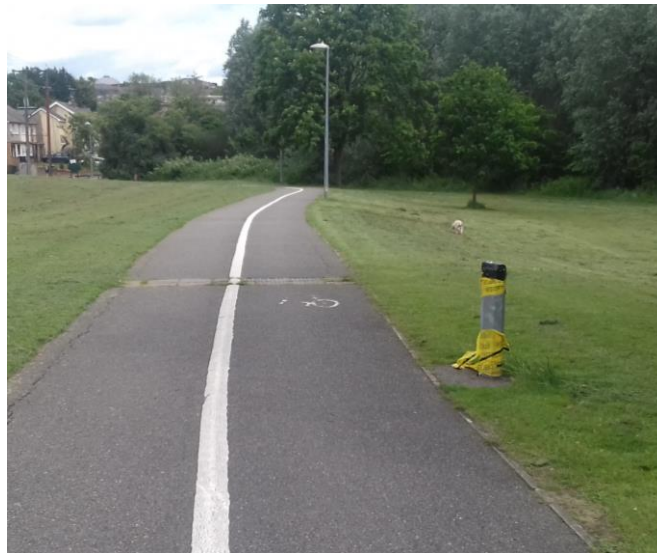
During the site visit it was observed that a lighting column within the green space area of Tortoiseshell Way had been damaged and removed (See RSA1 Image 12 overleaf). Whilst it is appreciated that this likely to be a maintenance issue, failure to provide an appropriate level of

lighting throughout the facility could lead to collisions between cyclists and pedestrians as well as increased security risk.

It is recommended that a review of all lighting is carried out for the extents of this scheme.

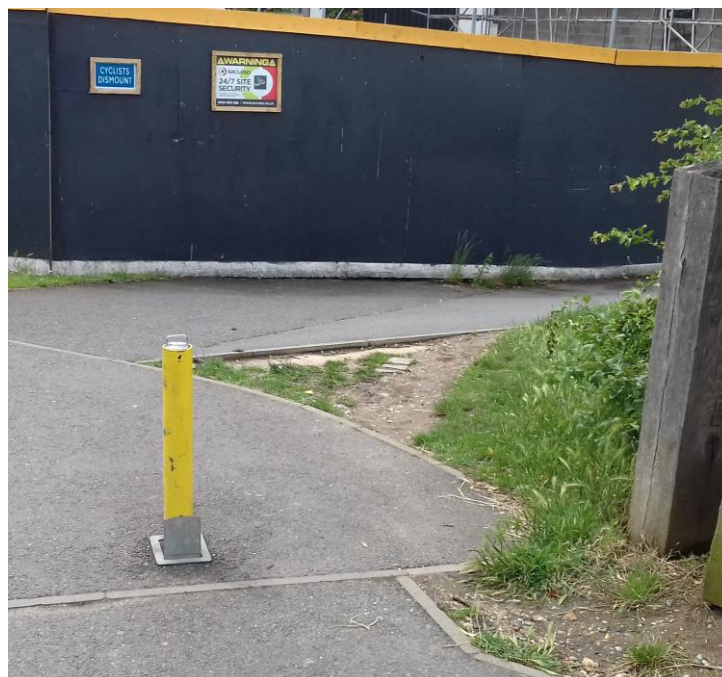
- 5.1 It was noted at the time of the site visit that there is a worn track where the proposed route joins the Flitch Way (See RSA1 Image 13 below). This would appear to be a desire line for existing users. It is recommended that the worn track is formalised as part of this scheme in order to ease transition from Flitch Way onto the proposed facility.
