Location: A127 J/w A176 Northern Roundabout, Basildon
District: Basildon
Collision Investigation Period: 01/01/2017 – 31/12/2019
Site Ranking: N/a

EXECUTIVE SUMMARY

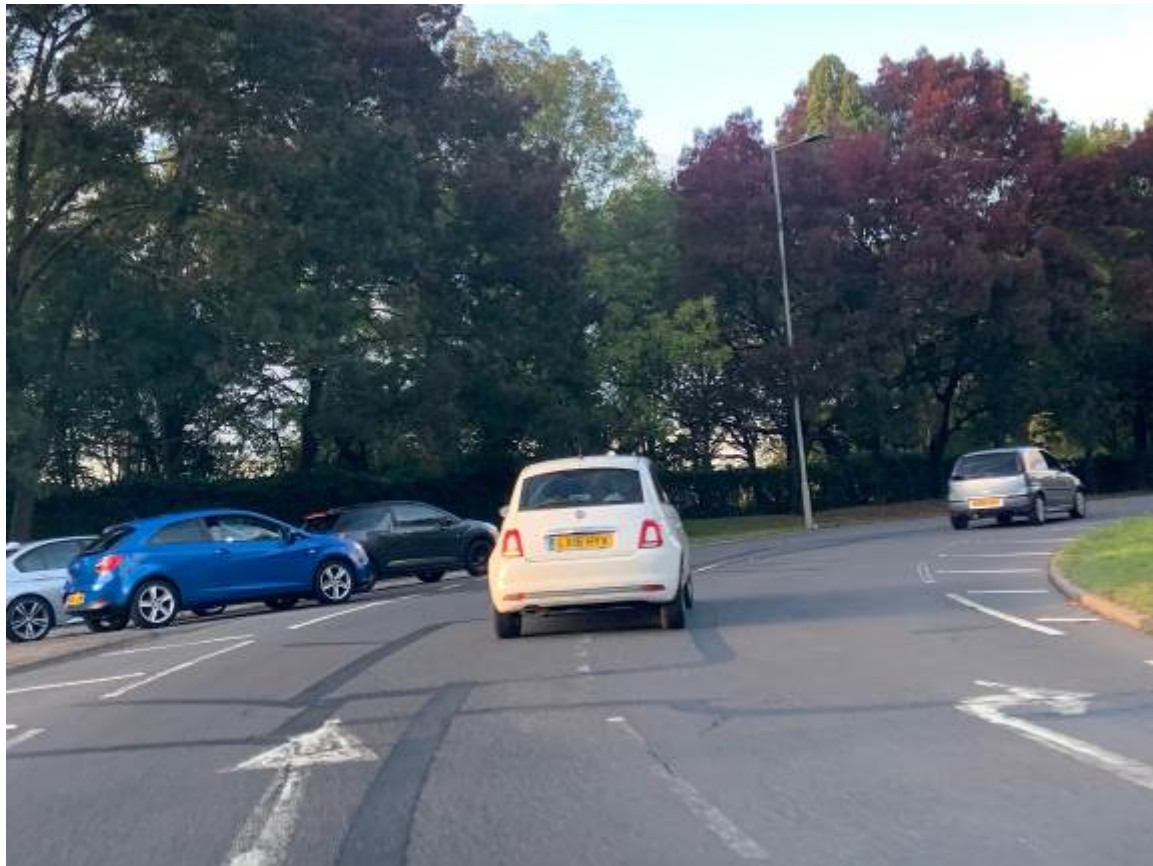
Image 2 – Northbound on roundabout circulatory (Lane discipline issues)

- 1) It is recommended that the existing spiral style circulatory road markings should be replaced with simplified, conventional roundabout markings (Matching those used on the southern roundabout, removing the ambiguity regarding which lane motorists should be using at the junction.
- 2) It is recommended that directional arrow road markings and associated lane destination signs should be provided on the A176 (Northbound) approach, and the South Wash Road (Southbound) approach to further emphasise which lanes should be used at the junction.

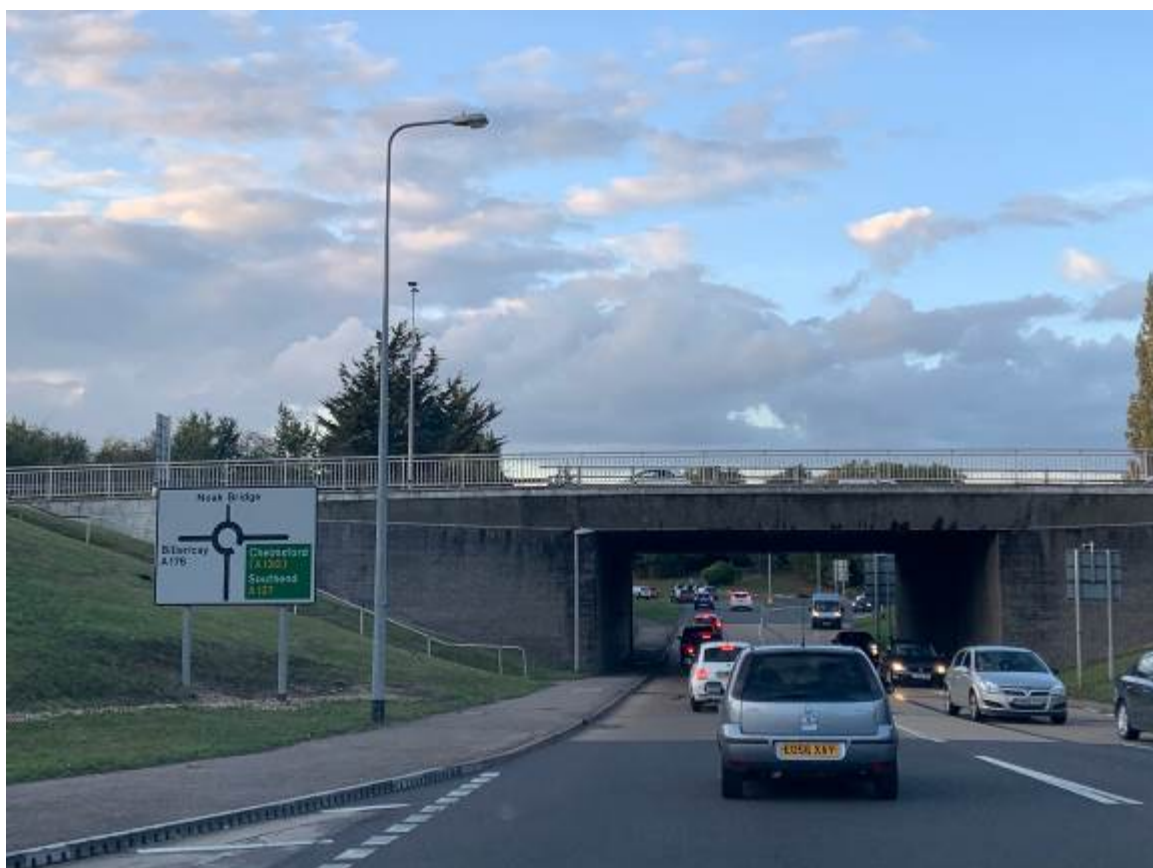
Image 3 – Map type ADS on northbound approach to junction.

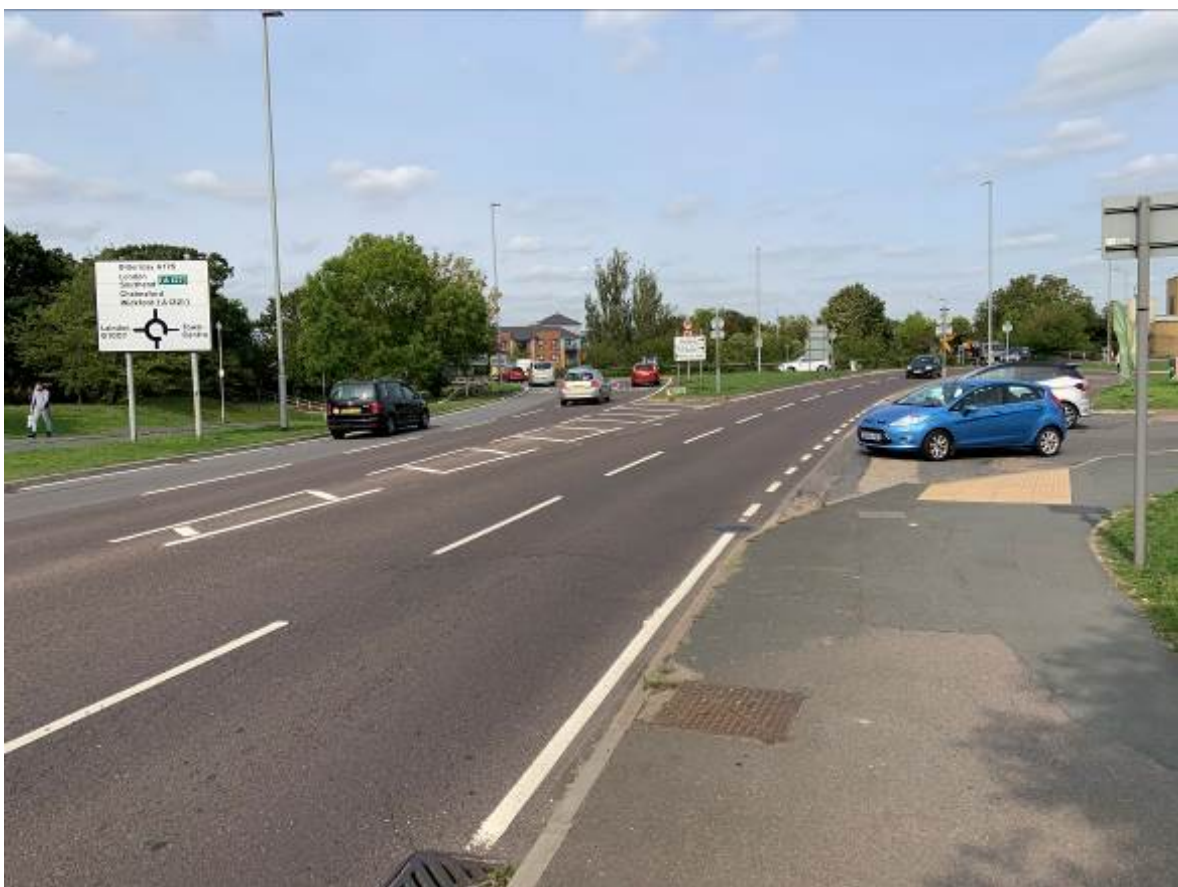
Image 5 – Two side by side vehicles attempting to join A176 from junction / vehicle access

Remedial Measures
<p>1) It is recommended that the southbound exit from Roundacre roundabout is reduced to a single lane on A176 Nethermayne to allow provision of a central refuge/waiting area between the northbound and southbound carriageways for vehicles turning right out of the BP service station to safely wait before joining the northbound carriageway.</p> <p>The A176 Nethermayne southbound carriageway could then widen out to two traffic lanes again on the approach to the traffic signalised junction with Ashdon Way.</p> <p>2) Existing directional arrow and destination markings, and lane destinations signs throughout the Roundacre junction will need to be amended to tie in with the new layout.</p>

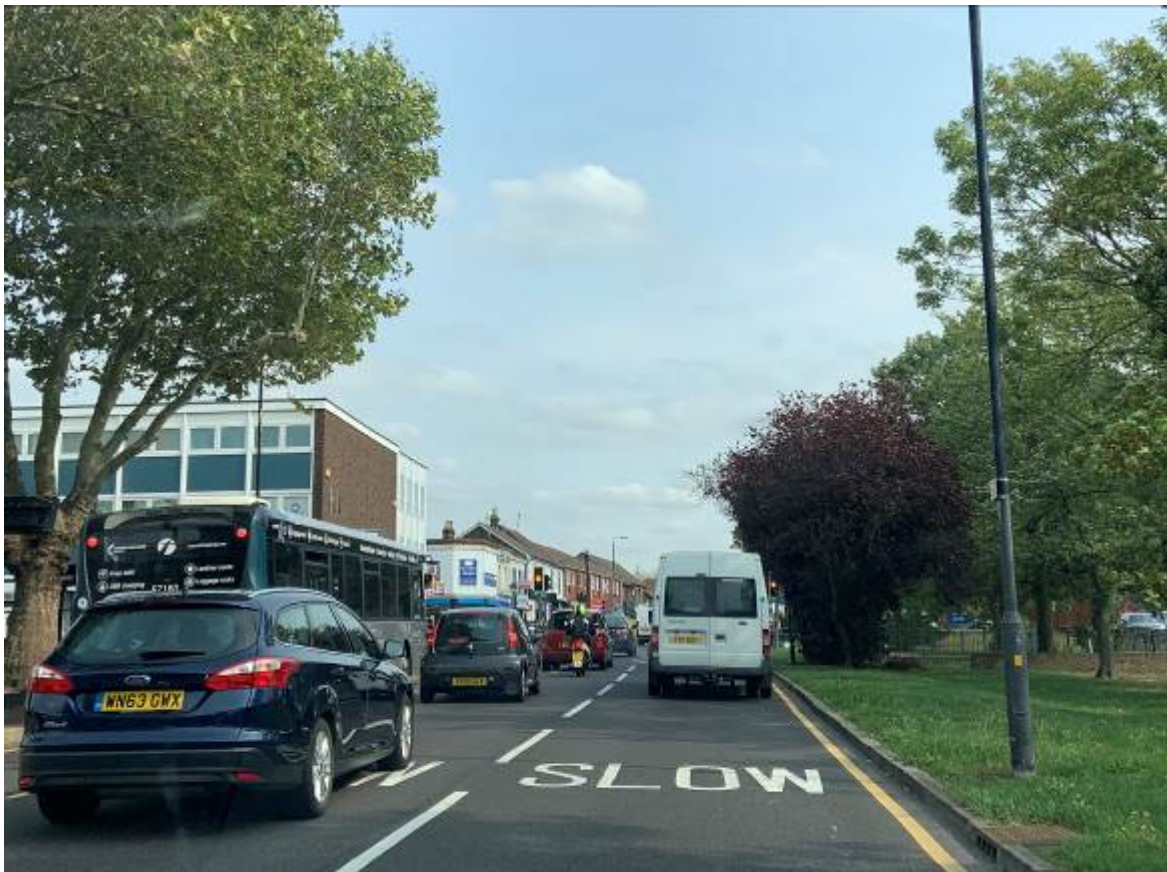
Image 2 – Eastbound approach to traffic signals (Offside signal head partially obscured)

Remedial Measures
<p>1) It is recommended that the existing overgrown vegetation (Trees) that are partially obscuring the offside signal head should be completely removed.</p> <p>2) Provide a 'Traffic signals ahead' warning sign to the offside of the carriageway on the eastbound approach, visible to road users as they leave the nearby roundabout junction.</p> <p>3) Dependant on estimated costs, provide additional high mounted traffic signal head(s) to increase conspicuity of the traffic signals for approaching motorists.</p>

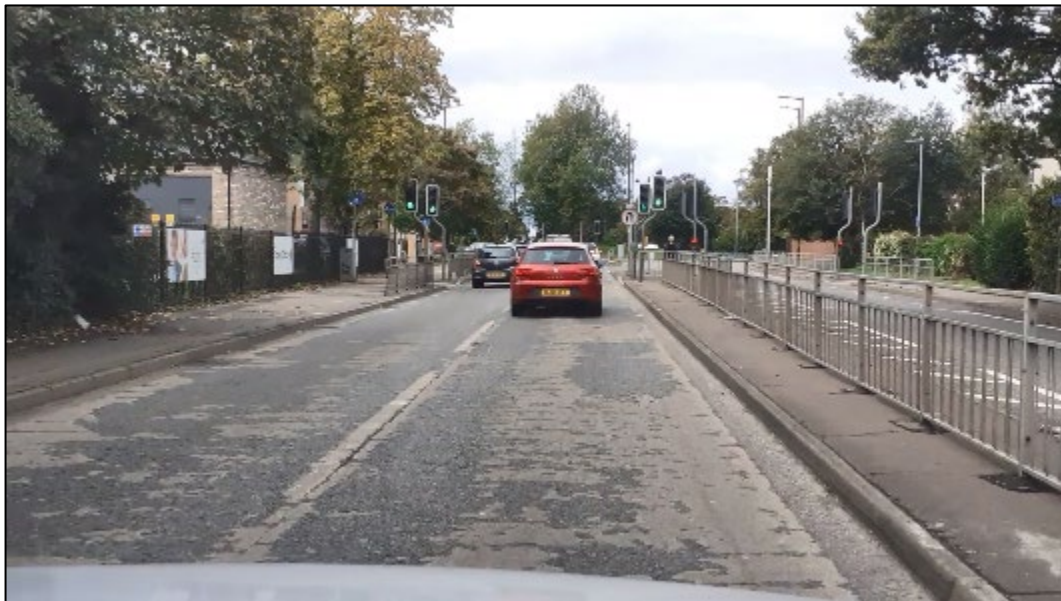
Image 7 – A1114 Princes Road westbound approach to Toucan crossing – poor condition of high-friction surface, poor conspicuity of road markings, and nearside trees compromising forward visibility

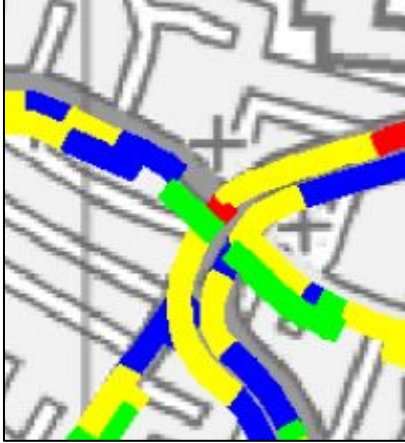
Road Surface	<p>Poor condition in Parkway – existing high-friction surface stripped in wheel tracks on northbound approach to stop lines and in southbound right-turn lane. Good condition high-friction surfacing on approach to stop lines in Rainsford Road.</p>

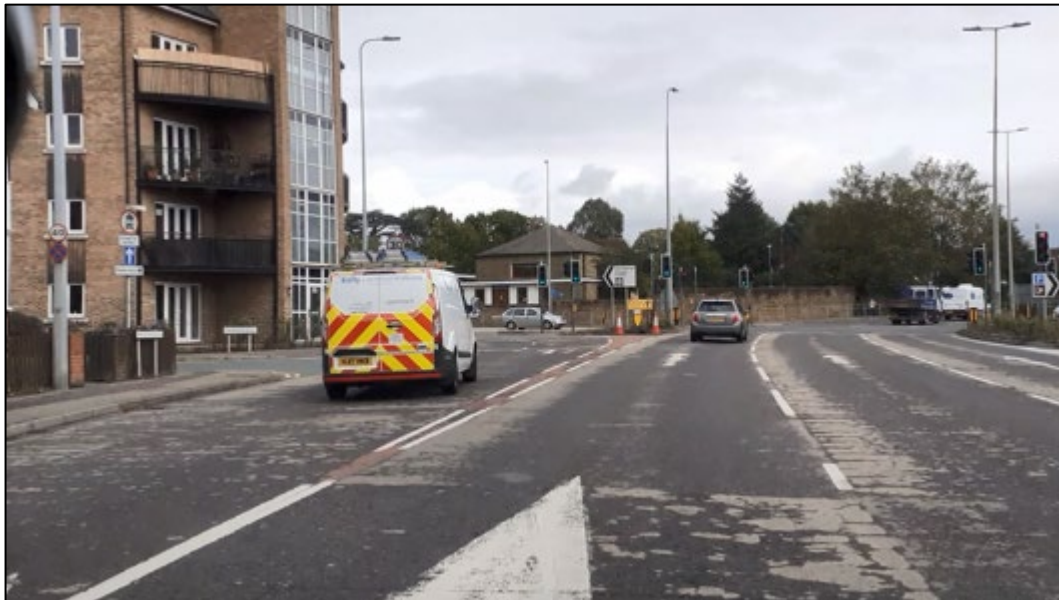
Image 1 – A1060 Parkway, northbound approach to junction.
Note deterioration of high-friction surfacing and poor conspicuity of road markings.

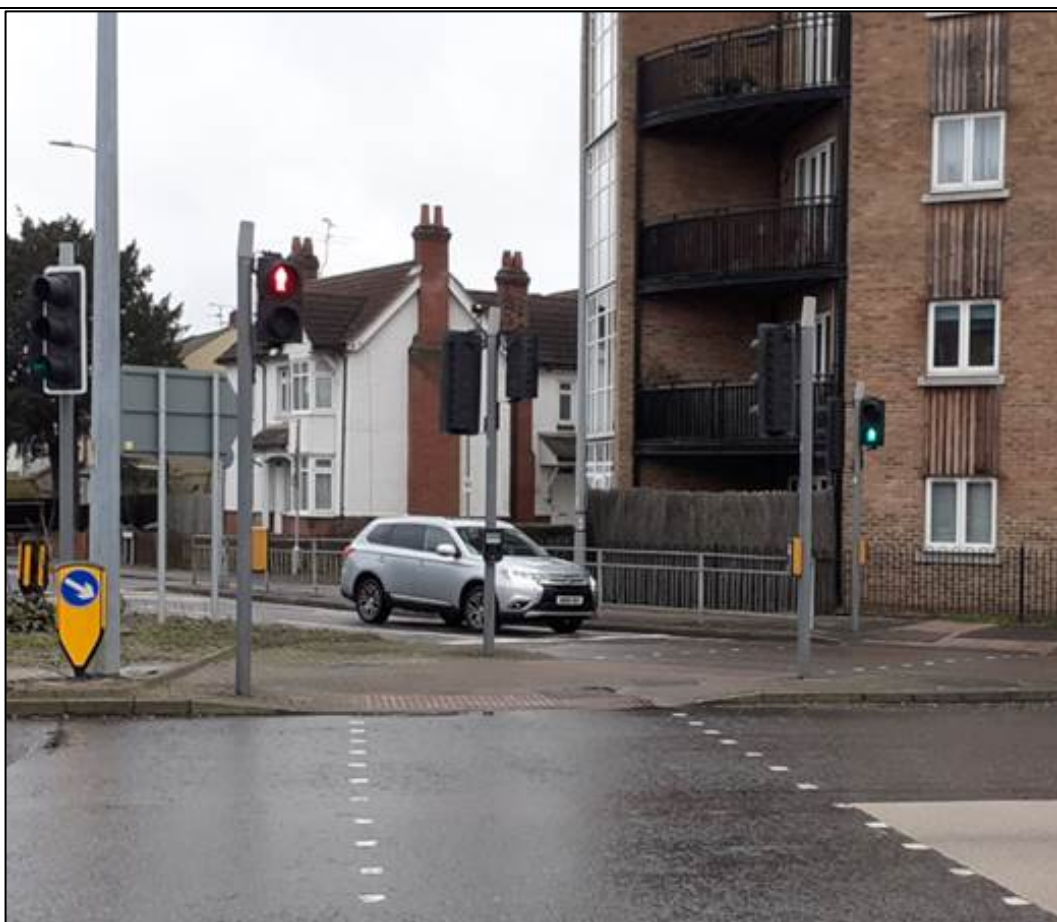
Image 6 – A1060 Rainsford Road (W) – looking north to south –
Pedestrian signal head 'see-through'

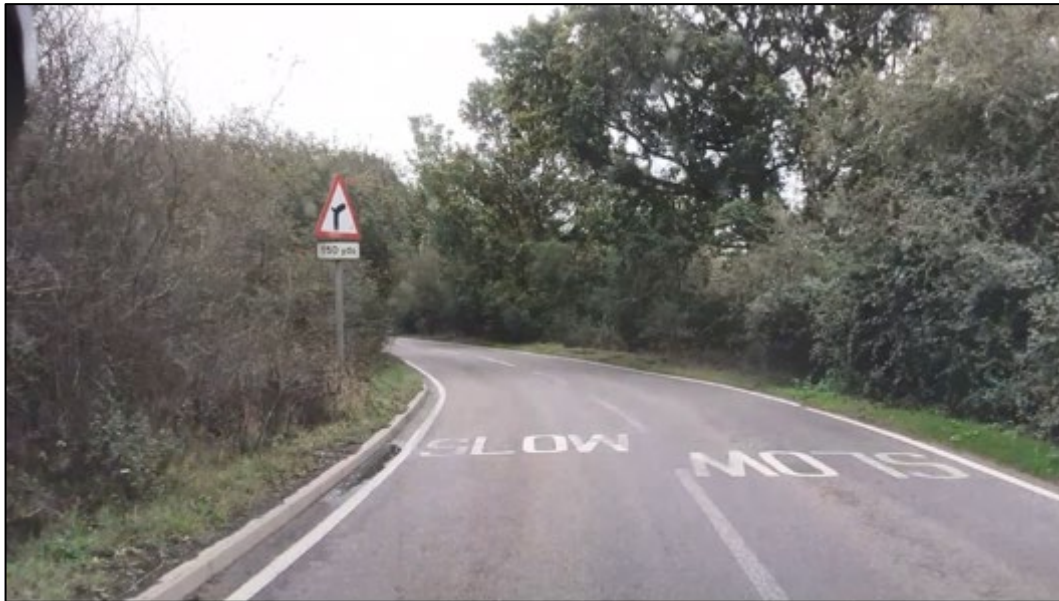
Image 3 – Boreham Road southbound
worn centre lines and restricted forward visibility through left/right bends

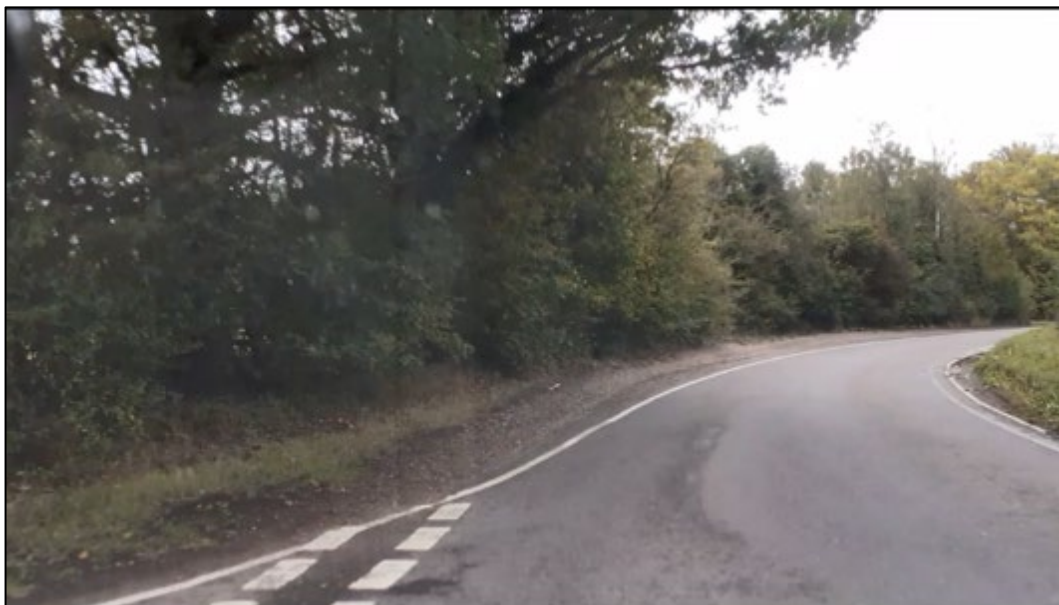
Image 4 – Boreham Road southbound, bend at j/w Birds Farm Lane
(opposing view to Image 7)
verge erosion/incursion to both sides and limited forward visibility through narrow bend

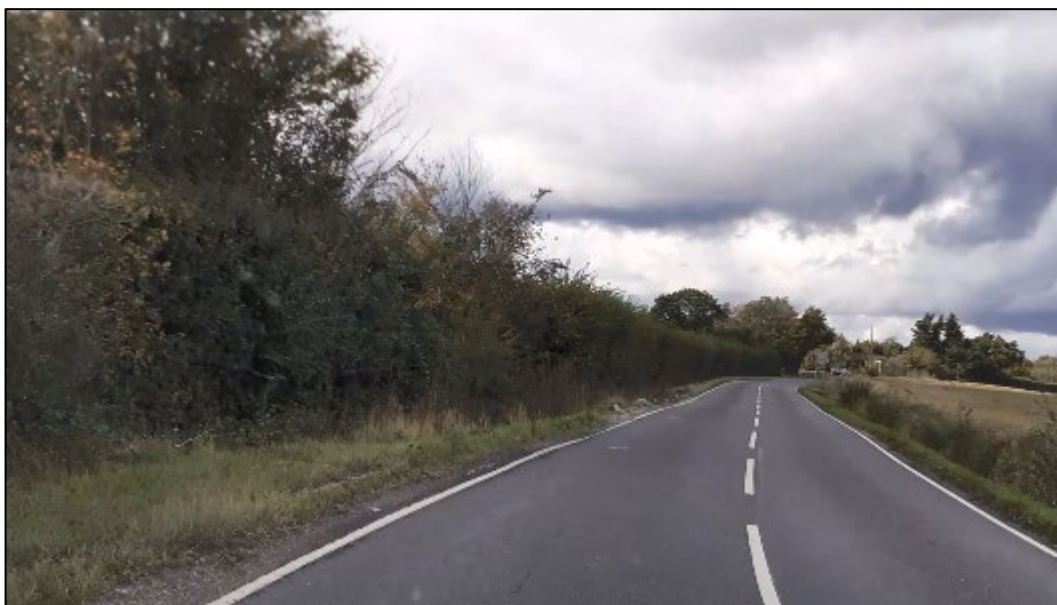
Image 8 – Waltham Road northbound, approaching j/w Cranham Road;
nearside verge erosion/incursion into roadside ditch

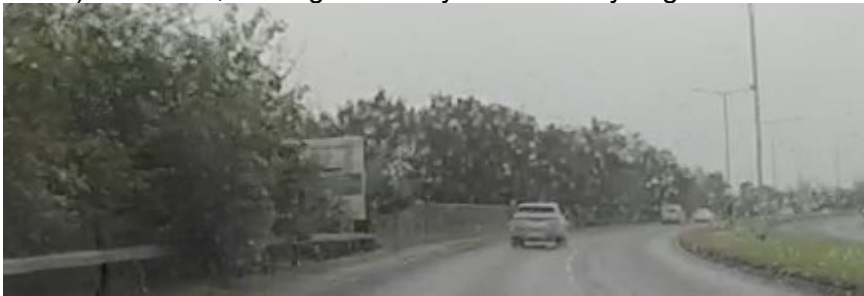
<p>Figure 1: ADS obscured by vegetation</p> <p>There are no lane destination signs present on any of the approaches.</p>

- 1) It is recommended that visibility to the right is restricted. For aesthetic considerations, it is proposed that vegetation in the form of hedgerow is provided in the central reserve.
- 2) It is recommended that the vegetation obscuring the ADS sign is removed.
