Location: Site 004 – A414 jw M11 Harlow (Hastingwood Rd)
District: Epping Forest
Collision Investigation Period: 01/01/2017 and 31/12/2019
Site Ranking: 004 (Rural Site)

EXECUTIVE SUMMARY

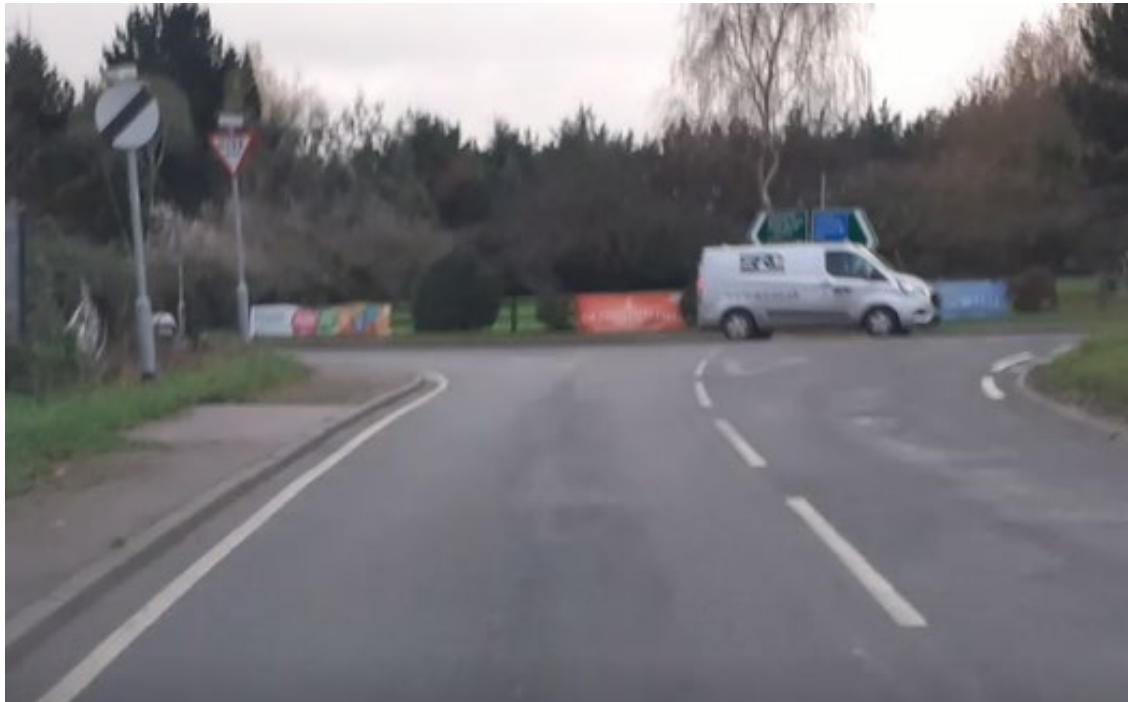
Image 1 – Hastingwood Rd approach to junction with Canes Lane

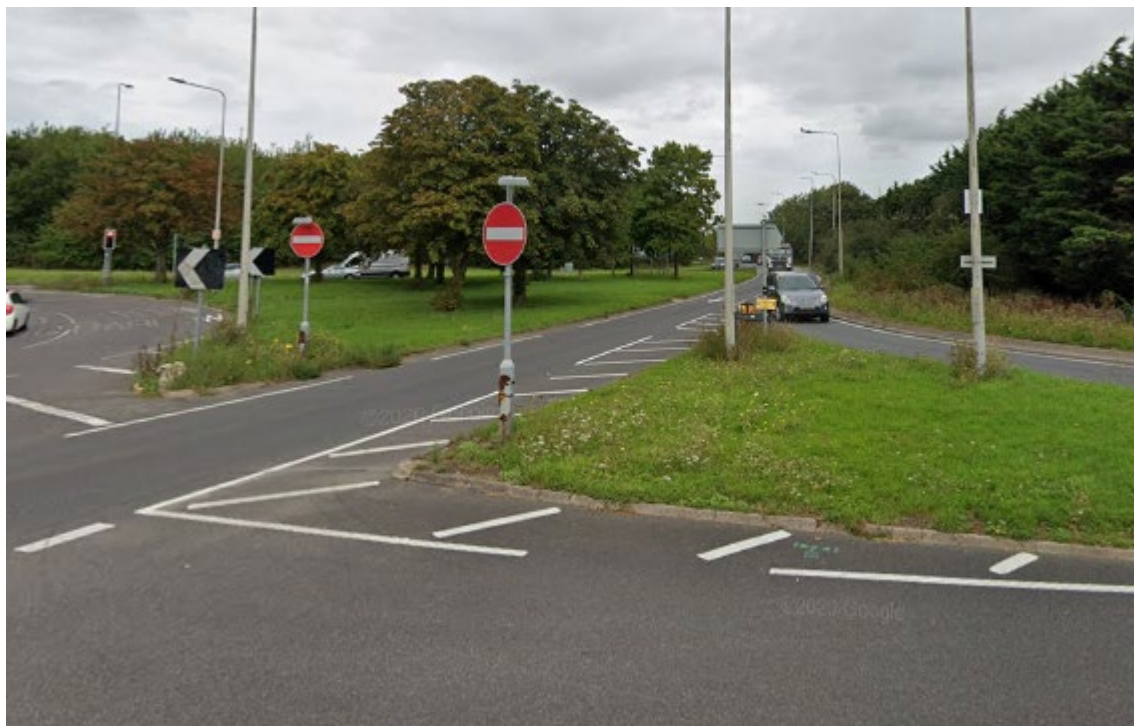
Image 2 – View to right from Hastingwood Road

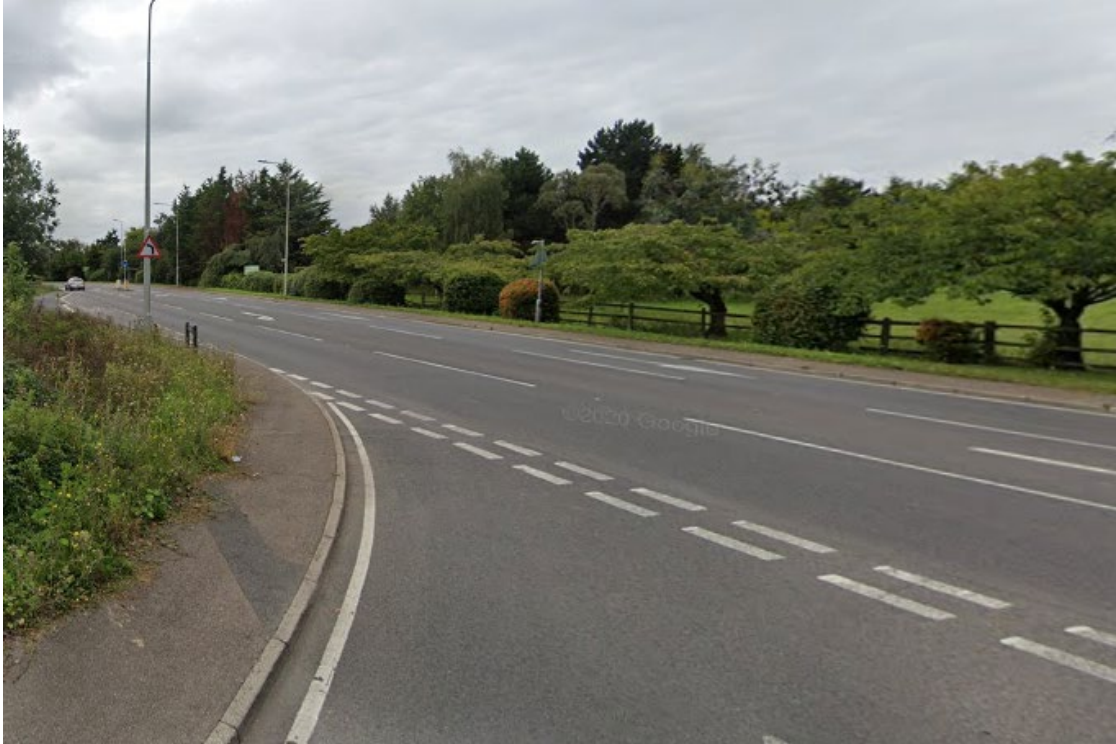
Image 3 – View to left from Hastingwood Road

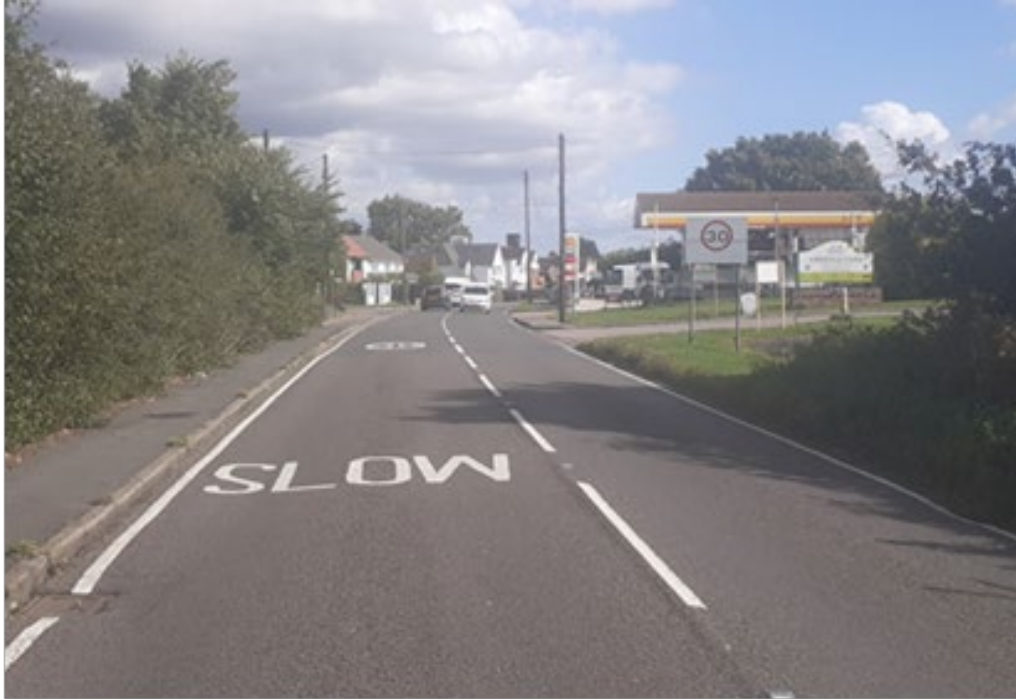
Image 1 – A113 London Rd north-east approach to 30 limit.

- 1) It is recommended that provision of enhanced (yellow backing) 30mph Terminals signs and extend the 30 speed restriction on north-east bound approach to encourage compliance with posted speed restriction.
- 2) The addition of 'Gateway' features are also considered if there is sufficient highway space.

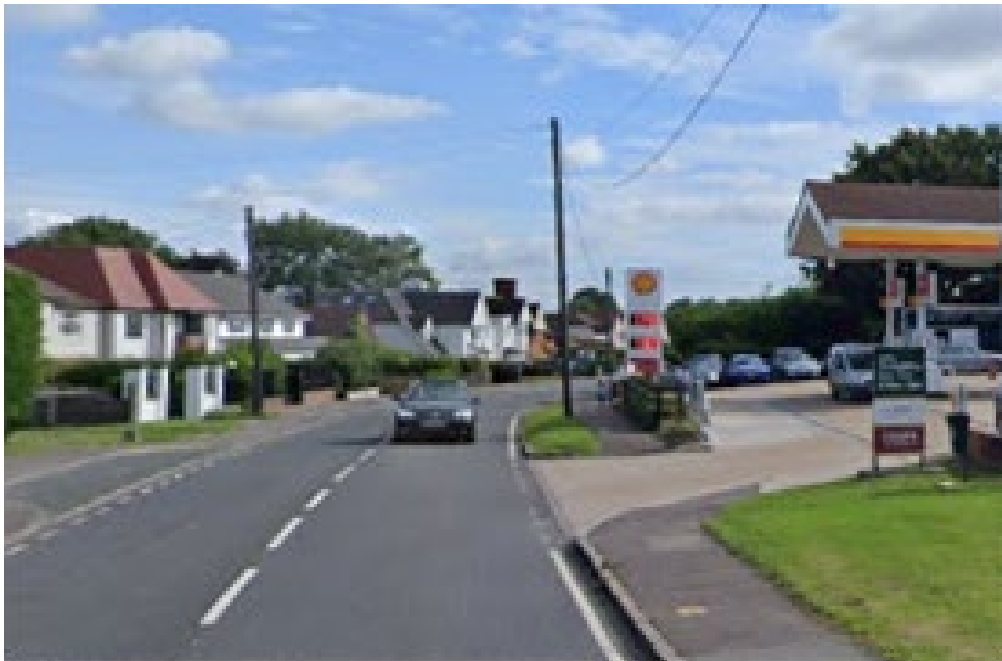
Image 2 – A113 London Rd north-east approach to filling station

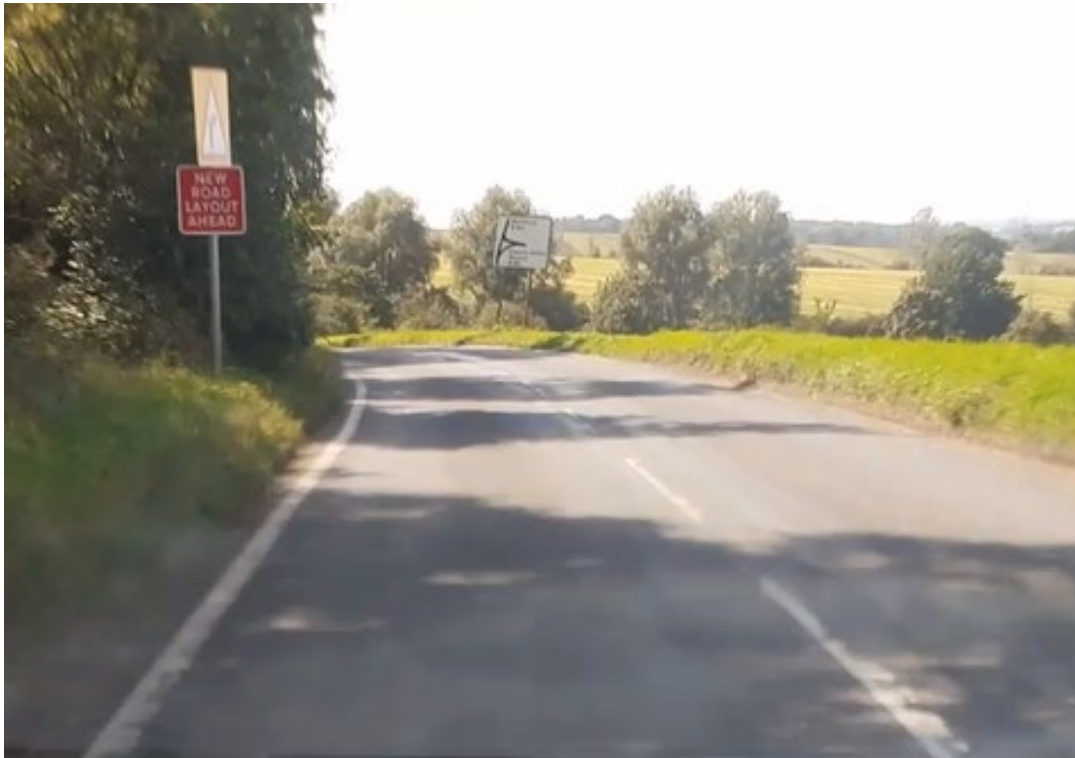
Image 1 – B181 (Lindsey St) South-west bound approach to junction (junction on bend and advanced directional signs)

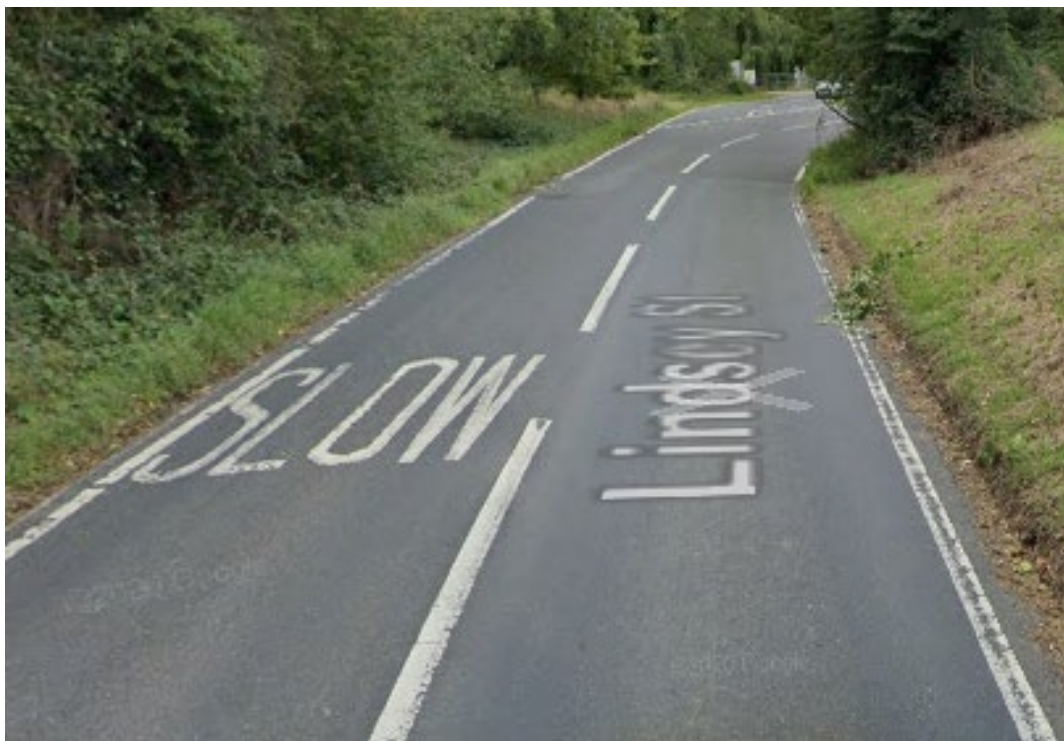
Image 2 – B181 (Lindsey St) South-west bound approach to junction

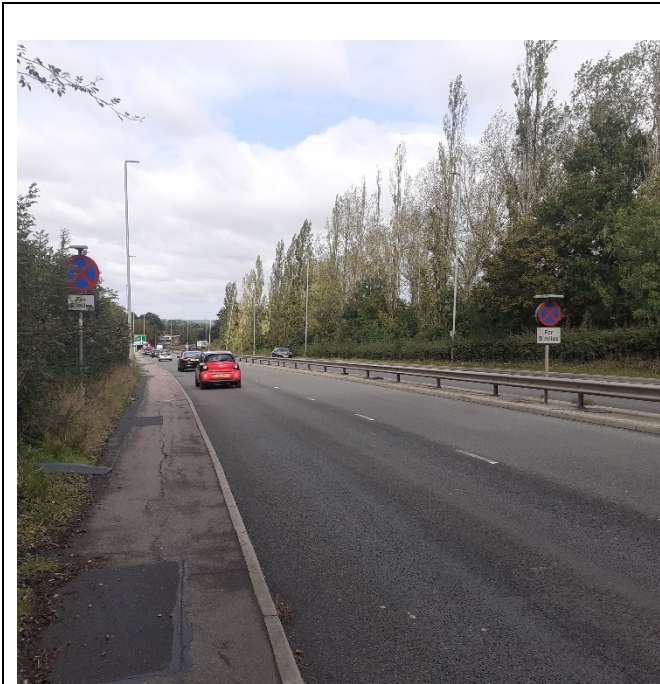
Image 1 - A414 northbound approach to roundabout showing Clearway signs.

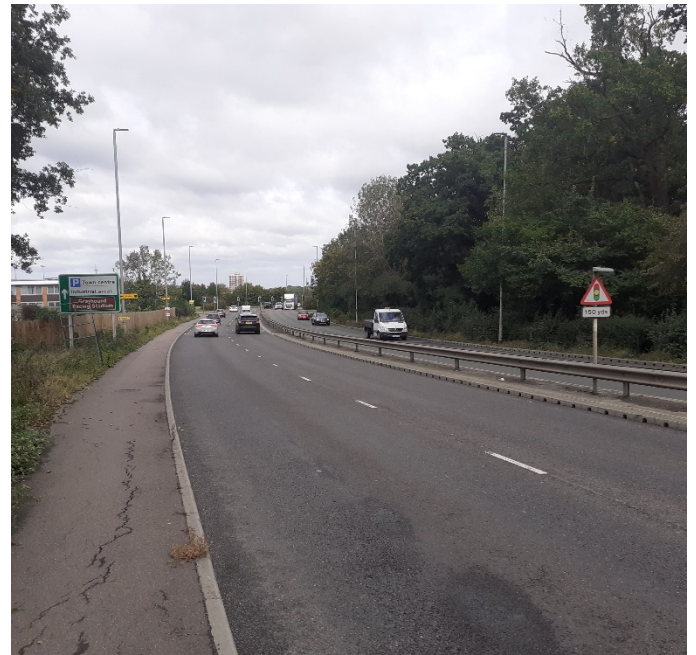
Image 2 – A414 northbound approach to roundabout showing Traffic Signals Ahead warning sign.

- Replace existing traffic signals ahead signs with enhanced (yellow backing) signs to both sides of the carriageway.
- Provide 'Traffic queues likely on road ahead' Diagram 584 with Queues likely sub-plate to both sides of the carriageway,

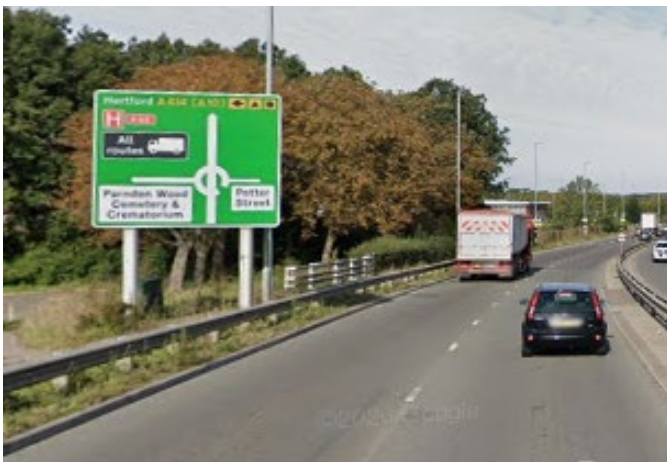
Image 3 – A414 northbound approach to roundabout showing Advanced Directional sign.

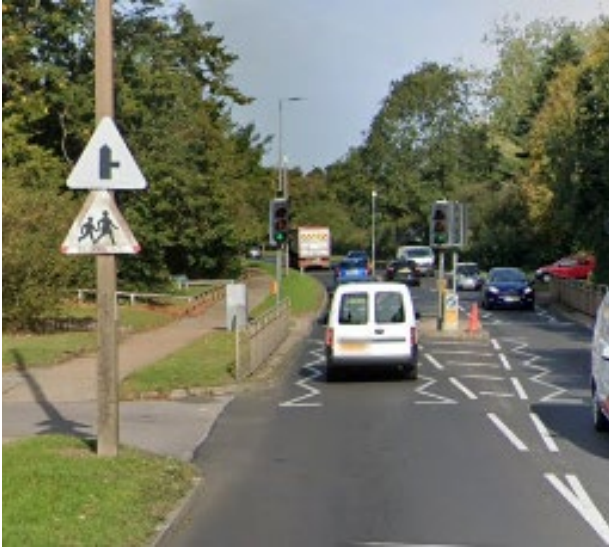
Image 1 – Warning signs on Howard Way northbound approach

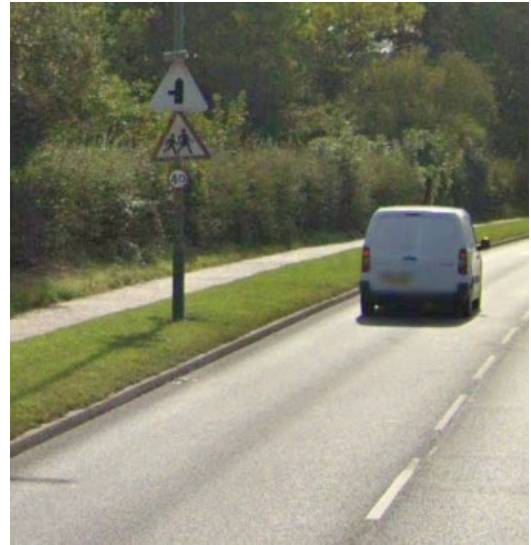
Image 2 – Warning signs on Howard Way southbound approach

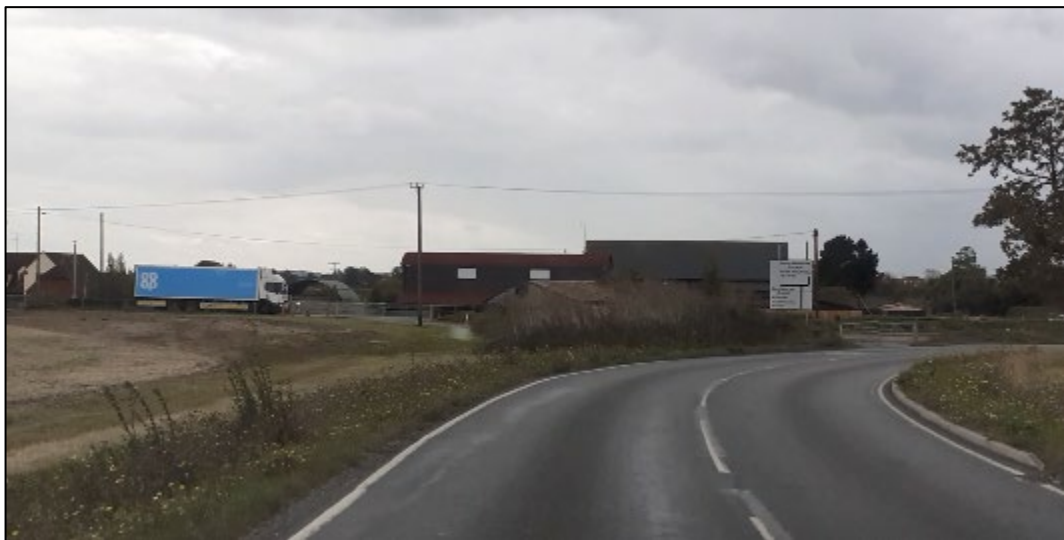
Image 7 – B1010 Fambridge Road (Kits Hill) southbound
Illustrating wide view of approaching westbound traffic prior to junction

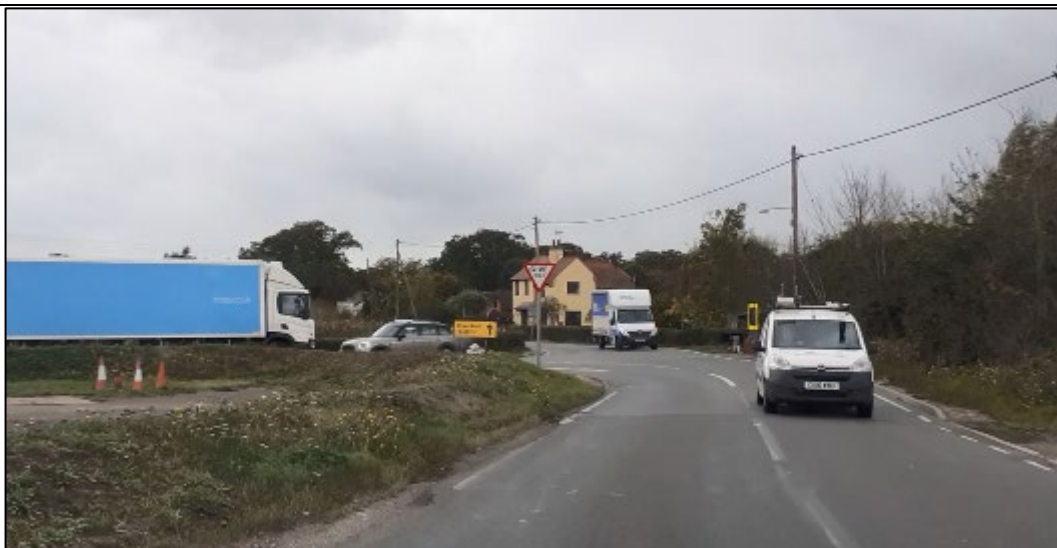
Image 8 – Fambridge Road (Kits Hill) southbound – approaching ‘Give Way’ line at junction.

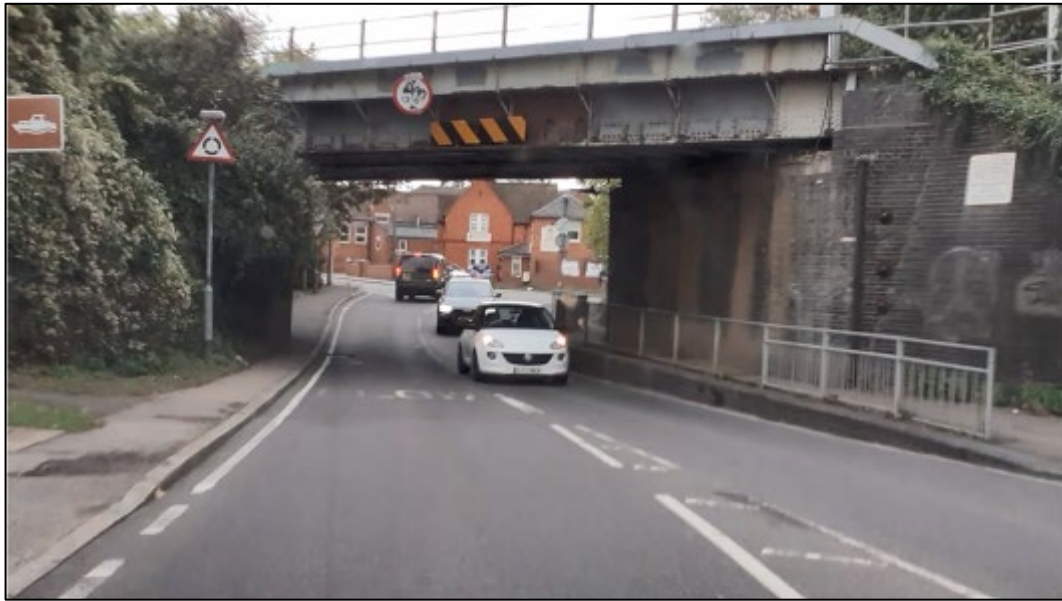
Image 1 – Hall Road eastbound, forward view to mini-roundabout

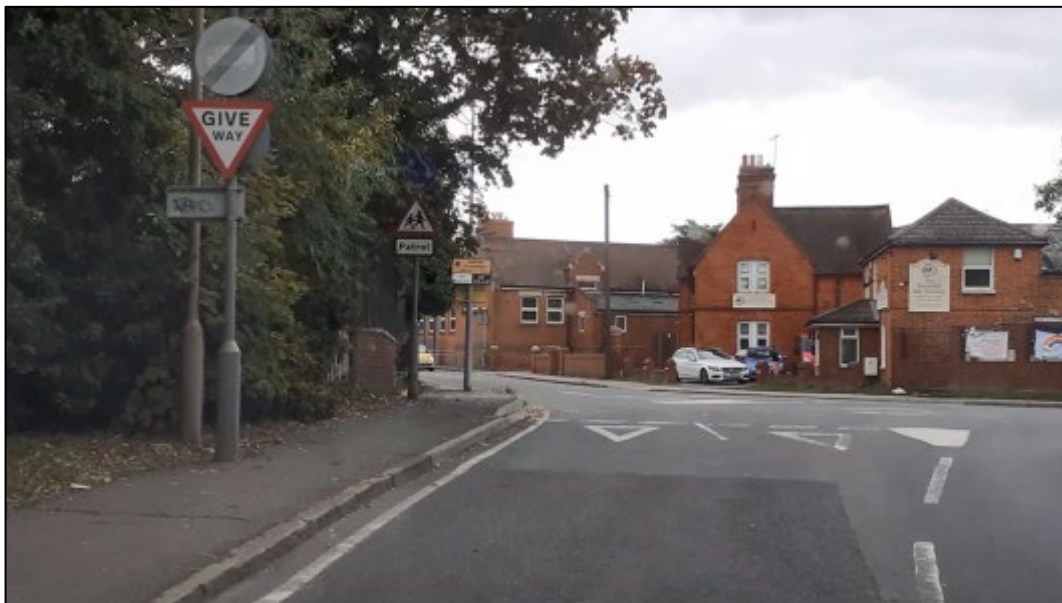
Image 2 – Hall Road eastbound, two-lane approach to mini-roundabout

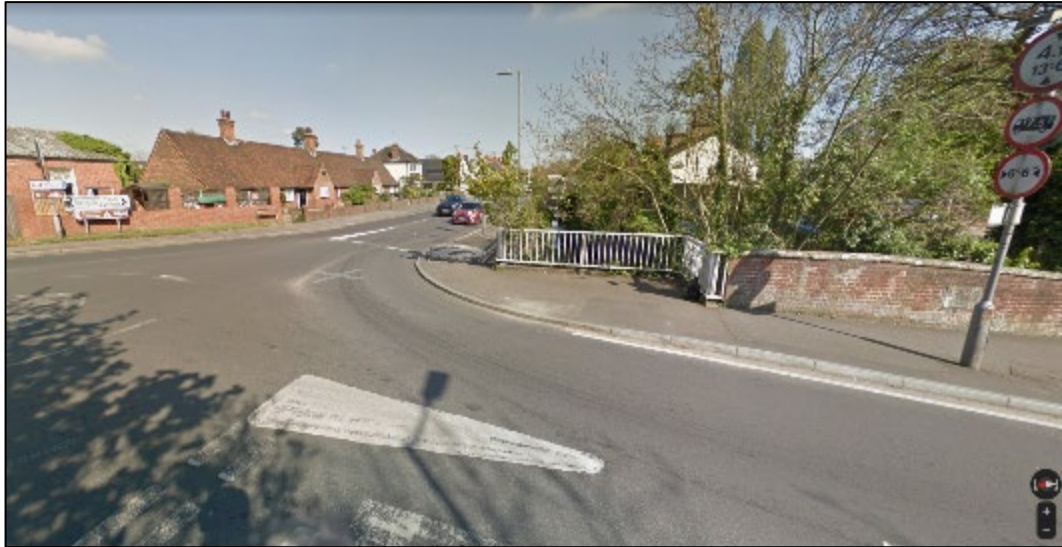
Image 3 – view to right at mini-roundabout from Hall Road (from Google Streetview, 2019)

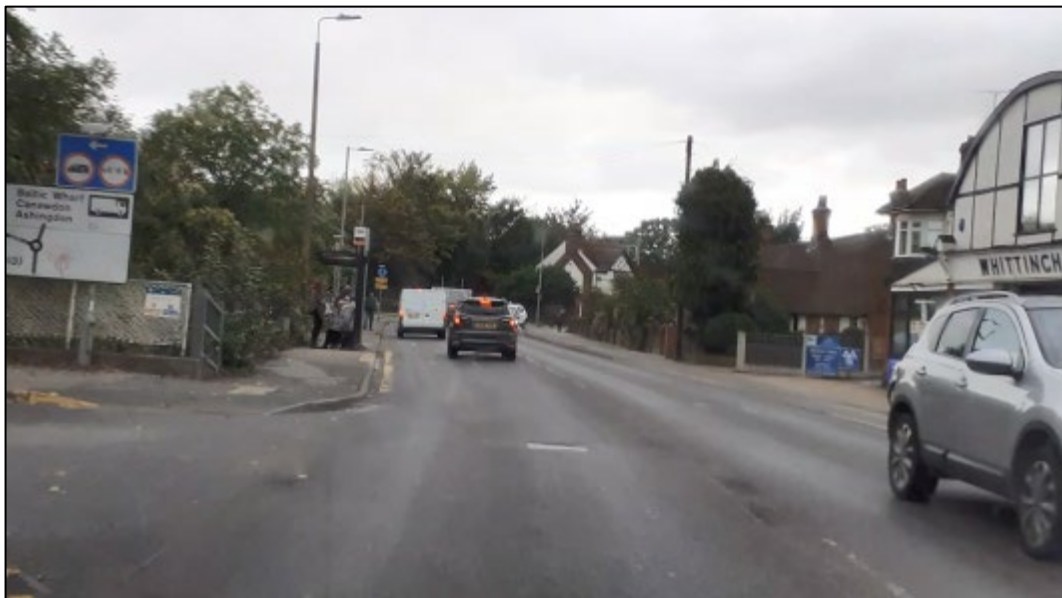
Image 4 – West Street westbound approach.
Note ADS sign set well back, and bus stop shelter obscuring signs beyond

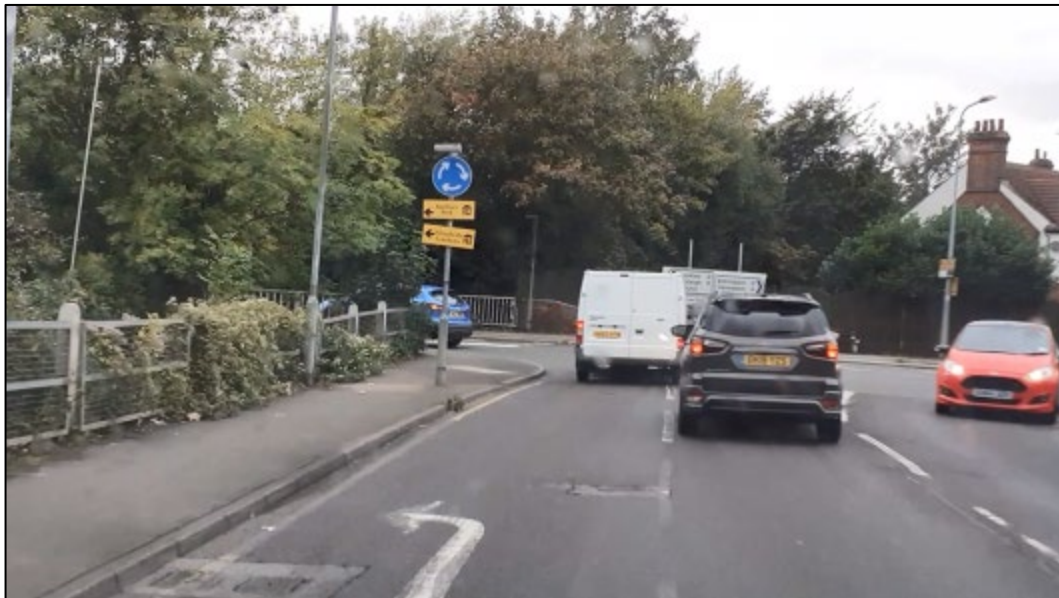
Image 5 – West Street (westbound) at mini-roundabout
Note faded road markings, prominent temporary signs, and vegetation to nearside

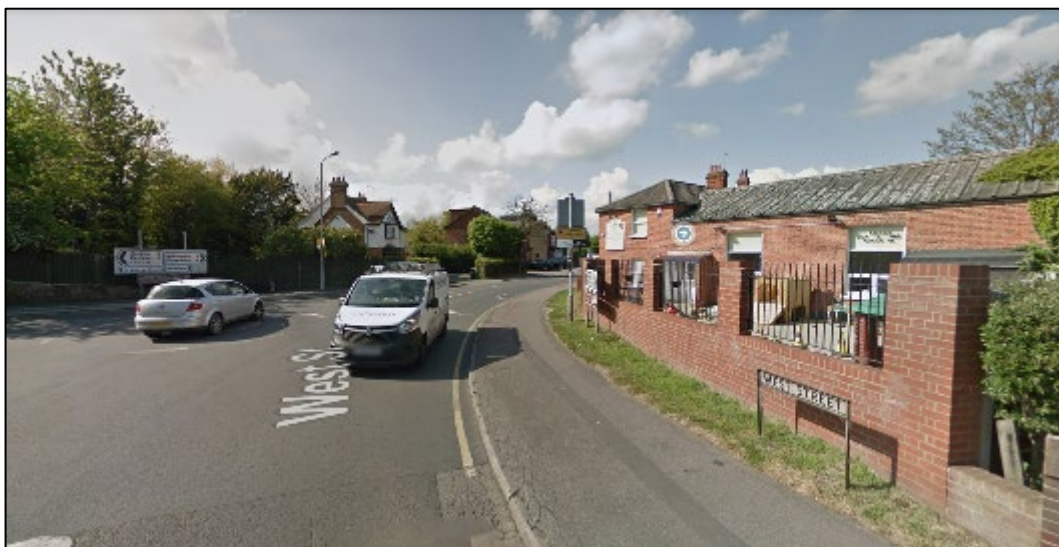
Image 6 – West Street, looking north to Ashingdon Road
(from Google Streetview, 2019)

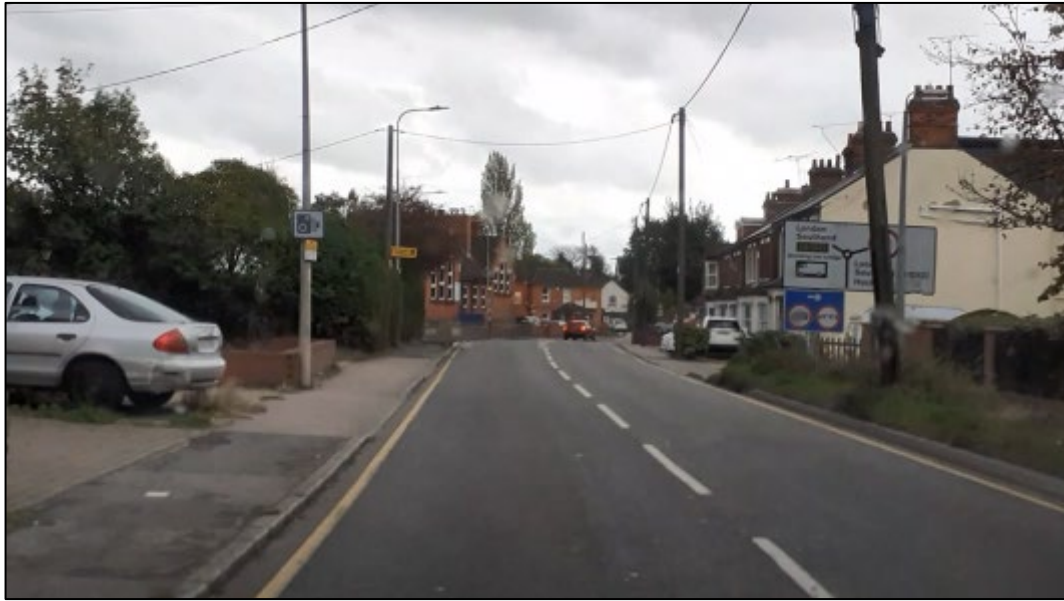
Image 7 – Ashington Road (southbound) approach
Obscured map-type sign to the offside and zebra crossing outside the primary school ahead

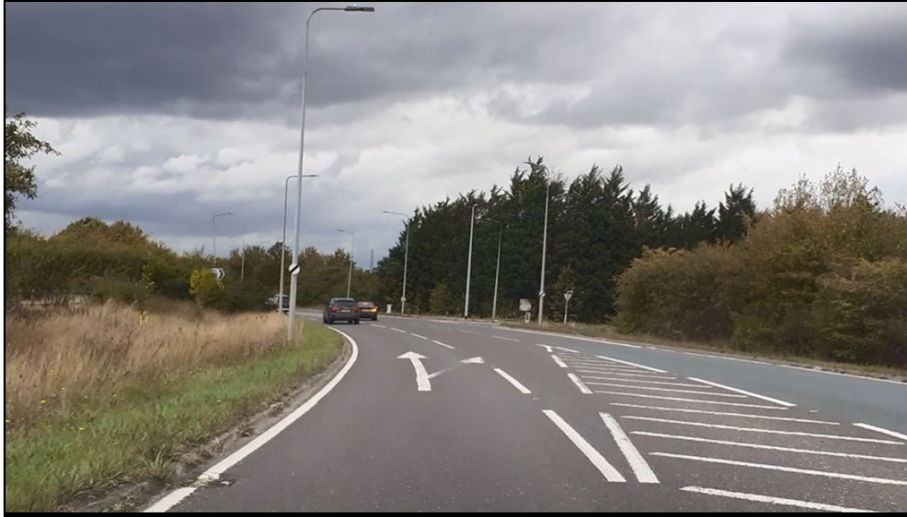
Image 1 – A1245 Northbound approach to junction

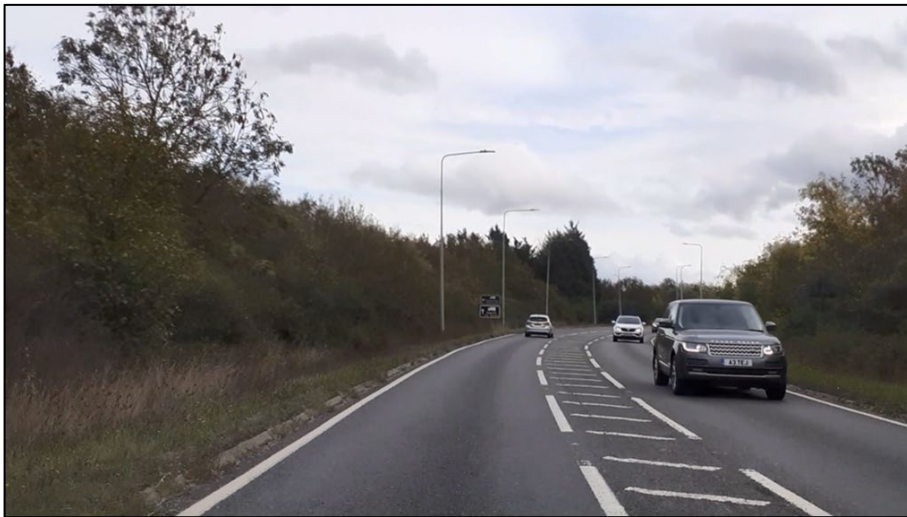
Image 2 – A1245 Southbound approach to junction

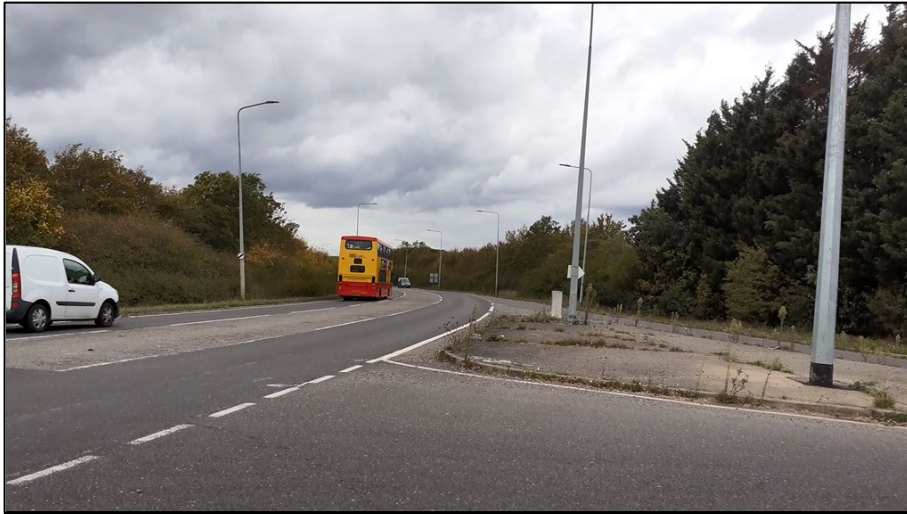
Image 3 – looking north from Chelmsford Road, southbound vehicles approaching

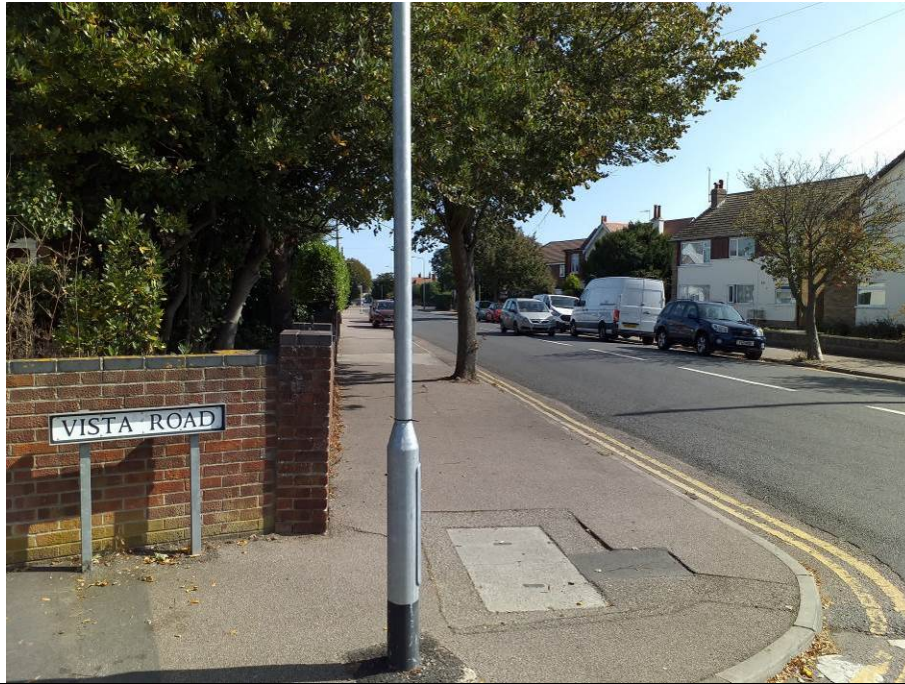
Image 1 – Visibility to the left from Vista Road.

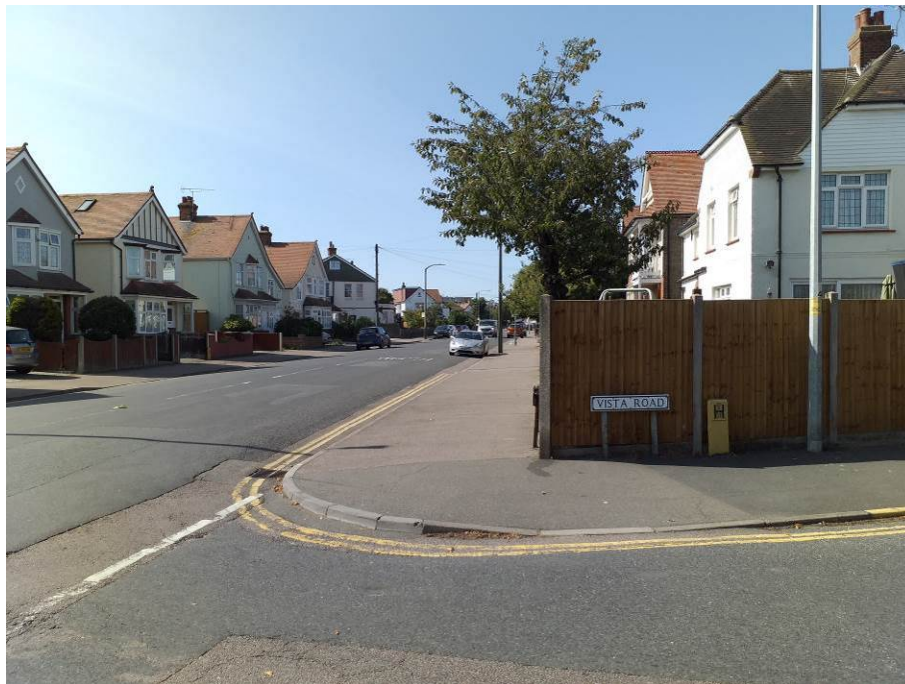
Image 2 – Visibility to the right from Vista Road

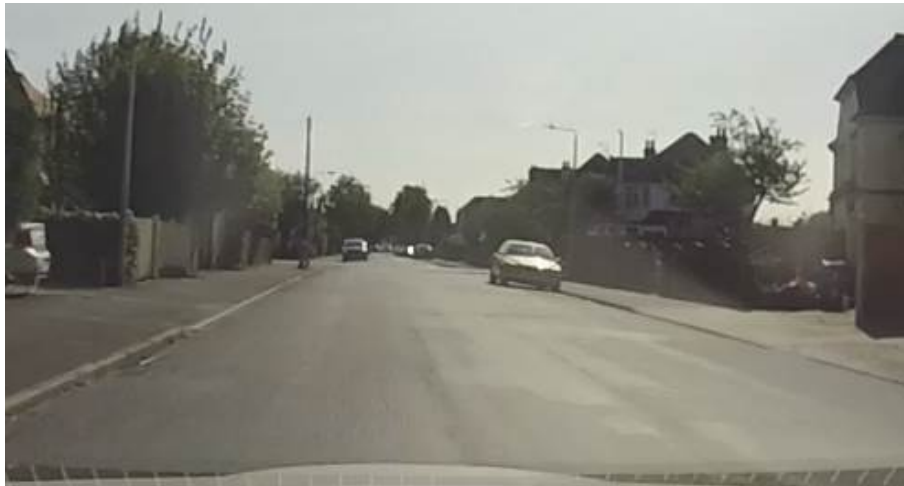
Image 3 – Vista Road approx. 50m. from junction

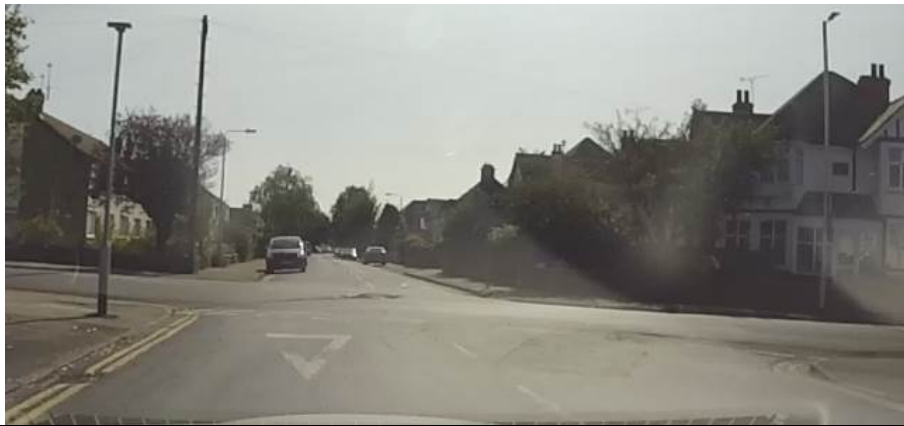
Image 4 – Vista Road/Skelmersdale Road junction

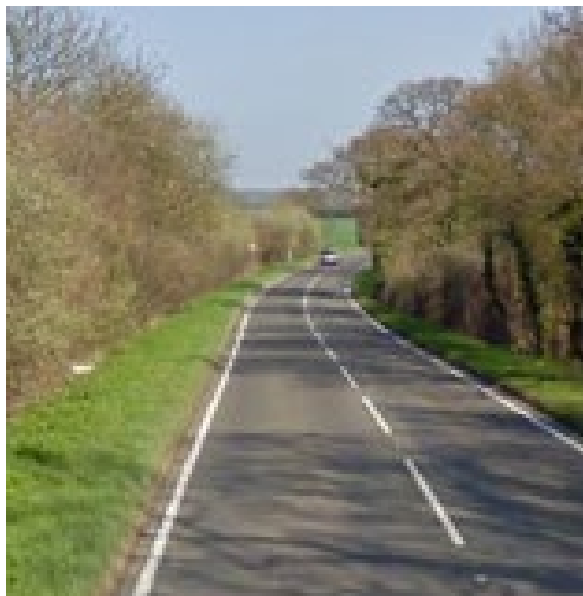
Image 1 – Eastbound approach, straight section warning centre line

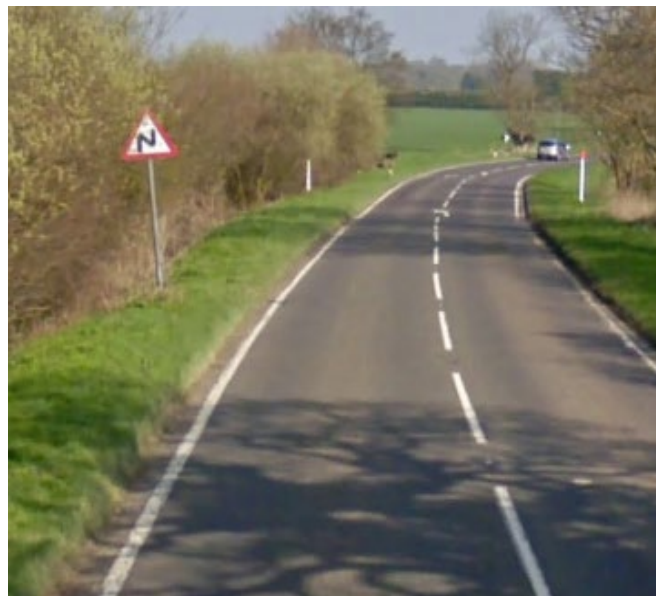
Image 2 – Eastbound approach to bends showing 'Series of bends' warning sign and guidance arrow.

- Provide enhanced (yellow backing boards) advanced 'Series of Bends Ahead' warning signs on both approaches
- Provide a (right hand) bend warning sign with an advisory 40mph speed limit sub-plate on the eastbound approach
- Replace existing chevron signs with yellow backed chevron signs to improve conspicuity.

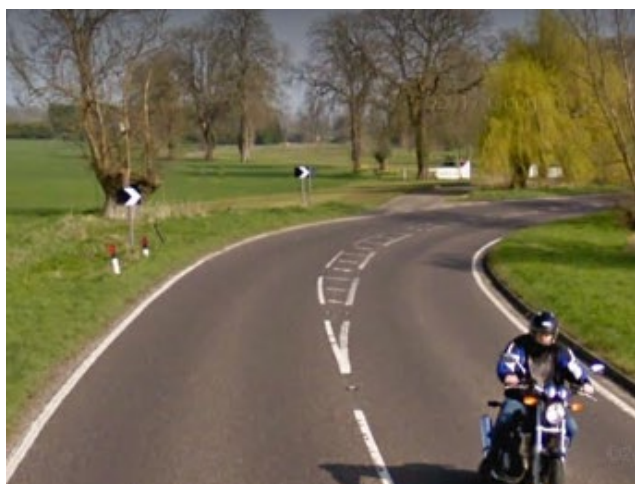
Image 3 – Eastbound entering the bend, showing single chevron signs and centre hatching
