Site Report Essex Highways Casualty Reduction Site Report 2019/20

Location: A176 Uppermayne Roundabout Junction with A176 Noak Hill Road, South Wash Road & A127 Eastbound Off-slip, Noak Bridge

Collision Investigation Period: 01/01/2015 – 31/12/2017

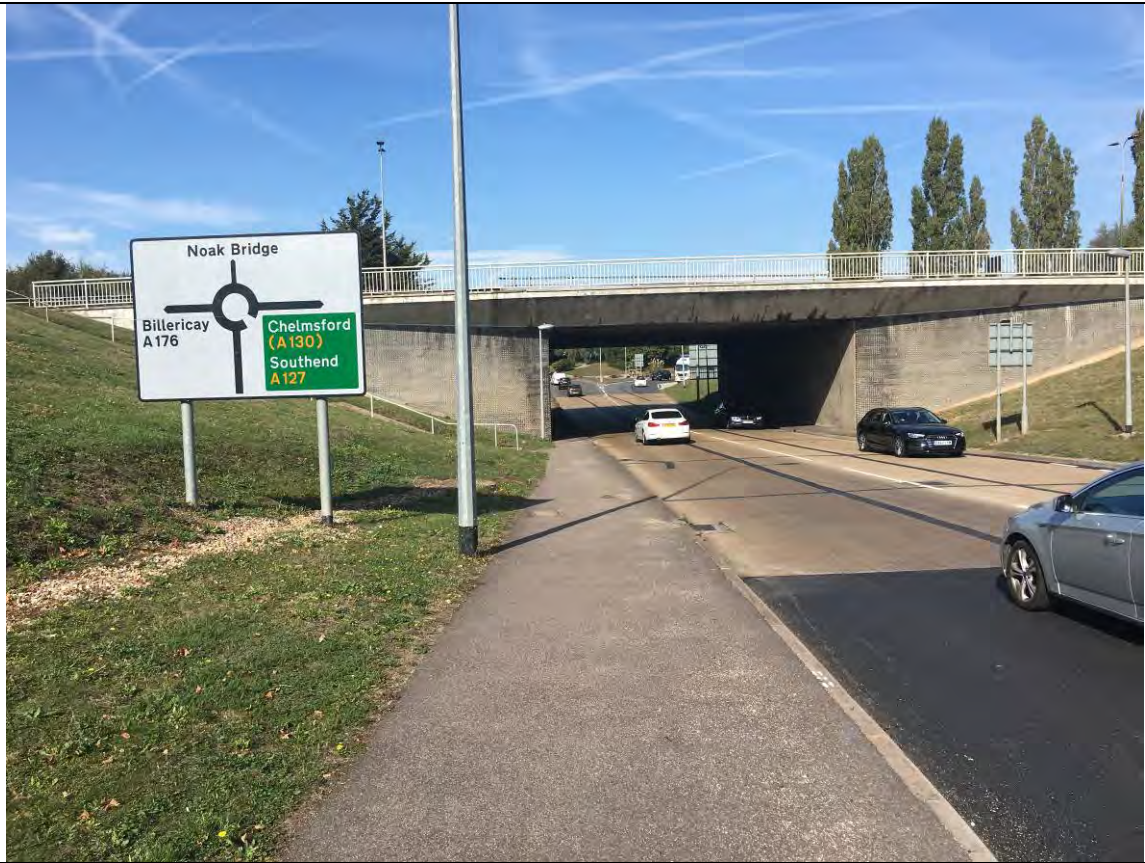
Image 4 – Map type advanced directional sign on northbound approach

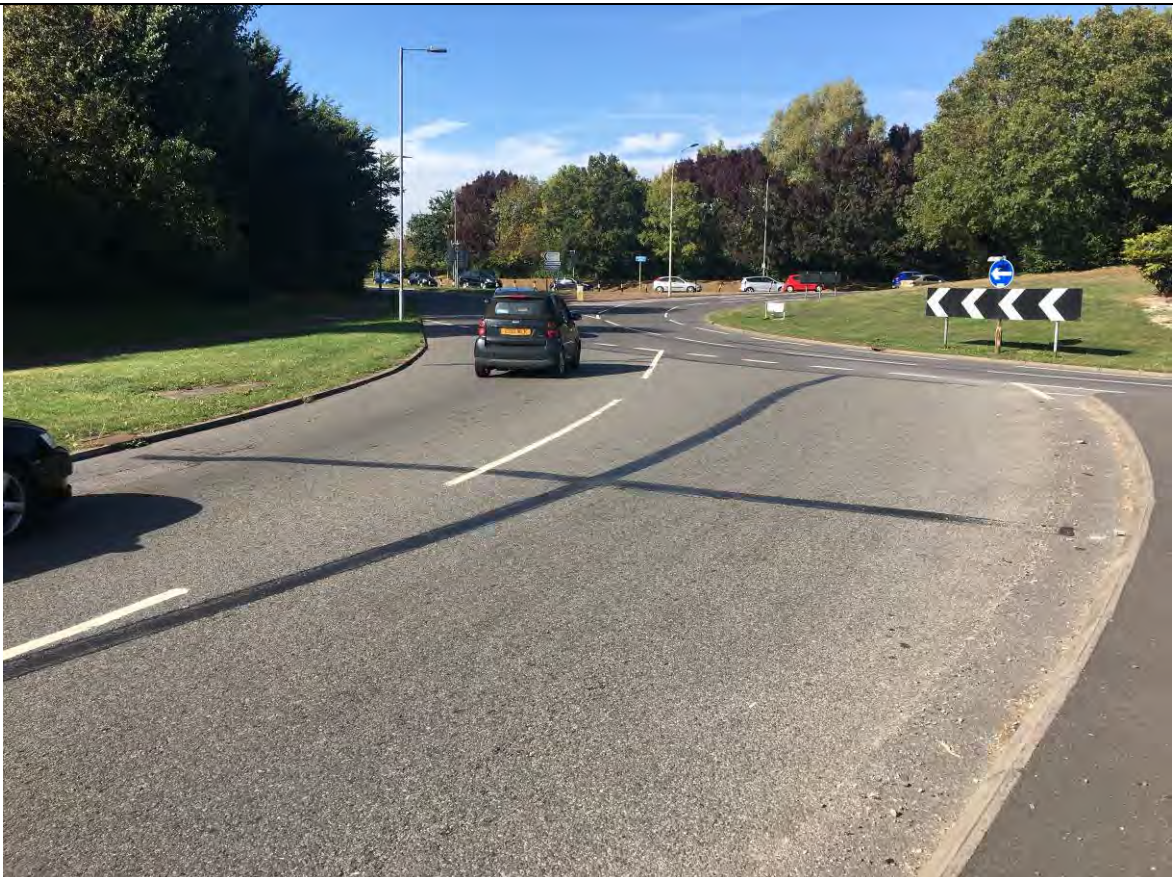
Image 5 – Chevron sign facing the northbound approach

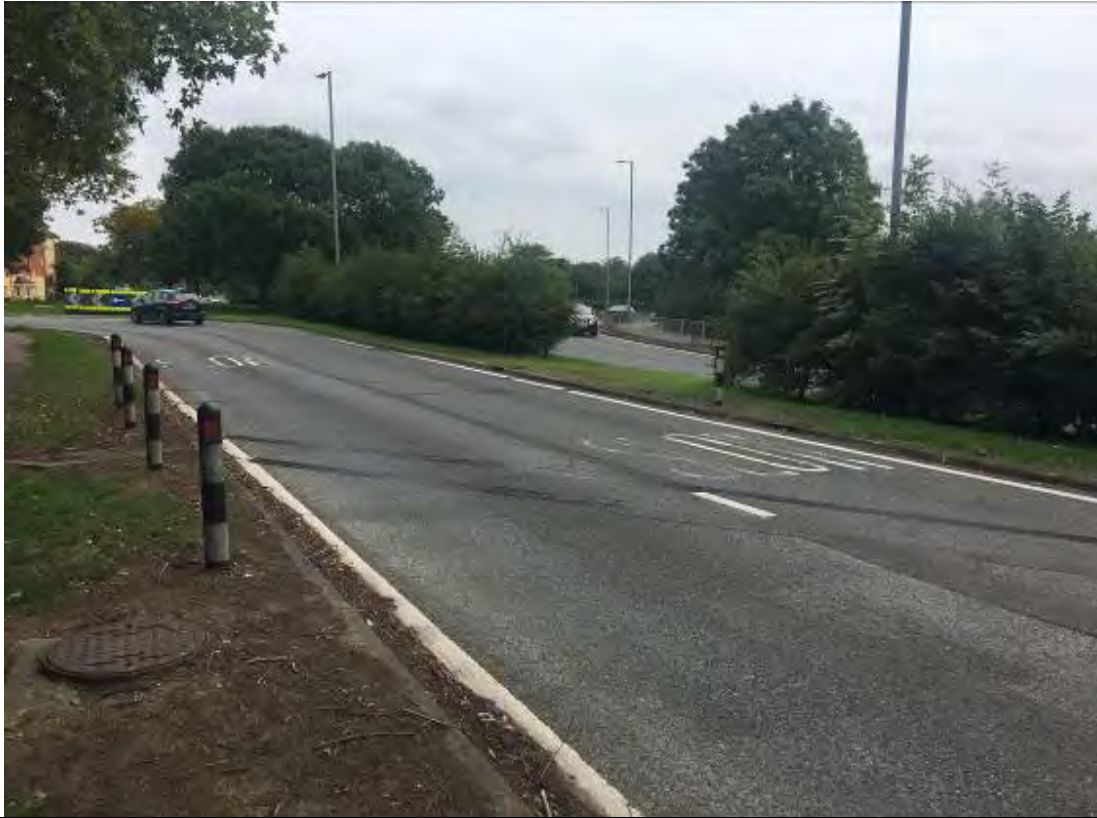
Image 2 – Gap in the existing highway screening / hedgerow

- 2) It is recommended that the gap in the existing highway screening / hedgerow should be filled in to reduce the potential for approaching motorists to look for gaps in traffic on the roundabout circulatory and approach the roundabout at inappropriate speeds.

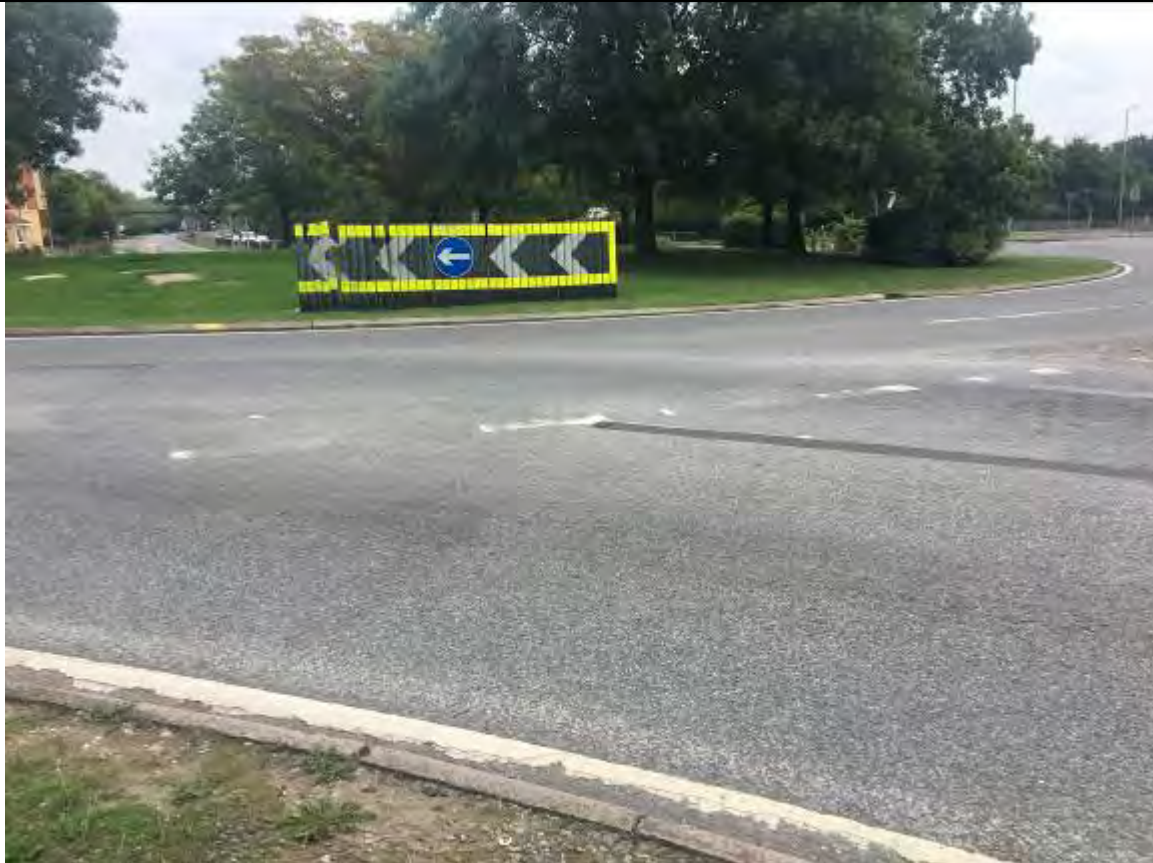
Image 4 – Existing 'Chevroflex' type sign facing the eastbound approach

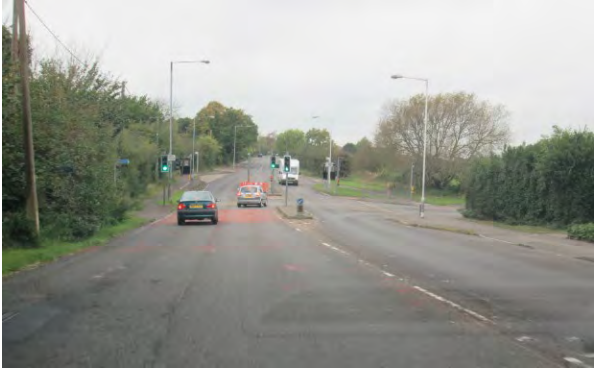
<p>Image 1 – B1464 westbound approach</p>	<p>Image 2 – B1464 – right turn filter into Pound Lane</p>

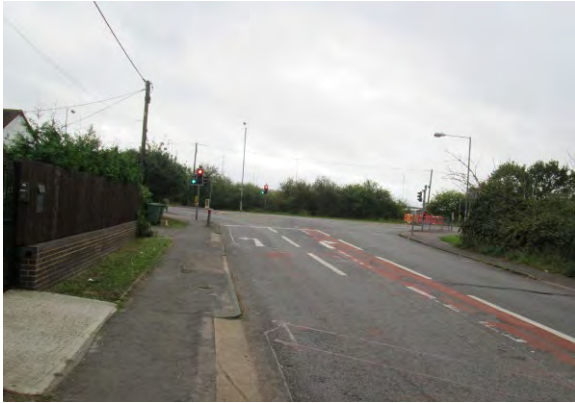
<p>Image 3 – Pound Lane southbound approach to junction</p>	<p>Image 4 – B1464 junction with Pound Lane</p>

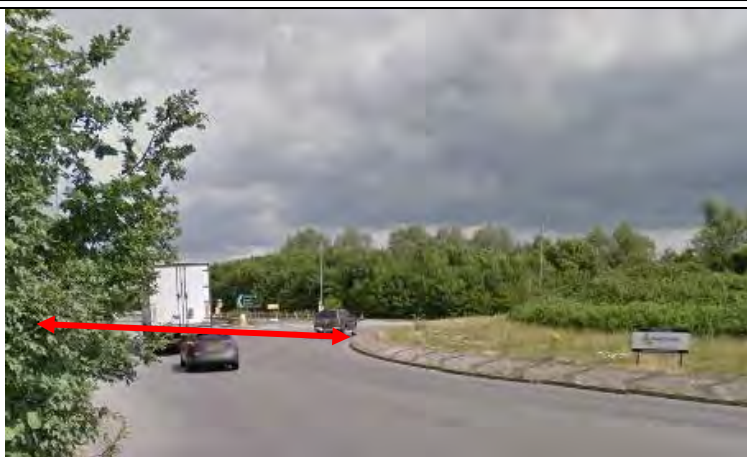
Image 1 – view looking north west from the A131 western arm.
View shows wide carriageway widths and vegetation in the nearside verge

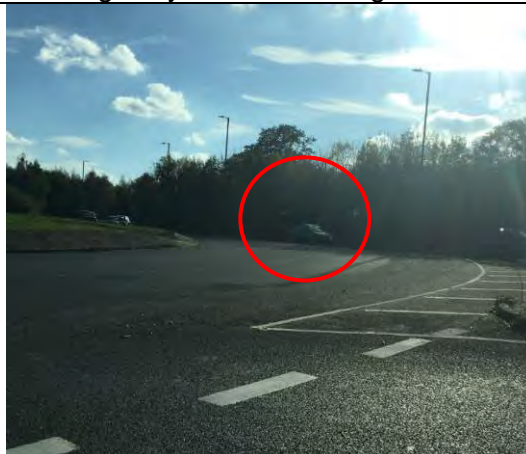
Image 2 – View looking at the circulatory for A131 northern arm when heading south. Image shows motorist not indicating to head north on the A131

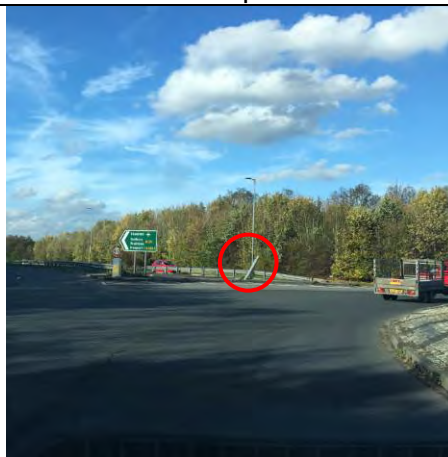
Image 4 – View travelling from A131 Western arm to London Road west to North. Image shows damaged lamp column

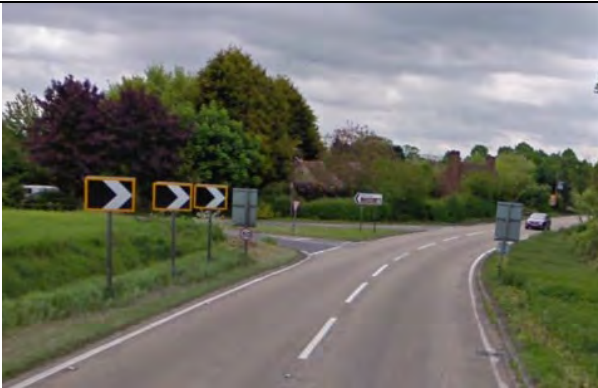
1 – View looking south on Witham Road with the junction for Temple Lane on the left

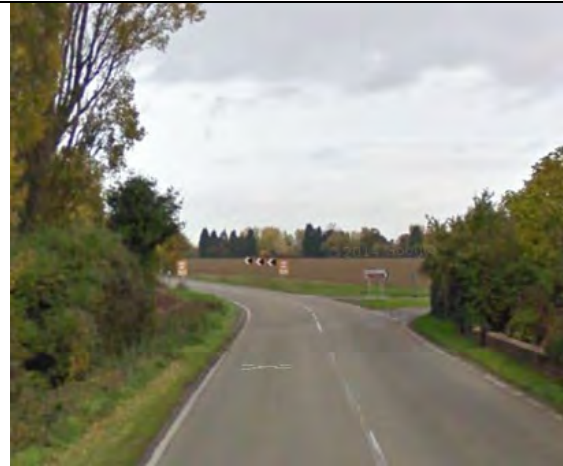
Image 2 – View looking north on Witham Road with the junction for Temple Lane on the right

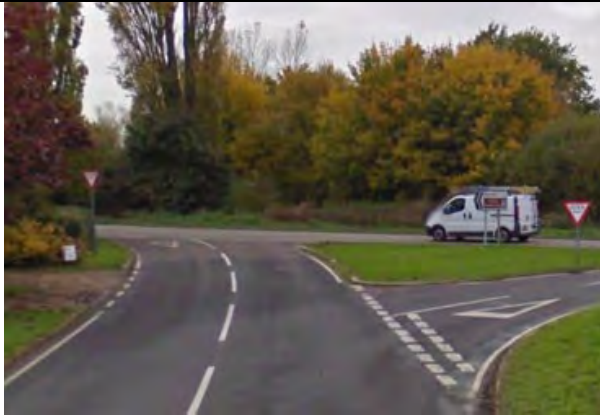
Image 3 – View looking west on Temple Lane
(van travelling south on Witham Road)

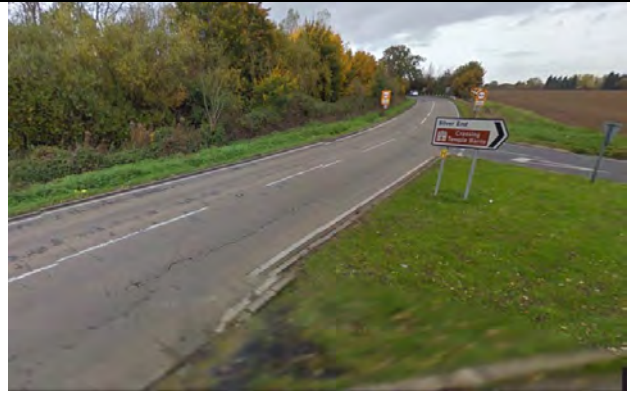
Image 4 – Existing flag tourist sign within
visibility splay

- 1: It is felt realigning the junction would help provide better inter-visibility between motorists on Witham road to motorists turning right from Temple Lane.
- 2: remove the bennet island and provide a normal junction layout which would also help reduce traffic speeds into and out of the junction pushing the give-way line further north. Which in turn will allow motorists to sit further north when turning into the junction.
- 3: There is a water main and fire hydrant this needs to be relocated to the northern verge.
- 4: provide new road surface and associated road markings.
- 5: Provide new giveway signing and relocate existing flag signs.
- 6: Review southbound approach signing of the junction itself.

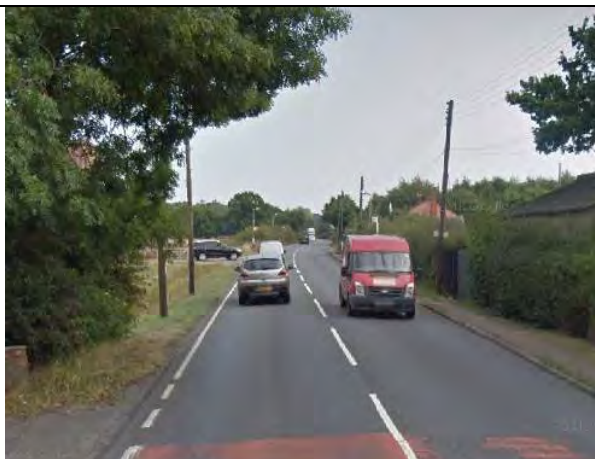
Image 1 – View looking north east with the crematorium to the left of the image.

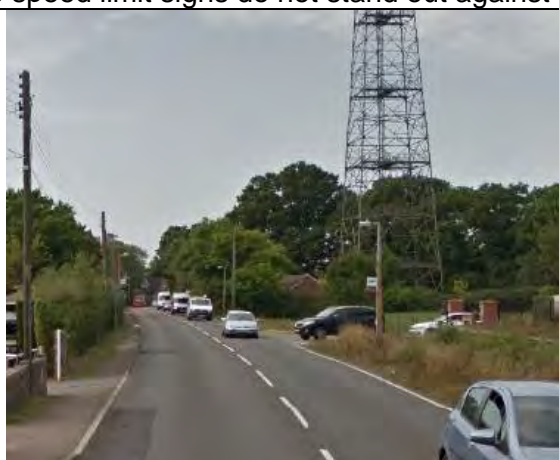
Image 11 – View looking South/West on Halstead Road with the change in speed limit (circled in red), note the speed limit signs do not stand out against the back ground.

- 1) It is recommended that improvements are made to highlight the speed limit change close to the Crematorium (as seen in image 11) .The start of the 40mph limit is not very well defined due to the amount of vegetation by the road side. The signs could be mounted on White Oak/ or similar Gateway posts to highlight the speed limit change.
- 2) It is recommended that verge marker posts at 20m centres are provided on either side of A131 Halstead Road from the change of speed 40mph limit (north of the cemetery) up to its junction with Russel Road. On the bends the provision of these marker posts should be reduced to 10m centres 50m either side of the bends.
- 3) It is recommended that the existing Deer Warning sign is replaced with two new yellow backed Deer Warning Signs one in either verge to warn motorists in both directions of the hazard of animals crossing the carriageway.

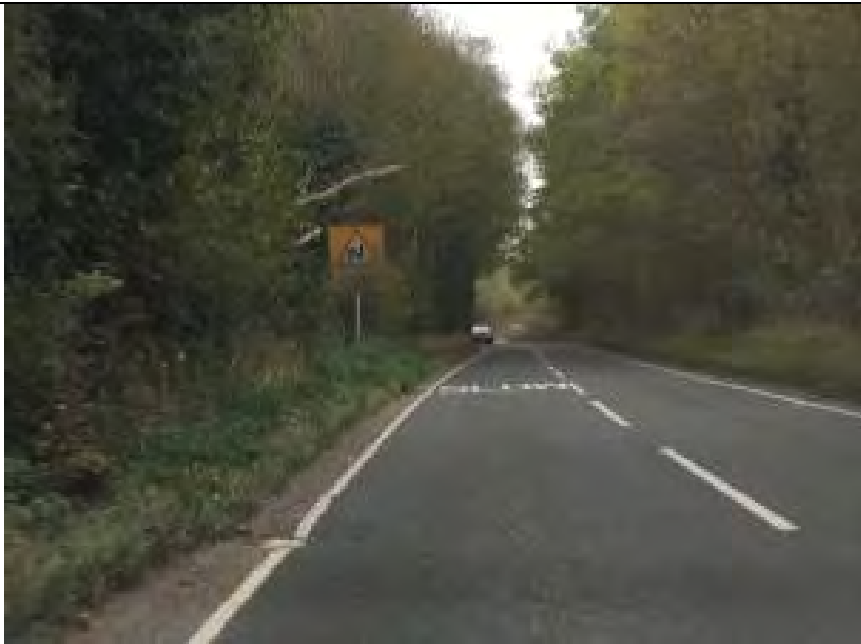
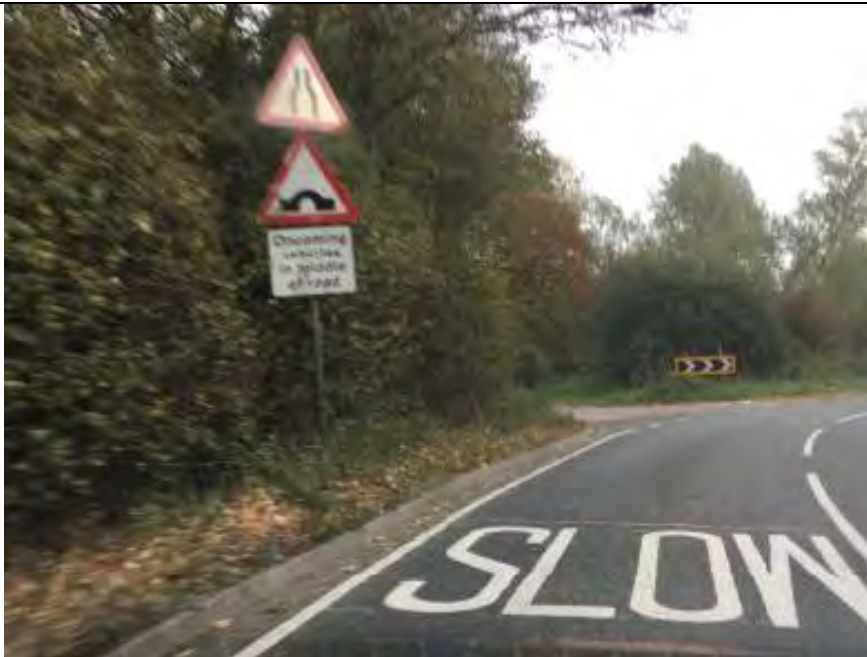
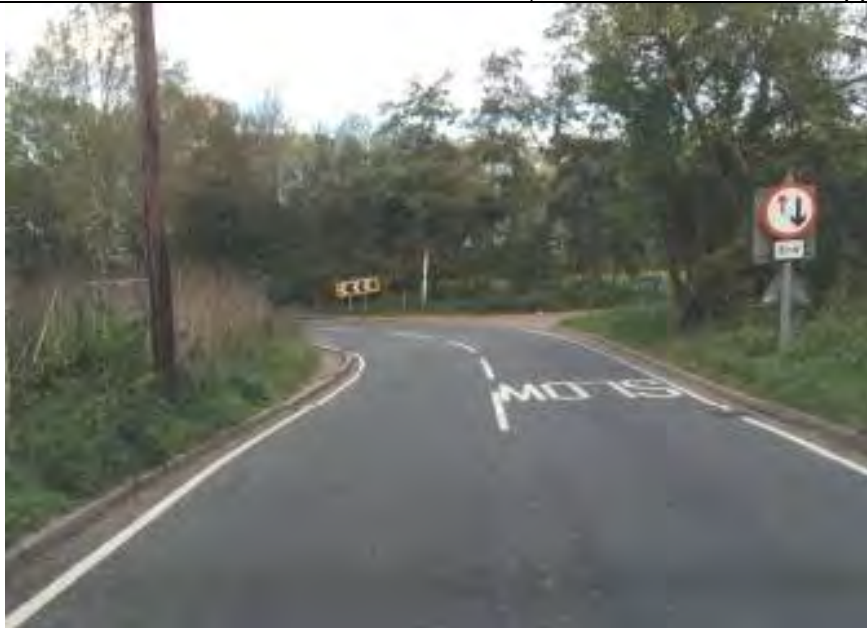
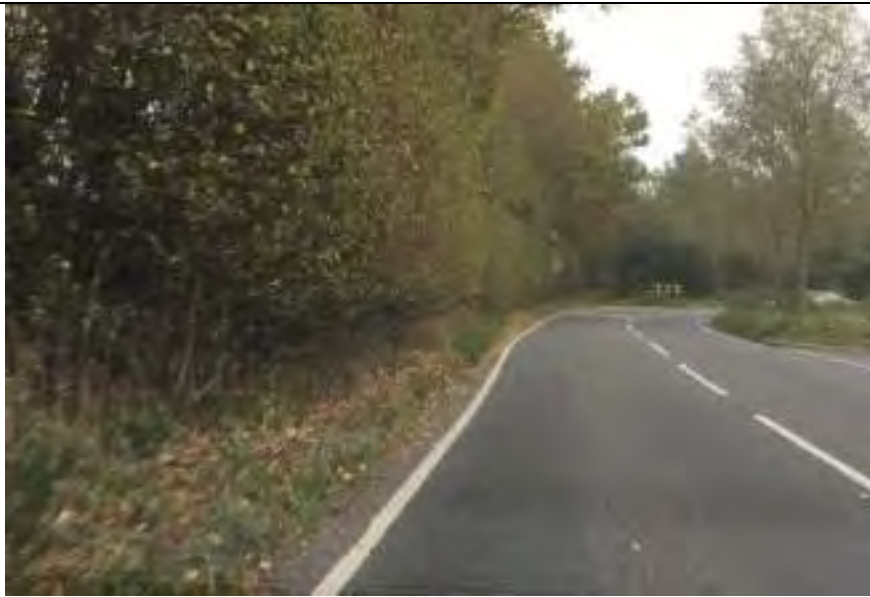
Principle: A study of the personal injury collisions at location shows a pattern of eastbound vehicles losing control at a bend in the road along Braxted Park Road. Improving chevron signing, providing reflective hazard marker posts and providing road studs in this location will better guide motorists around the bend. Moreover, improving visibility to existing signing by clearing surrounding vegetation and cleaning the sign faces will ensure motorists can easily observe them and react accordingly.

Remove existing chevron signs and replace with a number of back-to back single chevron signs (with yellow borders) placed consistently around the bend.

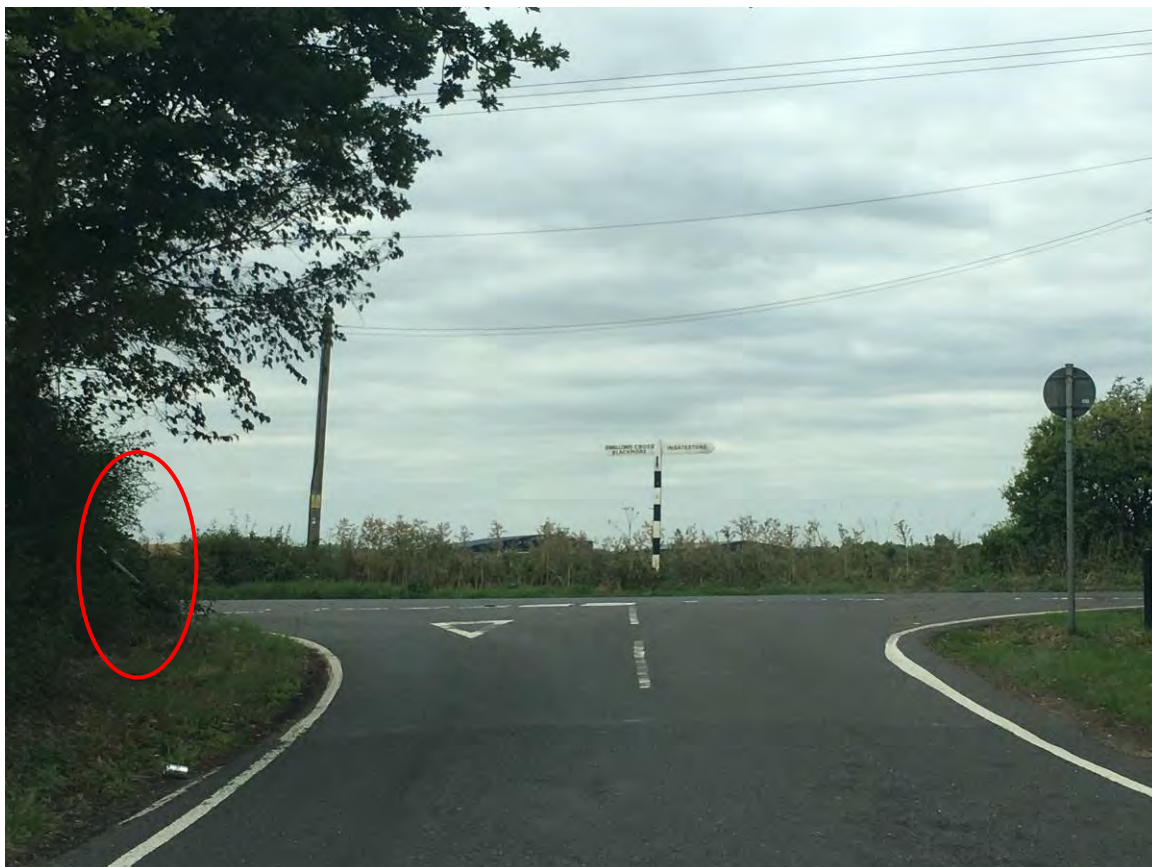
Image 3 – Reverse of existing '7.5T' weight limit signs, nearside sign leaning in verge

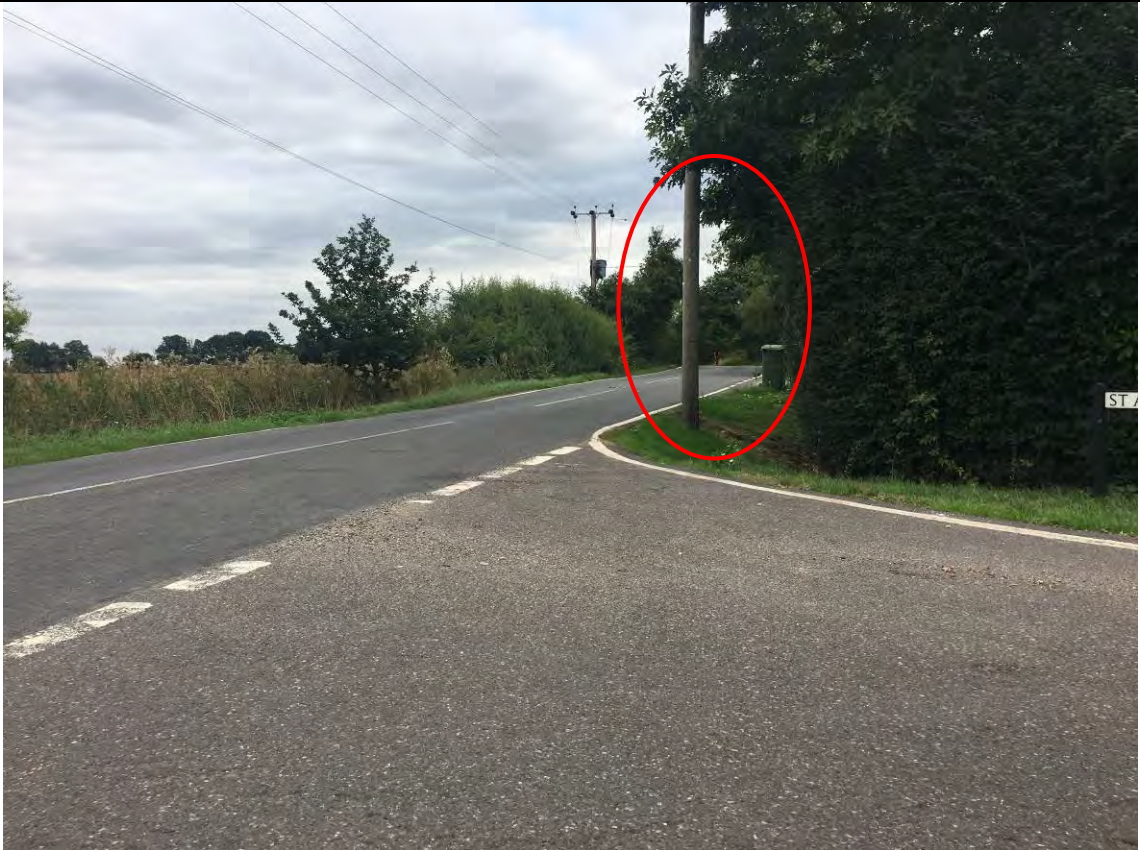
Image 6 – Telegraph pole and overgrown vegetation located the within visibility splay to the right when sitting in at the give way lines on St Annes Road

- 1) It is recommended that any overgrown vegetation located within the visibility splay should be cut back and maintained on a regular basis.
- 2) It is recommended that the existing 'Side road ahead' warning sign on the Thoby Lane eastbound approach should be replaced with a new yellow backed version and overgrown vegetation should be cut back and maintained on a regular basis, or the sign should be relocated to an area without adjacent vegetation.

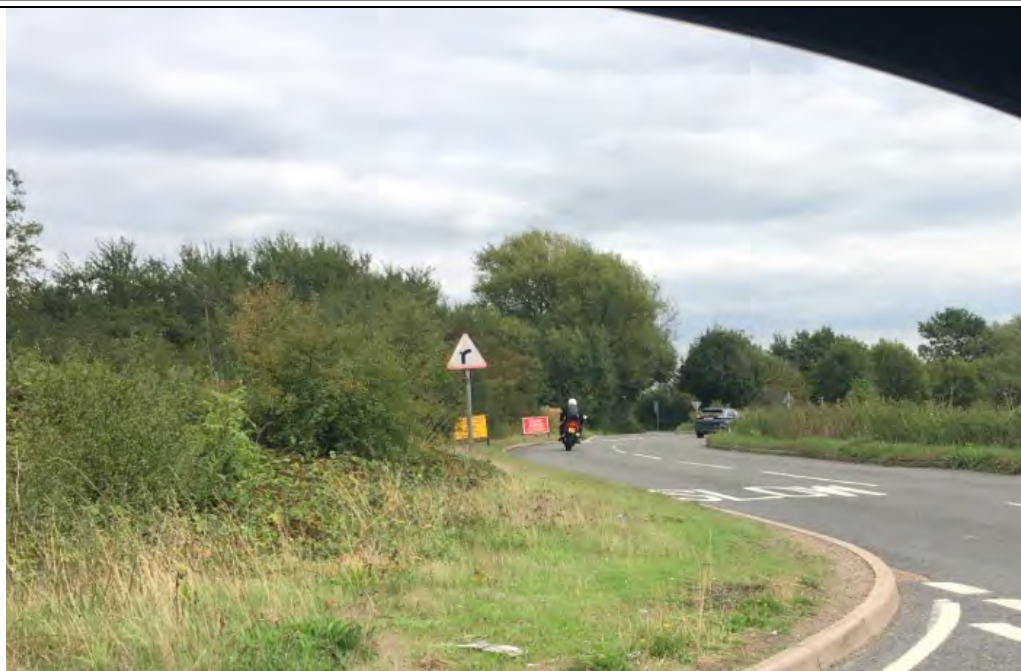
Image 1 – Existing ‘Side road on bend ahead’ warning sign on Wash Road / Widvale Road eastbound approach is partially faded

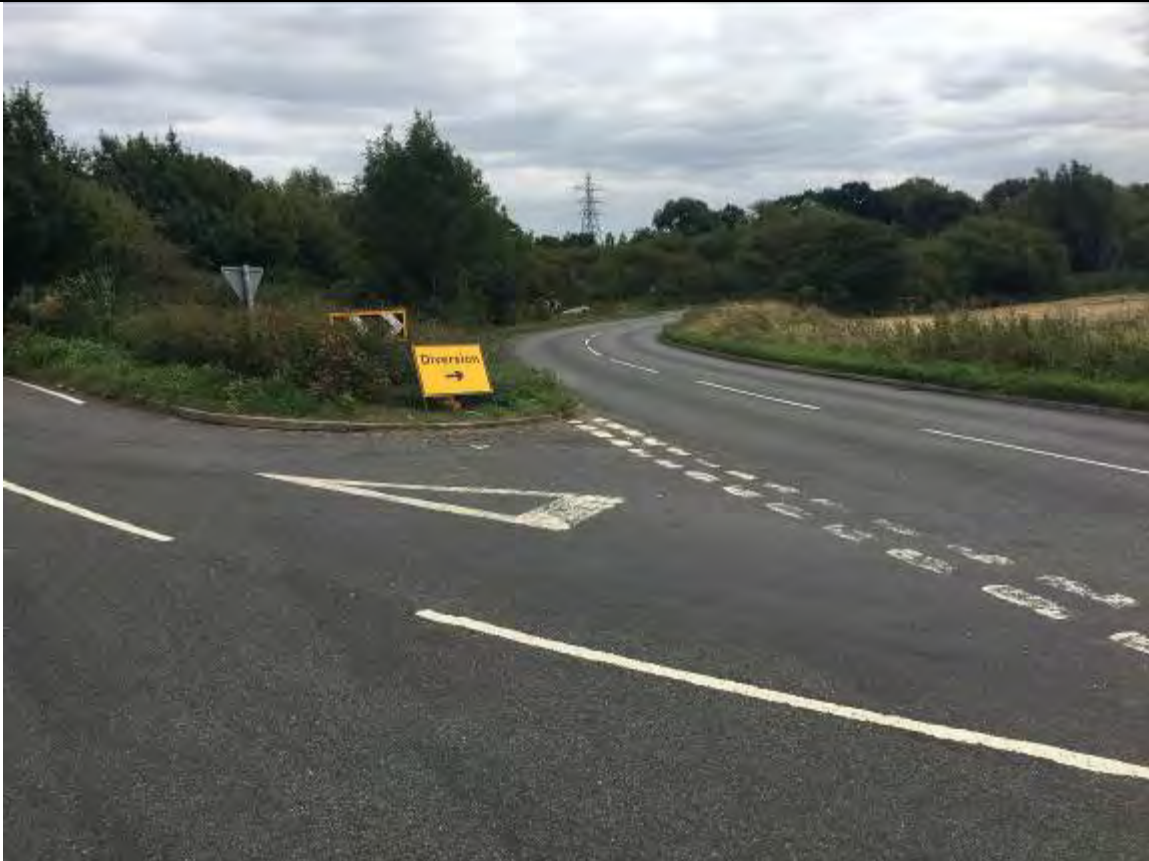
Image 2 – Existing yellow backed chevron signs facing eastbound motorists are partially obscured by overgrown vegetation

- 1) It is recommended that any overgrown vegetation located within the visibility splays should be cut back and maintained on a regular basis, including the area to the inside of the sharp bend (Subject to highway boundary). Overgrown areas of vegetation surrounding and/or obscuring existing chevron signs should also be cut back and maintained on a regular basis.
- 2) It is recommended that the existing 'Side road on bend ahead' warning signs on both Wash Road / Widvale Road approaches should be replaced with new yellow backed versions.
- 3) It is recommended that a new 'Give way' sign assembly should be provided on the Old Church Lane westbound approach (Southern section).

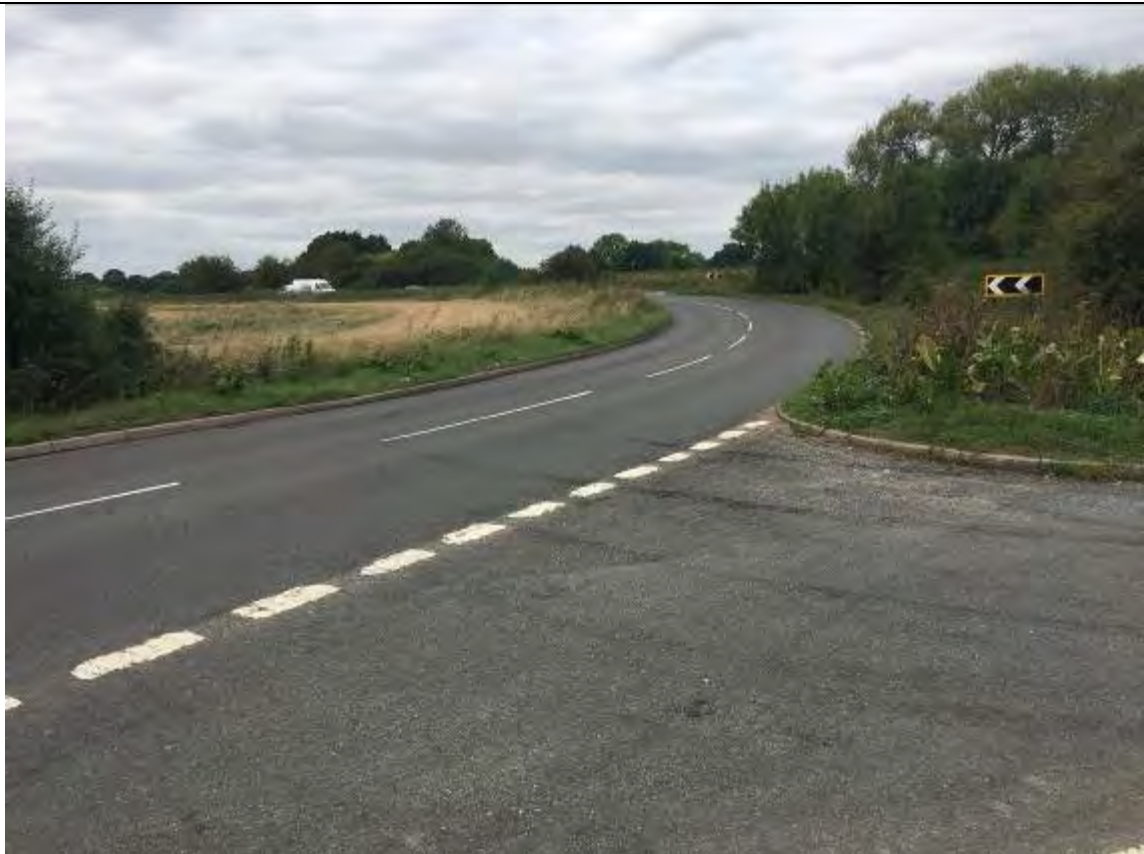
Image 4 – Existing yellow backed chevron signs facing northbound motorists are partially obscured by overgrown vegetation.

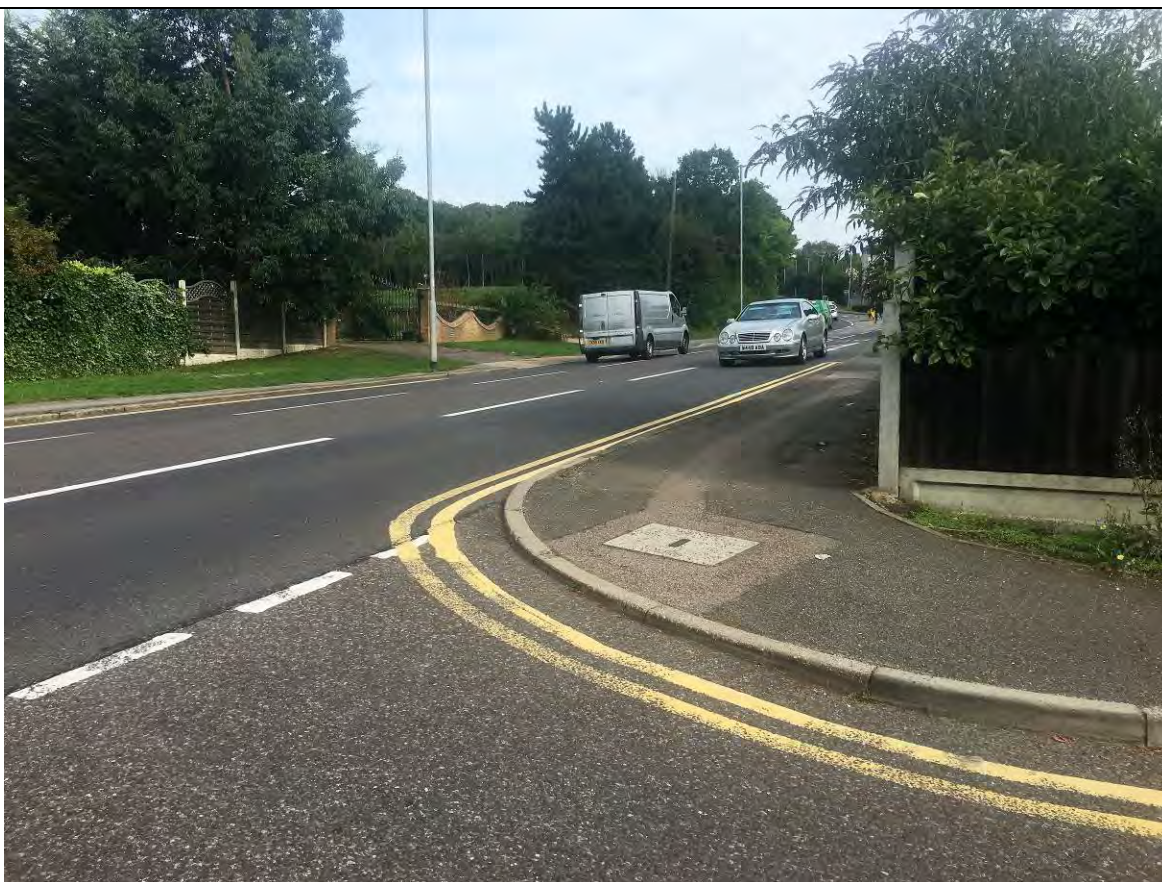
Image 2 – Visibility to the right obscured by a boundary fence

- 1) It is recommended that a feasibility study be carried out to identify if it is possible to re-align the kerb line to the southern side of A13 London Road in order to bring the give way lines forward in order to improve visibility splays for motorists turning out of Downer Road. It appears that it may be possible to narrow the existing right turn lanes to the centre of A13 London Road in order to shift the westbound running lane further north and therefore allow re-alignment of the southern kerb line.
- 2) It is recommend that the street name sign located to the southern side of Downer Road (South) should be relocated further into the junction, outside of the visibility splay.

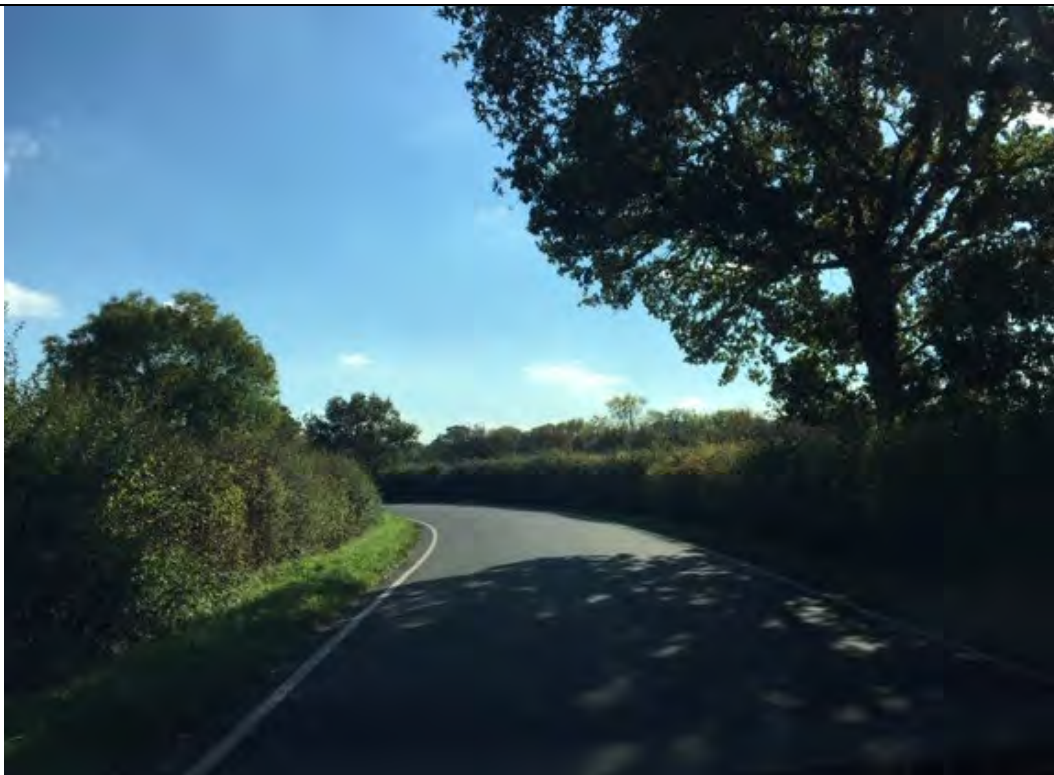
Image 1 – Southbound approach to southernmost bend

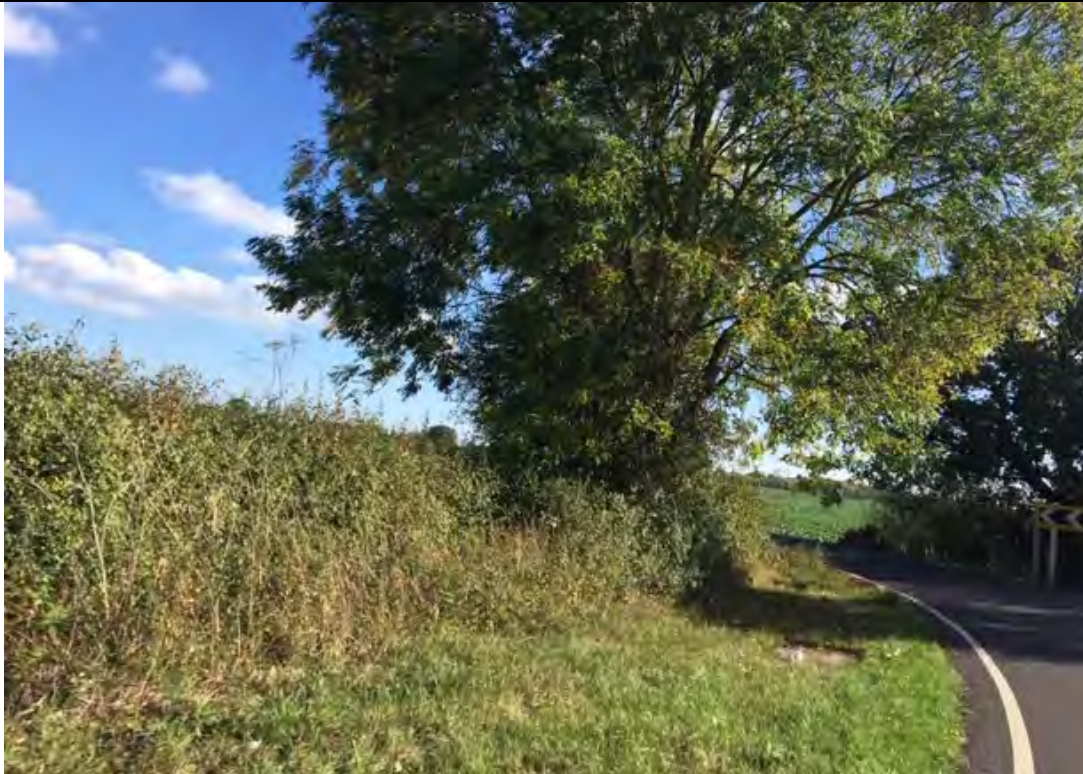
Image 2 – Vegetation within inside of southernmost bend obstructing forward visibility

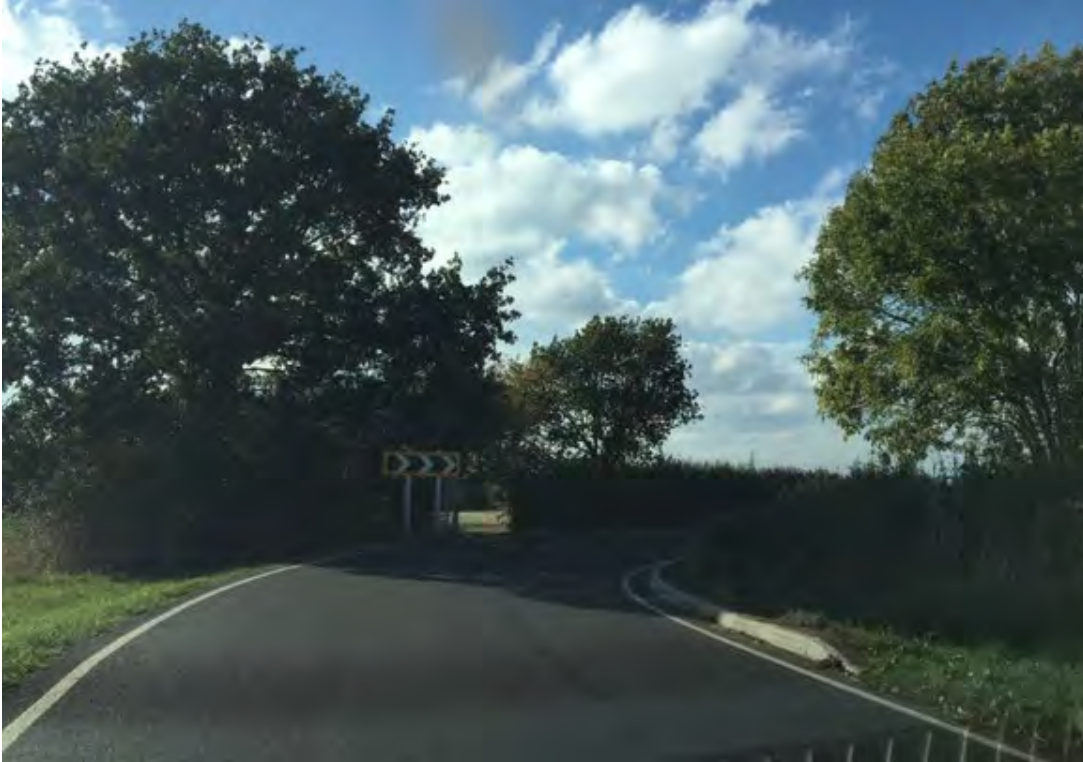
Image 3 – Westbound approach to southernmost bend

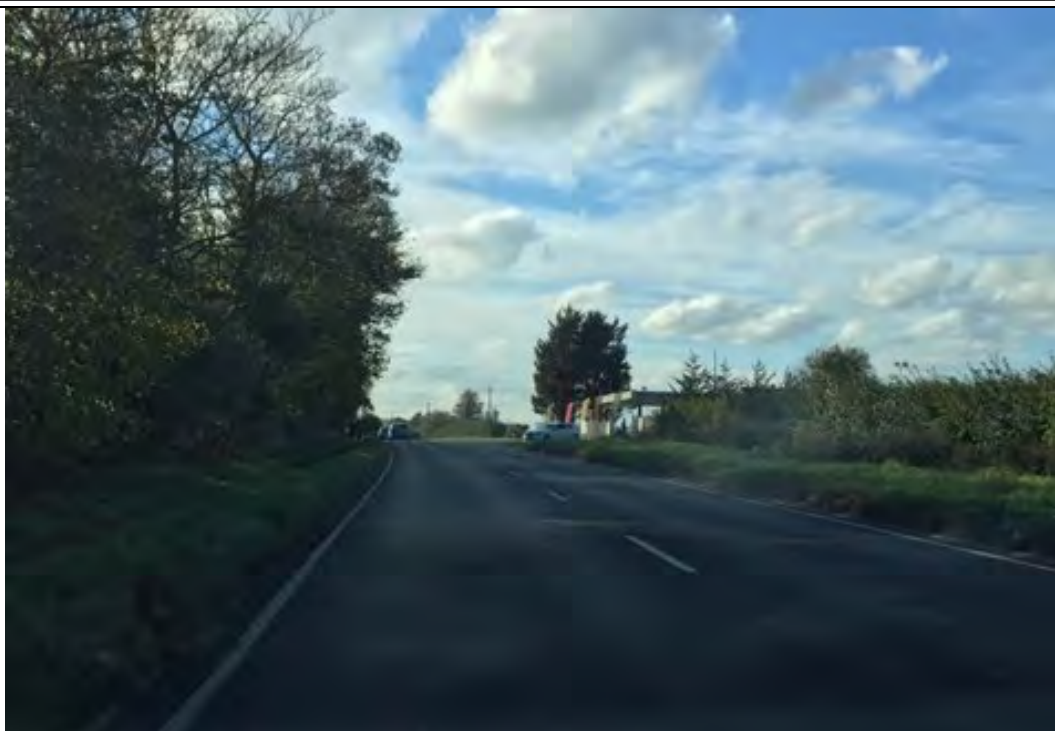
Image 1 – Roxwell Road; westbound approach to Car Wash facility

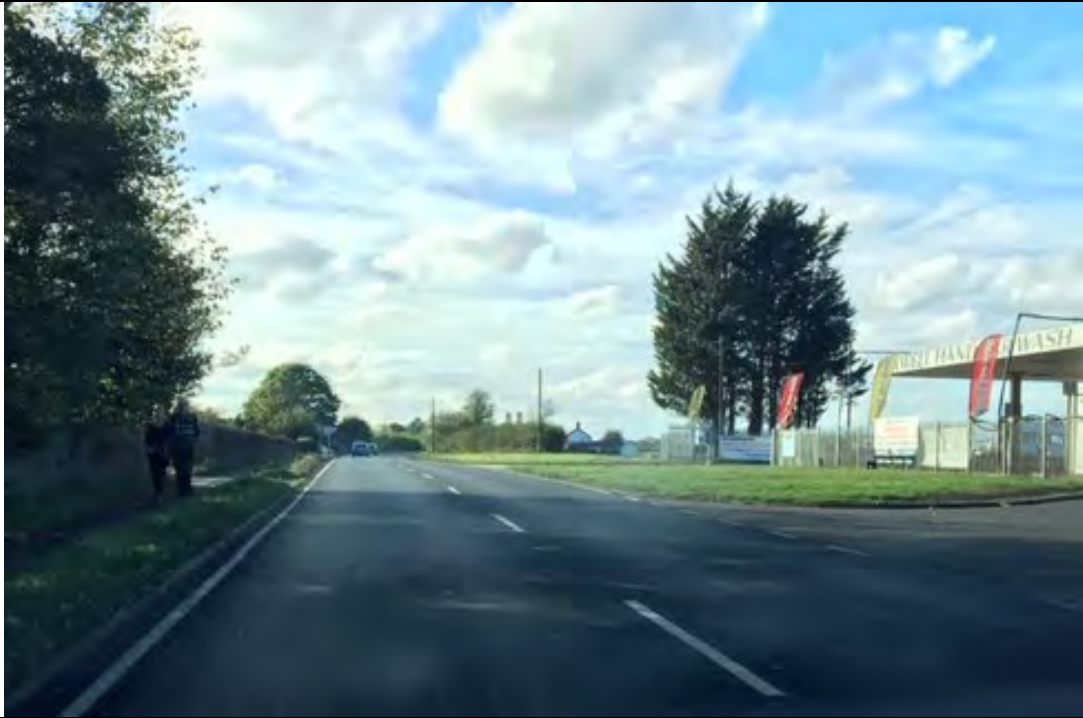
Image 2 – Roxwell Road; looking in a westerly direction at Car Wash facility

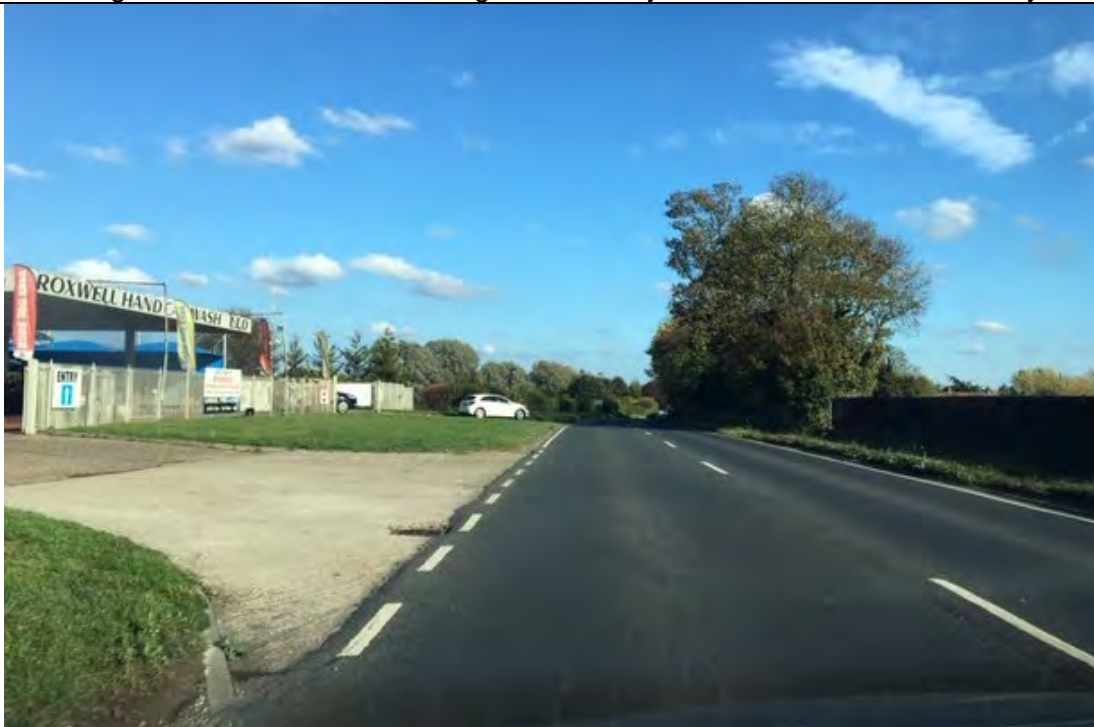
Image 3 – Roxwell Road; looking in an easterly direction at Car Wash facility entry

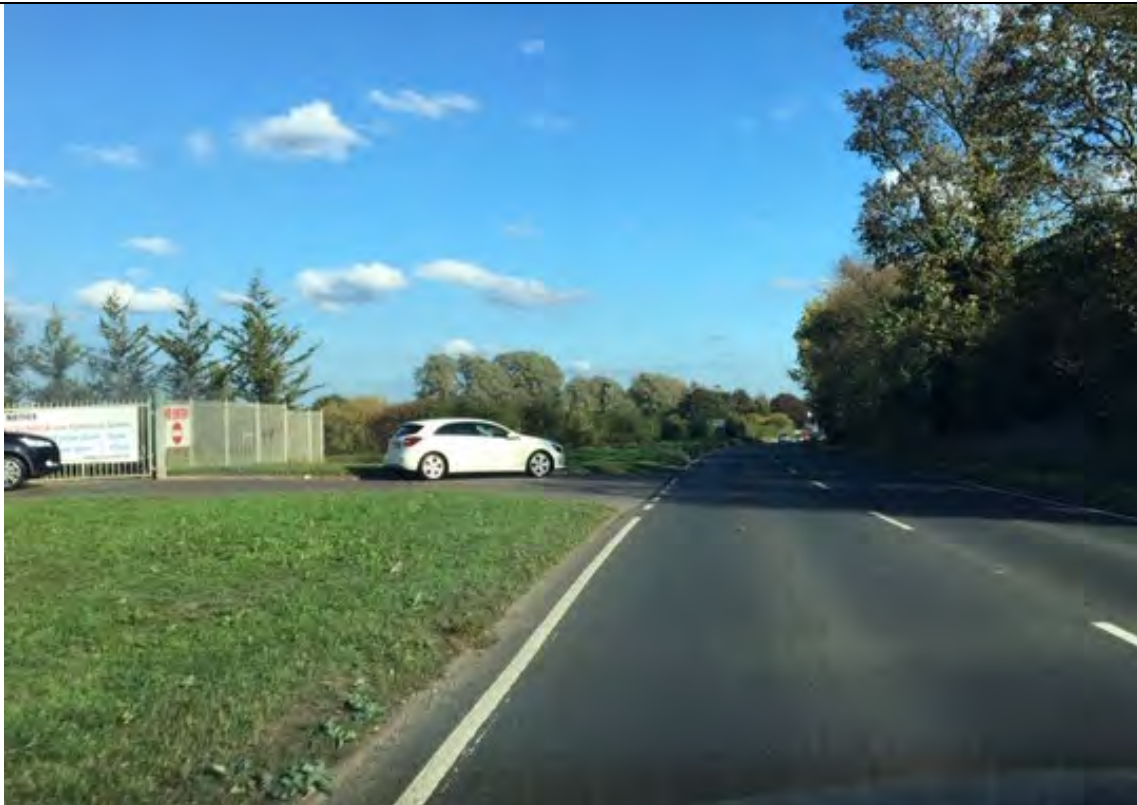
Image 4 – Roxwell Road; looking in an easterly direction at Car Wash facility exit

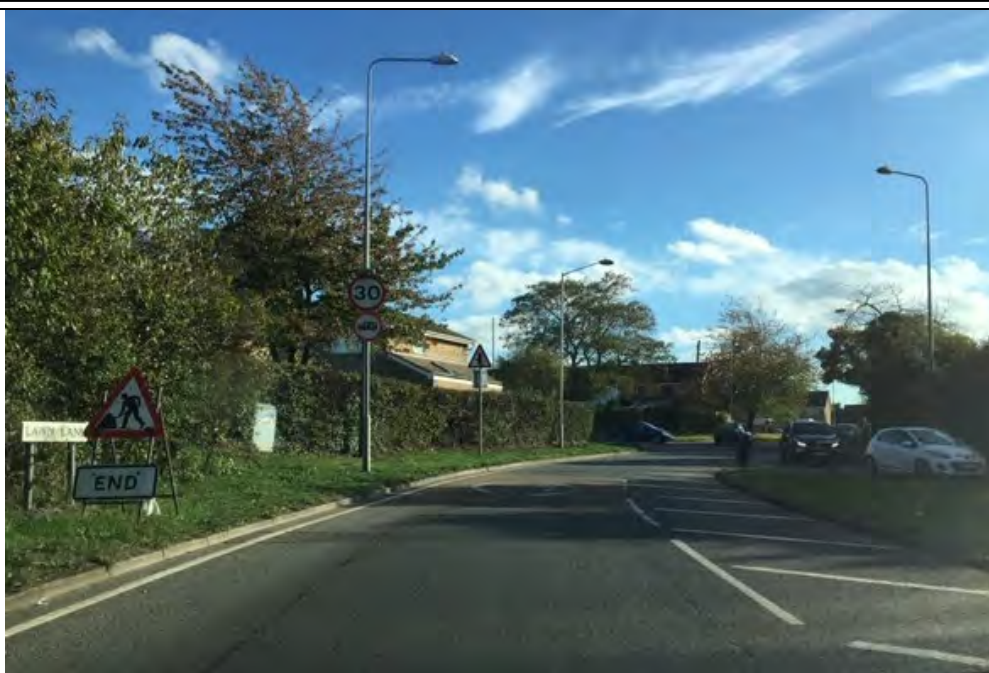
Image 1 – Lawn Lane; speed limit sign (nearside) for southbound vehicles exiting A1016 roundabout towards junction

Replace missing illuminated 30mph terminal sign within splitter island to reinforce the change in speed limit to motorists exiting the A1016 roundabout (if no electrical connection is present, then consider providing an unilluminated sign if scheme funding is an issue).
