Site Report Essex Highways Casualty Reduction Site Report 2019/20

Location: A176 Uppermayne Roundabout Junction with A176 Noak Hill Road, South Wash Road & A127 Eastbound Off-slip, Noak Bridge

Collision Investigation Period: 01/01/2015 – 31/12/2017

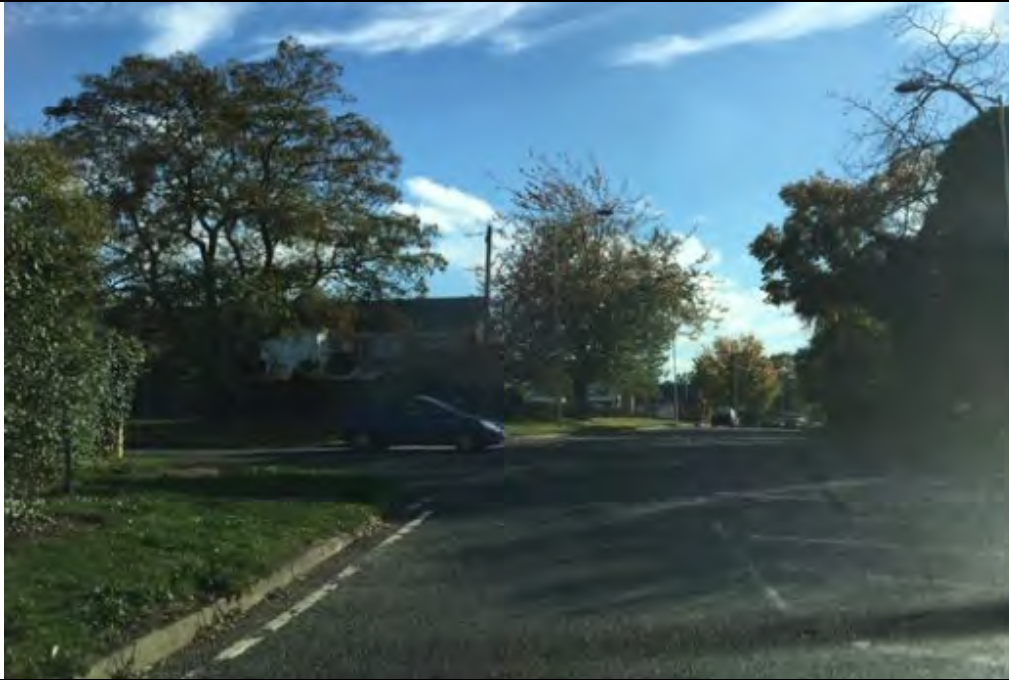
Image 2 – Lawn Lane; southbound approach to junction with Brackenden Drive

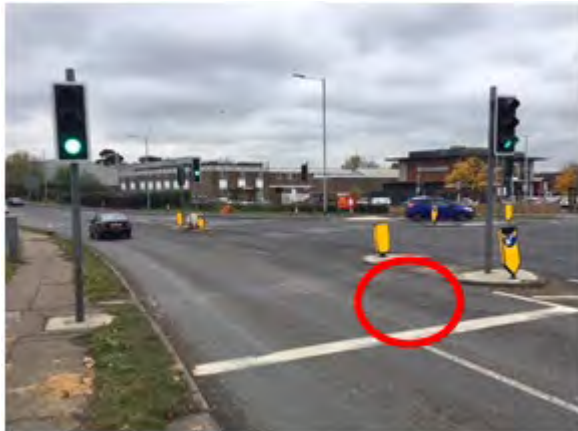
Image 1 – Southbound approach along Westway Road (current loop position for right turning traffic highlighted in red)

- Relocate traffic signal loop within carriageway for right turning vehicles further south into junction, to a point where waiting vehicles will activate the right turn phase.
- Following further discussions with ITS team (05/12/2018) – moving of stop line and providing right turn phase at this location is likely to cause a high level of capacity issues for road users attempting to travel north into Chelmsford. Other feasibility measures which include banning the right turn manoeuvre into Robjohns Rd are going to be explored from a modelling perspective in this year. With a potential design in Financial year 20_21

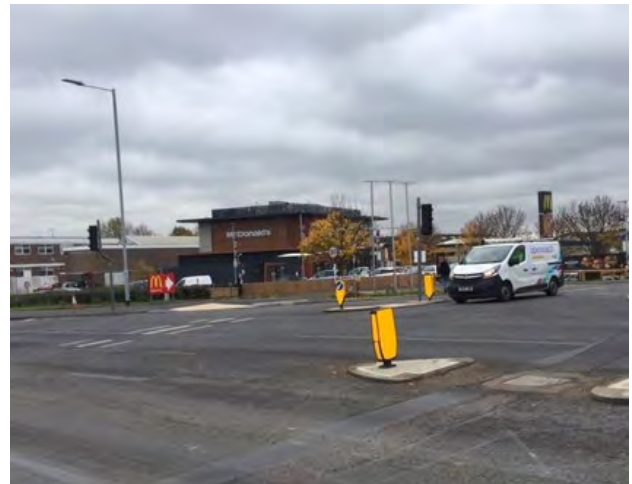
Image 2 – Looking at Robjohns Road arm from Westway

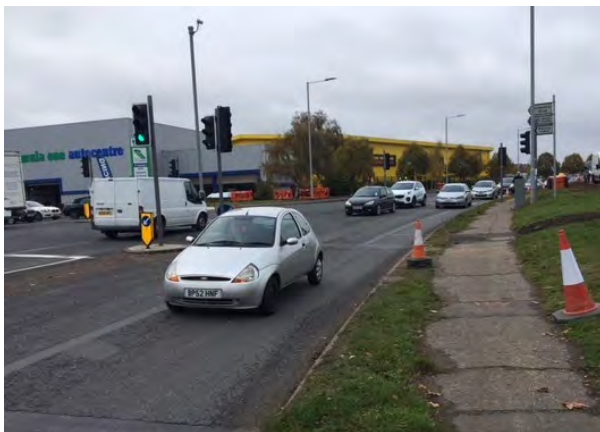
Image 3 – Westway; looking northbound towards junction

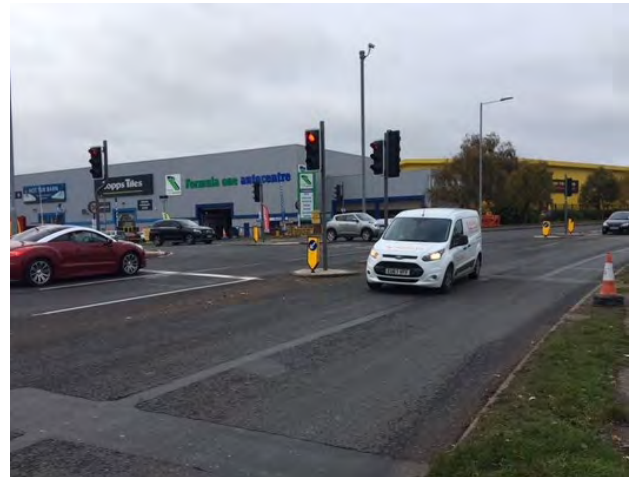
Image 4 – Westway; looking northbound across to Robjohns Road

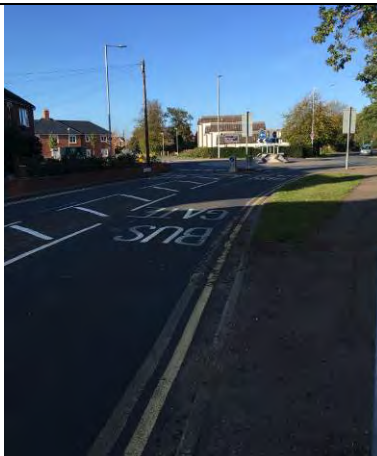
Image 1 – View looking North from the bus gate on Nayland Road

- 1) Discuss the location with Essex Cycling Strategy Leader:
- 2) It is recommended that additional shared use signing is provided on the shared footway/cycleway on the western side of Nayland Road. To highlight the facility for cyclists heading north on Nayland Road, across Wildeve Avenue and onto Boxted Rd.
- 3) It is recommended that the central hatching along Nayland Road is partially removed and a cycle right turn lane is provided to allow cyclists to turn right and join the shared facility on the corner of Nayland Road (new dropped kerbing will be required on the corner) and Northern Approach Road when passing through the bus gate, this will allow them to use the toucan crossing on Northern Approach Road. See proposed route in red below.

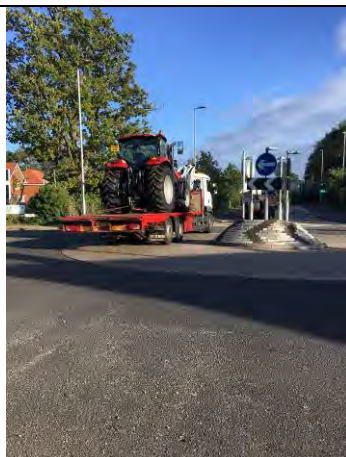
Image 2 – View looking East on Wildeve Avenue (notice articulated vehicle over running the over run area)

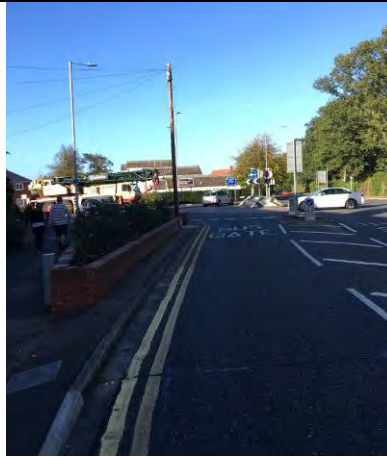
Image 3 – View looking North from the bus gate on Nayland Road

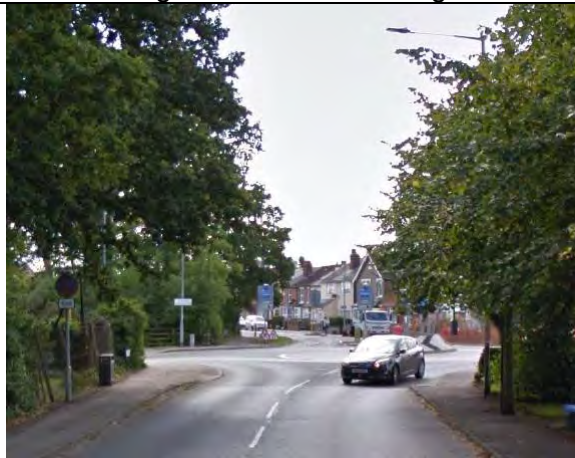
Image 4 – View looking south at the roundabout on Boxted Road

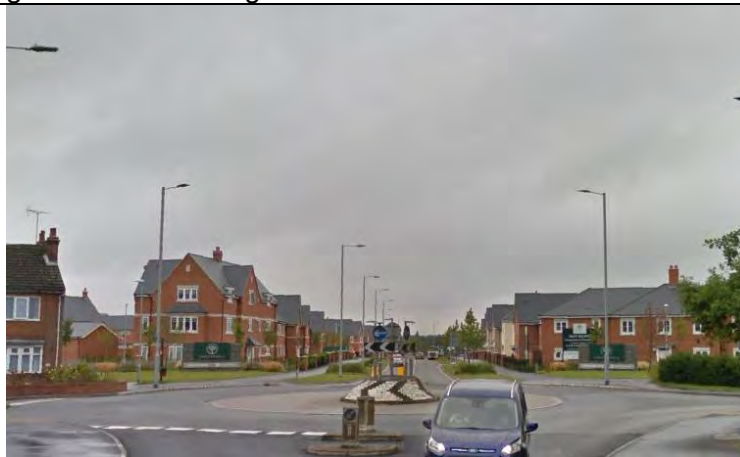
Image 5 – View looking west on Northern Approach Road.

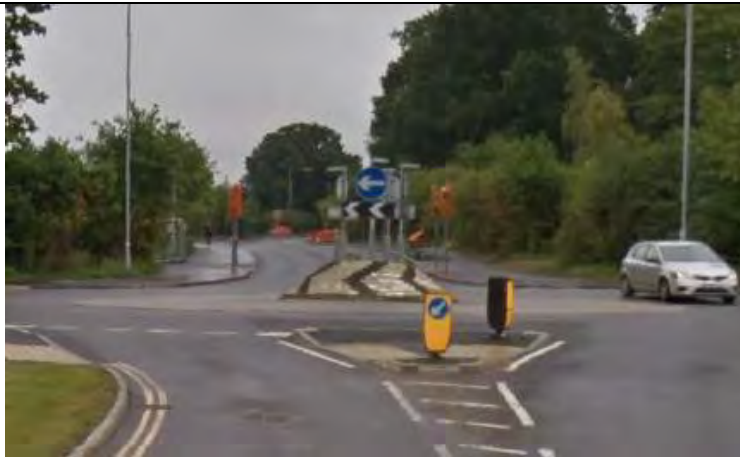
Image 6 – View looking East on Wildeve Avenue

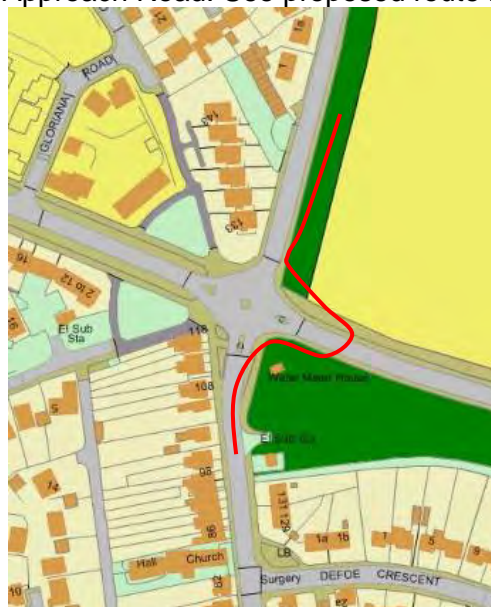
Image 7: Red line showing preferred route from Nayland Road to Boxted Road using new Toucan crossing.

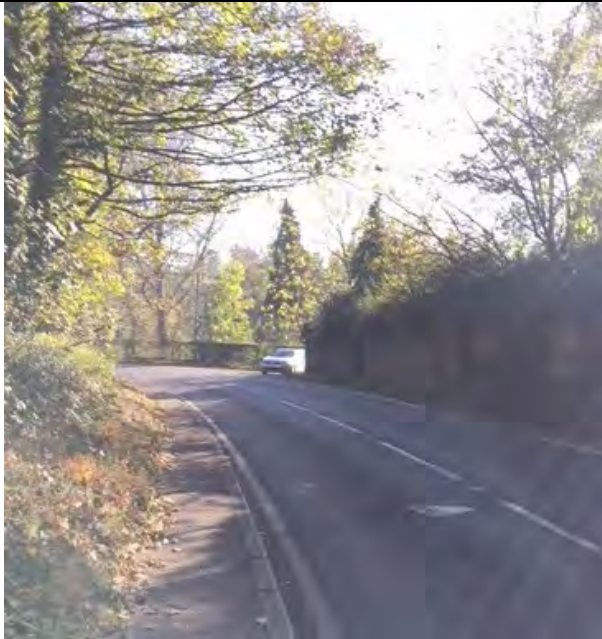
Image 1 –

Colchester Road Heading South east

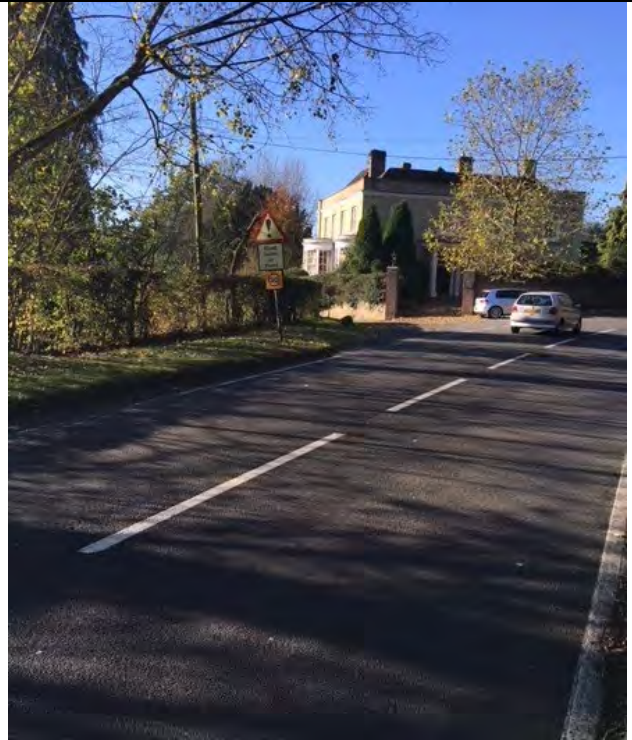
Image 2 –

Colchester Road Heading North west

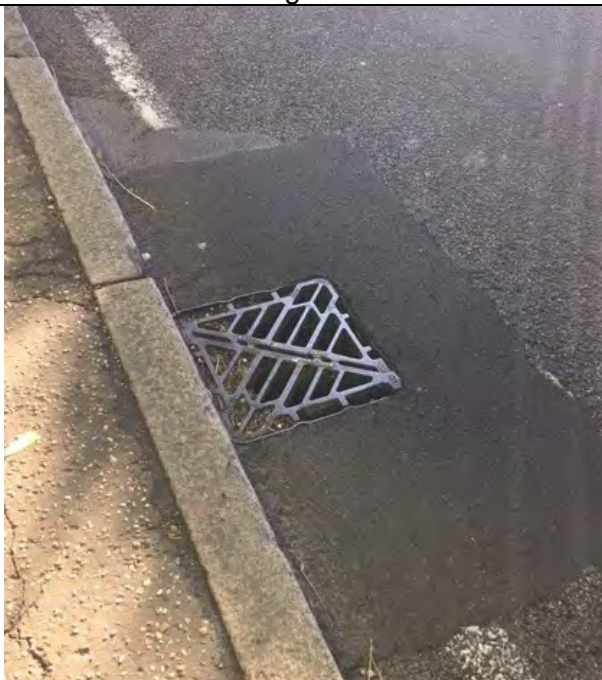
Existing gulley opposite Lanes Road junction

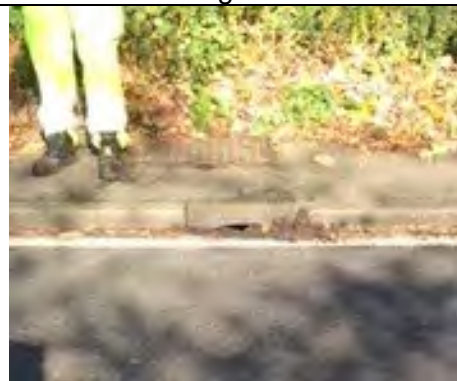
Image 3 –

Existing Gulley offset opposite Lanes Road junction

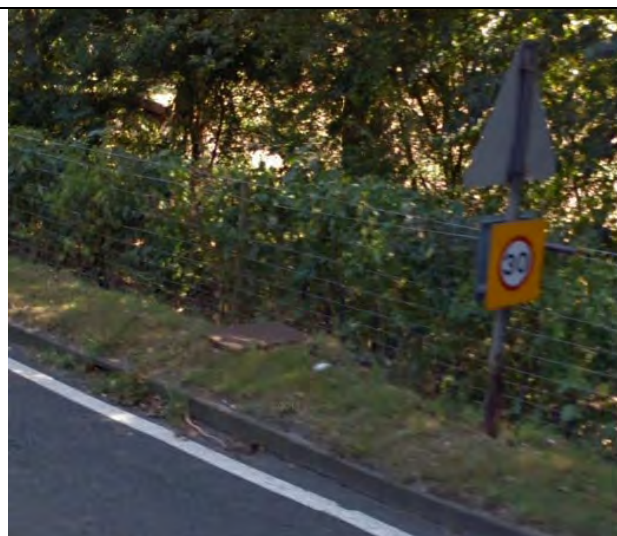
Image 5 –

Existing gulley offlet south east of the bend likely to be piped into adjacent field.

- 2: If the system is damaged or the soak away is no longer working arrange for repairs to the system to be made.
- 3: If capacity is available within the system undertake a topo survey to locate the low spots within the carriageway and install 2 x new gulley's on the bend.

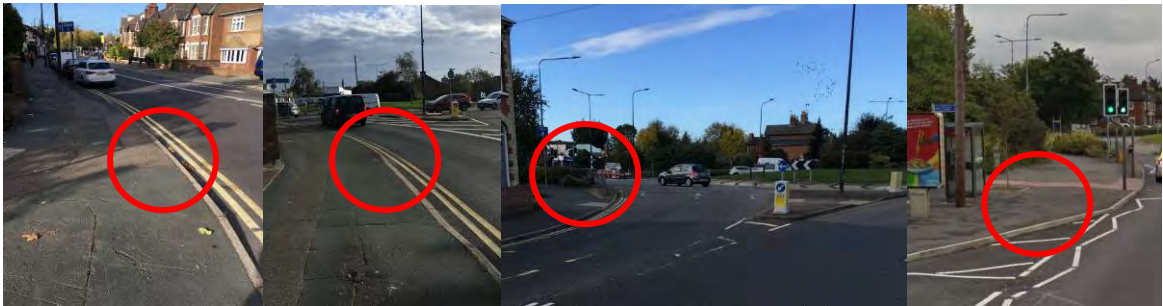
Images- 7, 8, 9, 10 Red circles showing preferred location of new cycle scoops.

- 4) It is recommended that entry and exit to the shared cycleway is investigated for all four arms of the roundabout in the form of new cycle slips/ scoops so that cyclist can join the cycleway in advance of the roundabout. There are a number of areas that may be suitable (see Images below). It is recommended that a cycle symbol and left turn arrow is provided on the carriageway. Existing Hatching on Colne Bank Avenue will need to be removed. On Colne Bank Avenue and North Station Road (South) new dropped kerbing and profiled paving will be needed.

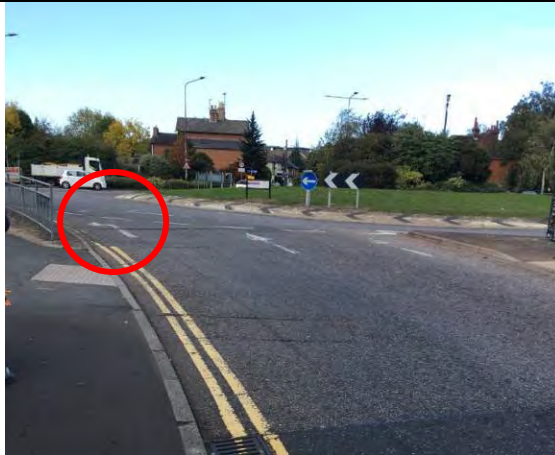
Image 12- Location of proposed Cycle lane.

- 5) Following survey results if on carriageway cycle numbers are high and that traffic flows are appropriate It is recommended that a short section of mandatory cycle lane at 1.5m wide is provided on North Station Road (southern arm) on the approach to the roundabout (see red circle on image 12 below), and that the three lanes for motor vehicles are removed and replaced with two lanes.

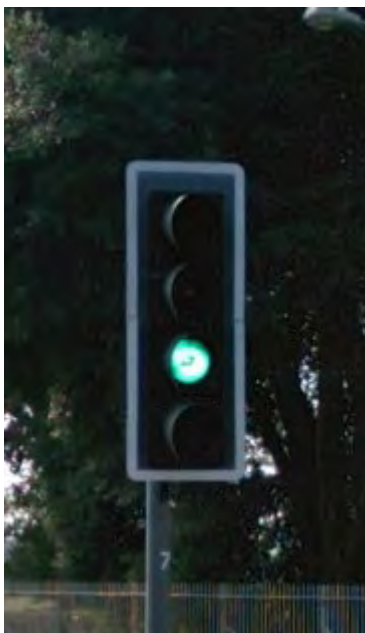
Image 5 –

Existing secondary head on Mersea Road for right turning traffic with indicative green situated below the "normal" green aspect.

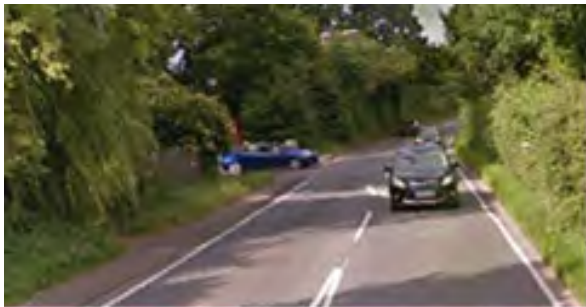
Image 1 – Abridge Road northeast bound approach to access

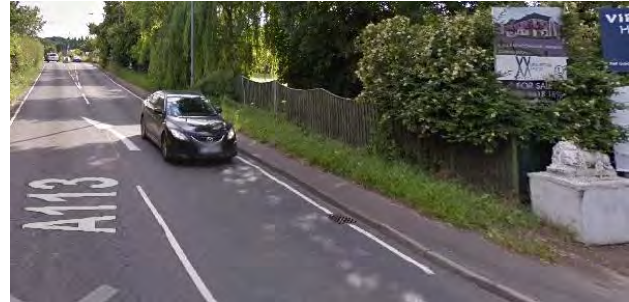
Image 2 – View to right from access

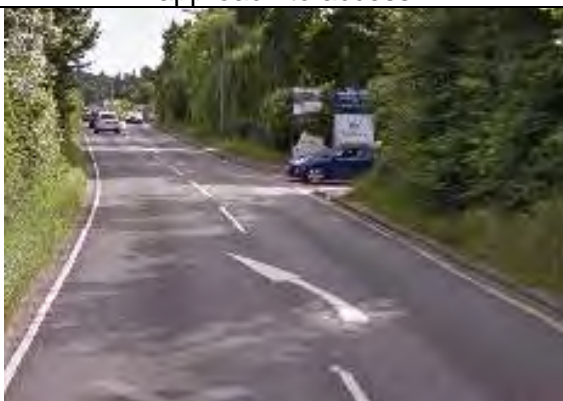
Image 3 – Abridge Road southwest bound approach to access

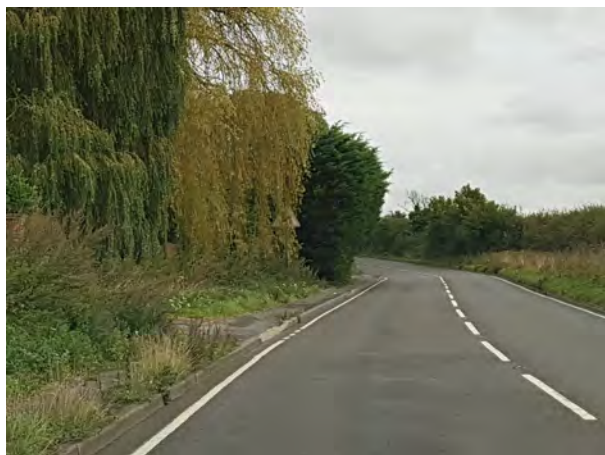
Image 1 – Romford Rd north bound approach to bends

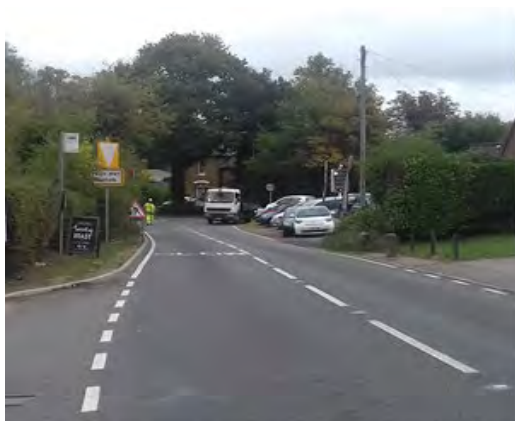
Image 1 – Common Rd northbound approach to junction.

- Replace the existing Give Way sign along Common Rd on a yellow backing which has become faded
- Clear all vegetation from traffic signs on all approaches
- Resurface the approaches with a high PSV surfacing.
- Move Give Way line on Common Road forward
- Reduce Common Road to a single lane exit with nearside hatching

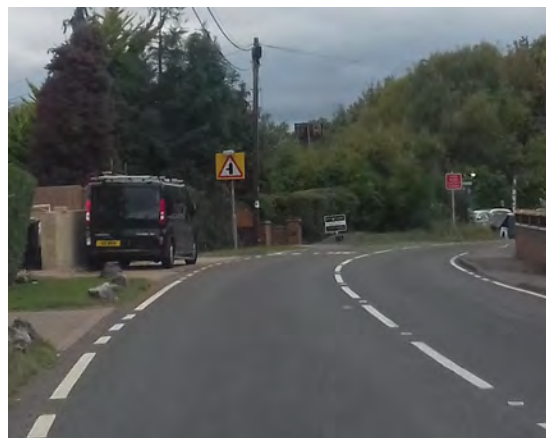
Image 2 – Epping Rd westbound approach to junction

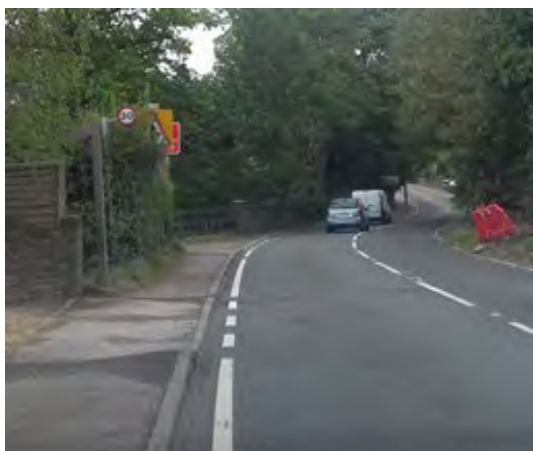
Image 3 – Epping Rd eastbound approach to junction

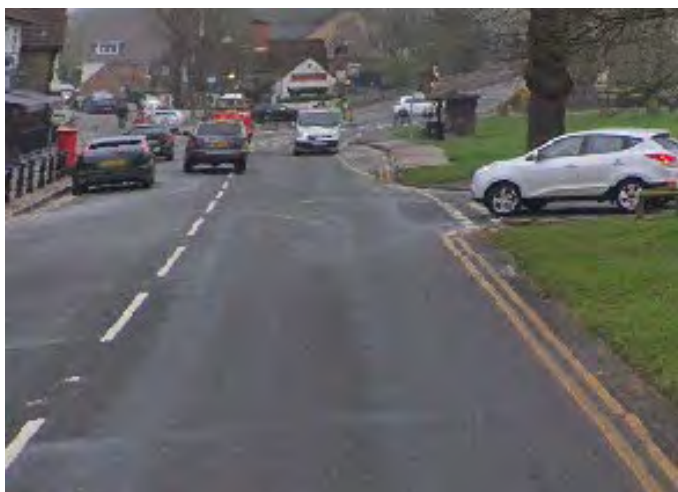
Image 1 – Eastbound (Coppice Row) approach to junction.

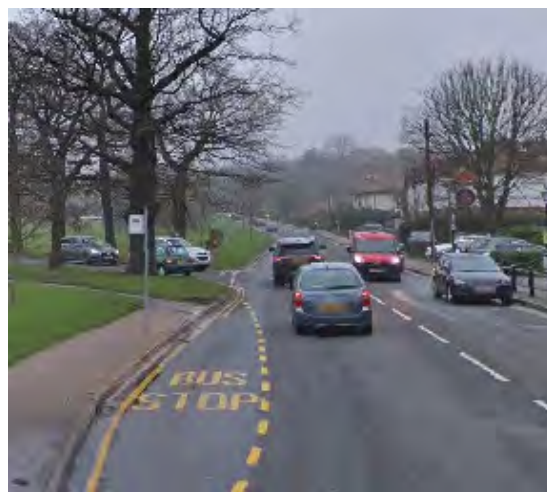
Image 2 – Westbound (Coppice Row) approach to junction.

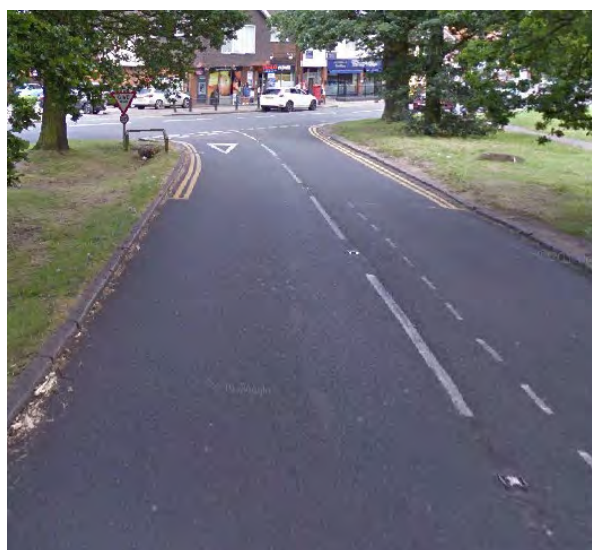
Image 3 – Northeast bound (Loughton Ln) approach

to junction. (showing previous no waiting at any time restriction)	
--	--

Remedial Measures
<p>A study of the PIC's at this location shows a pattern of drivers failing to give way to oncoming traffic when turning from Loughton Lane onto B172 Coppice Row.</p> <p>To provide improved visibility of traffic on Coppice Row and help prevent masking of westbound traffic on Coppice Row, it is proposed to provide the following measures to reduce the number of casualties at this location:</p> <ul style="list-style-type: none"> • Move the Give Way line on Loughton Lane and adjust kerb line. • Relocate the parking facilities on Loughton Lane further south • Relocate the Give Way sign in Loughton Lane.

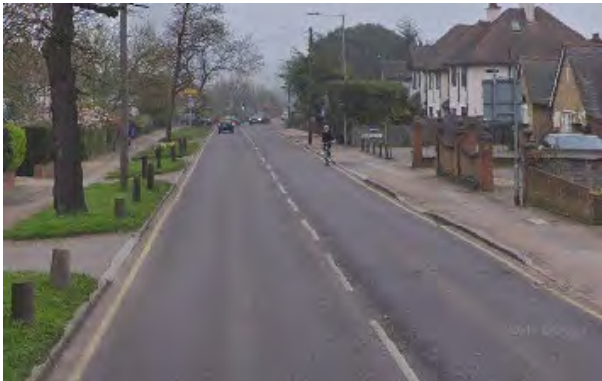
Image 1 – Palmerston Rd east bound approach.

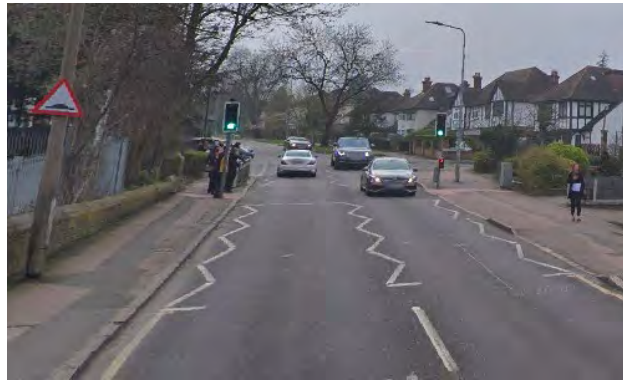
Image 2 – Palmerston Rd west bound approach.

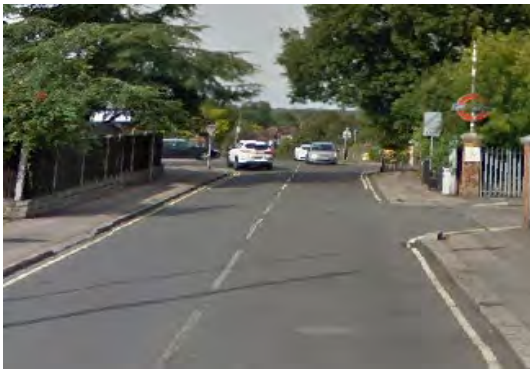
Image 3 – Victoria Rd approach to junction

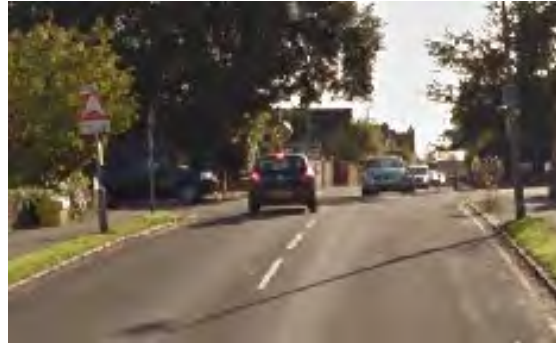
Image 4 – Stradbroke Grove approach to junction

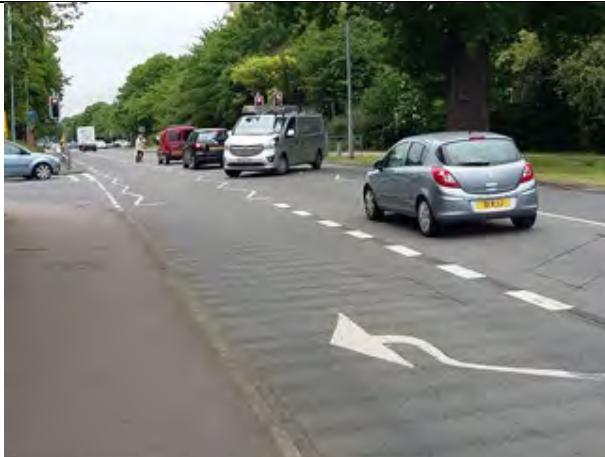
Image 1 – First Ave. westbound approach to junction with Orchard Croft.

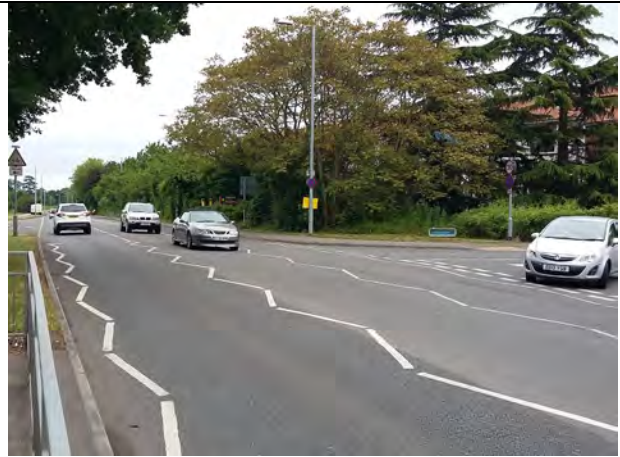
Image 2 – First Ave. eastbound approach to junction with Orchard Croft.

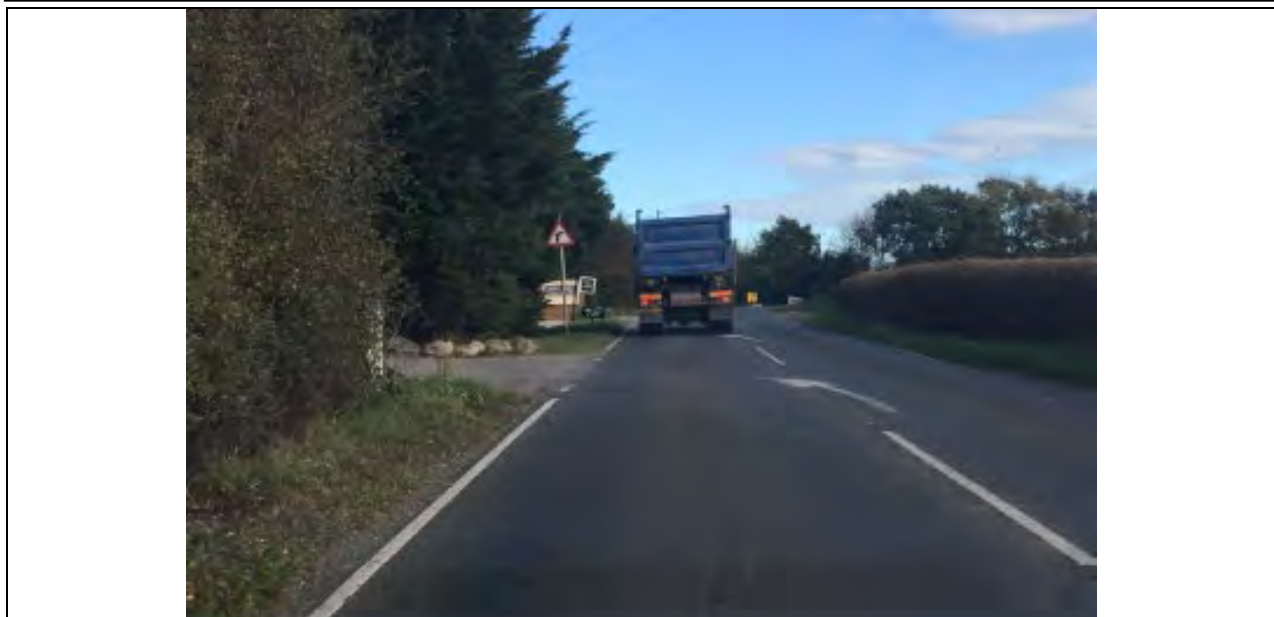
Image 1 – B1018 Burnham Road; eastbound approach to bend in road

- Provide a 'SLOW' road marking at the existing 'Junction on the outside of a bend ahead' warning sign (see Image 1, above) along the eastbound approach to the bend.
- Replace damaged direction signing at junction and on northbound approach to the bend (see Images 3 & 4, above).

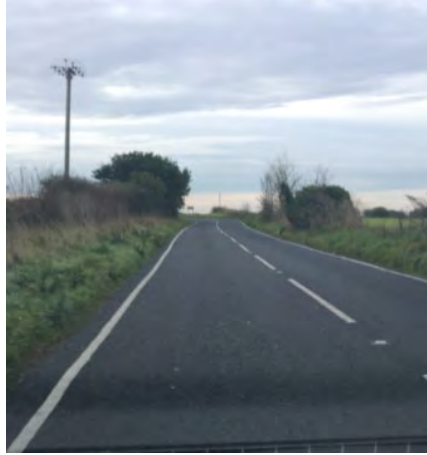
Image 1 – View looking south

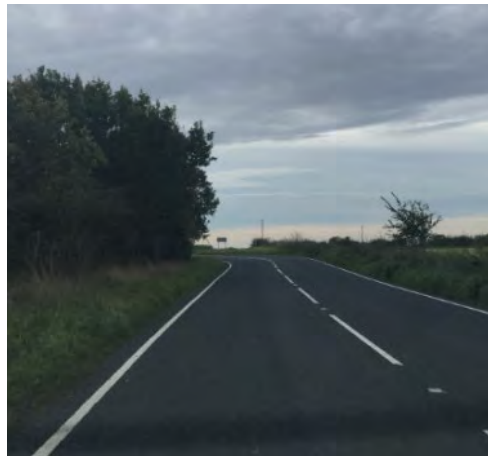
Image 2 – View looking south

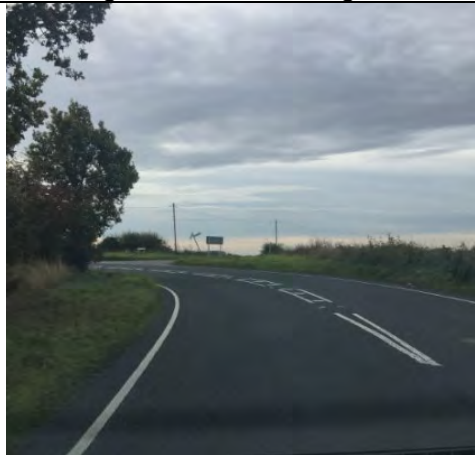
Image 3 – View looking south/ east

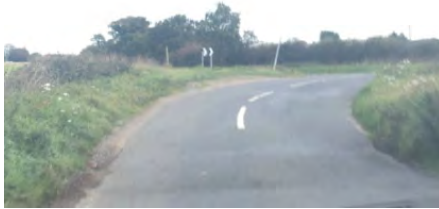
Image 4 – View looking east on Pedlers Corner

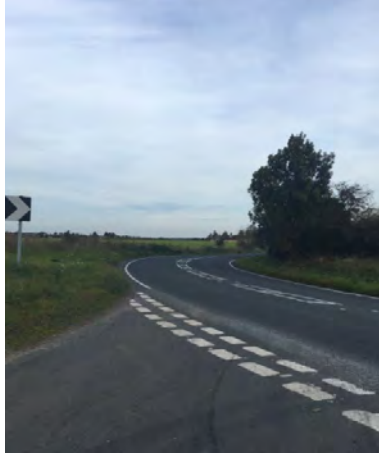
Image 5 – View looking north from the junction mouth

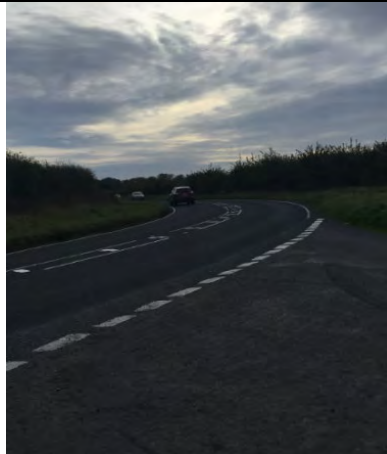
Image 6 – View looking east from the junction

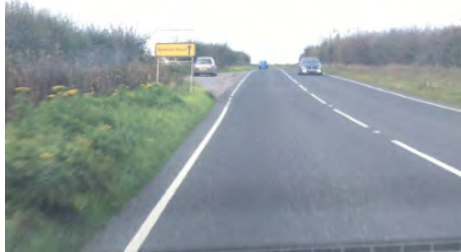
Image 7 – View looking west on the approach to the bend

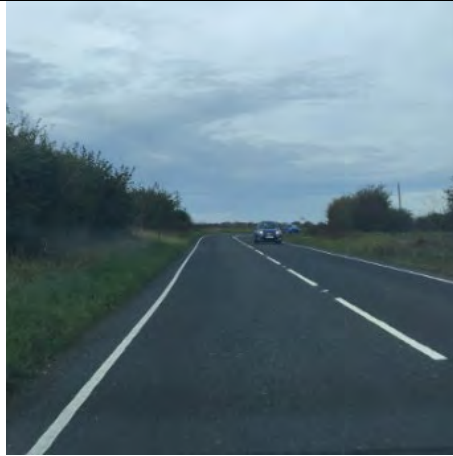
Image 8 – View looking west on the approach to the junction

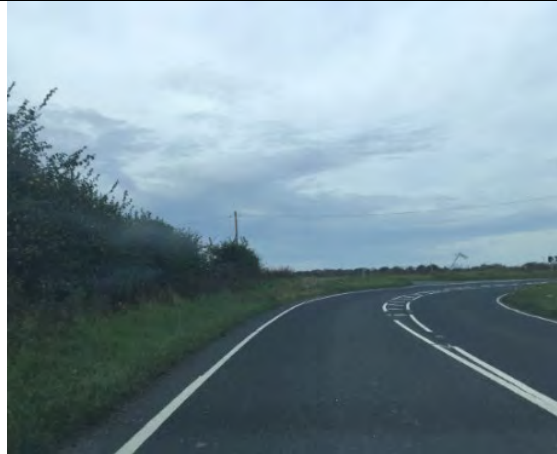
Image 9 – View looking South/West on the bend

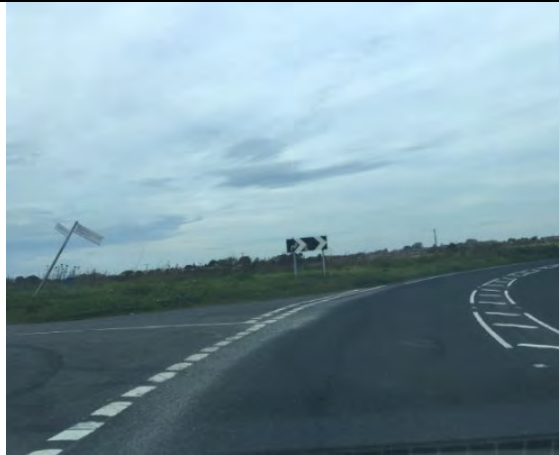
Image 10 – View looking West on the bend (note damaged flag signs)

- 1) It is recommended that the individual black chevron sign is removed and replaced with six individual yellow backed signs. 3 signs to be positioned on each side of the junction helping to clearly delineate the severity of the bend. These should be mounted back to back on the outside of the bend, 12 signs in total. Ensure that they are not situated within the visibility splay for the junction.

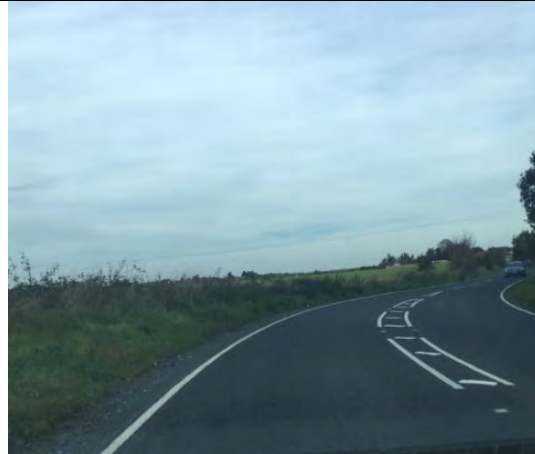
Image 11 – View looking north after the junction

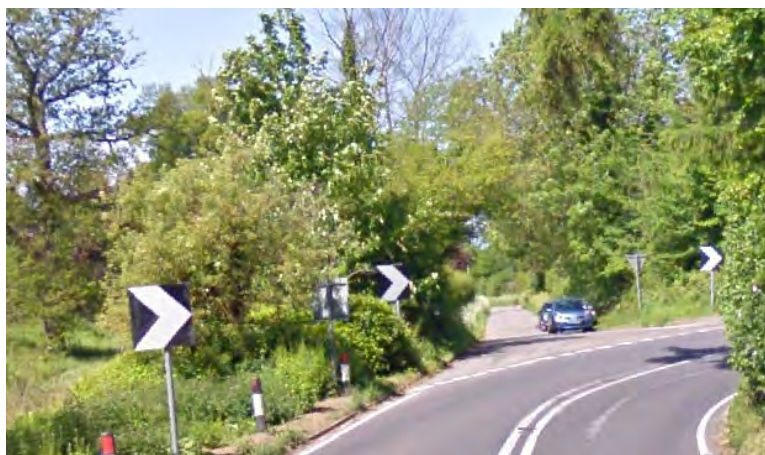
- 2) Image 12- Example of individual Chevron signs for a junction on a bend.

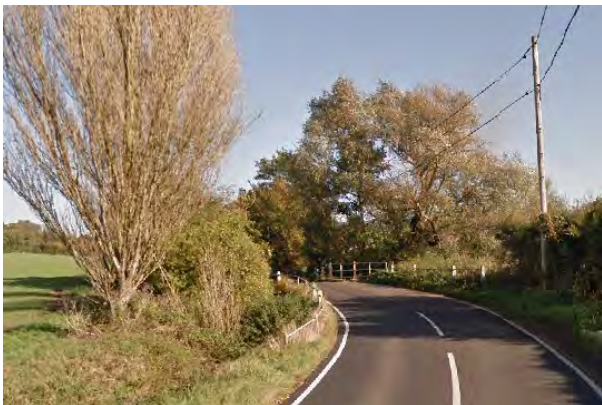
Image 3 –Limited forward visibility on north bound approach to bridge
