Location: A127 J/w A176 Northern Roundabout, Basildon
District: Basildon
Collision Investigation Period: 01/01/2017 – 31/12/2019
Site Ranking: N/a

EXECUTIVE SUMMARY

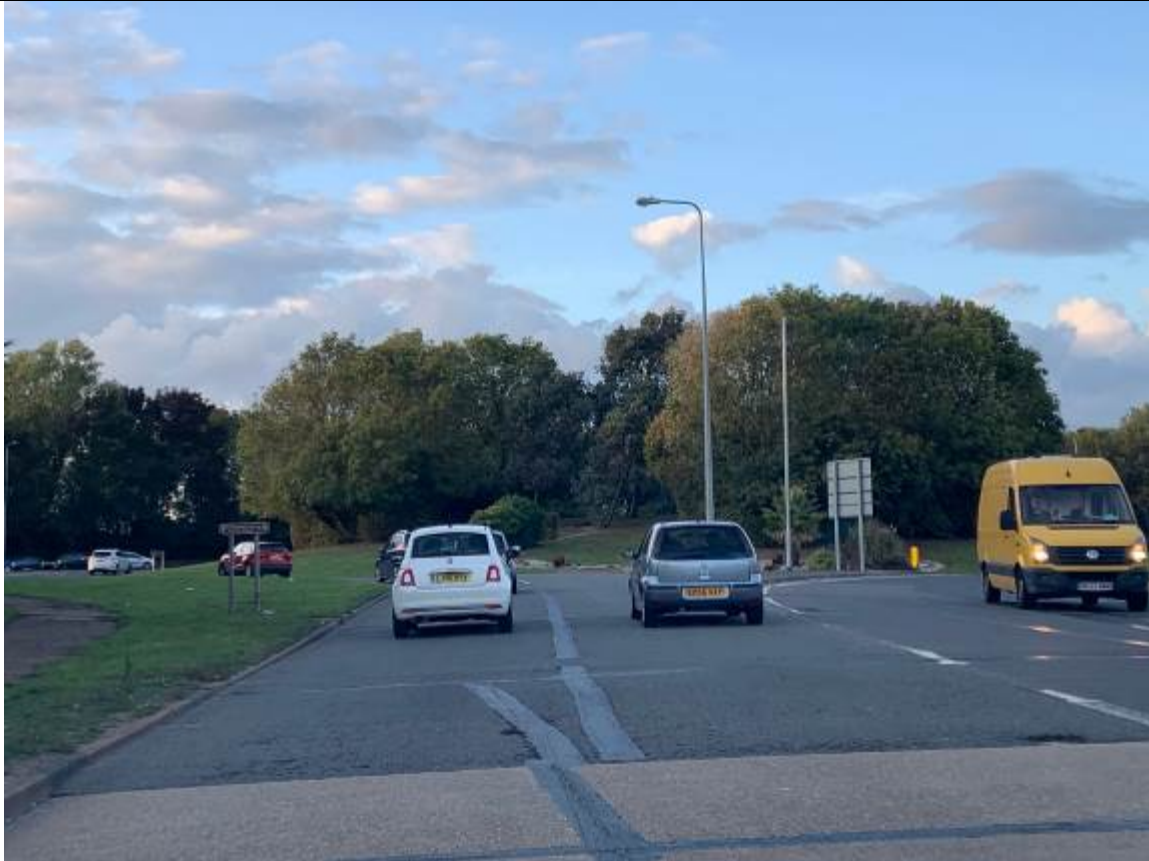
Image 1 – Northbound approach to junction.

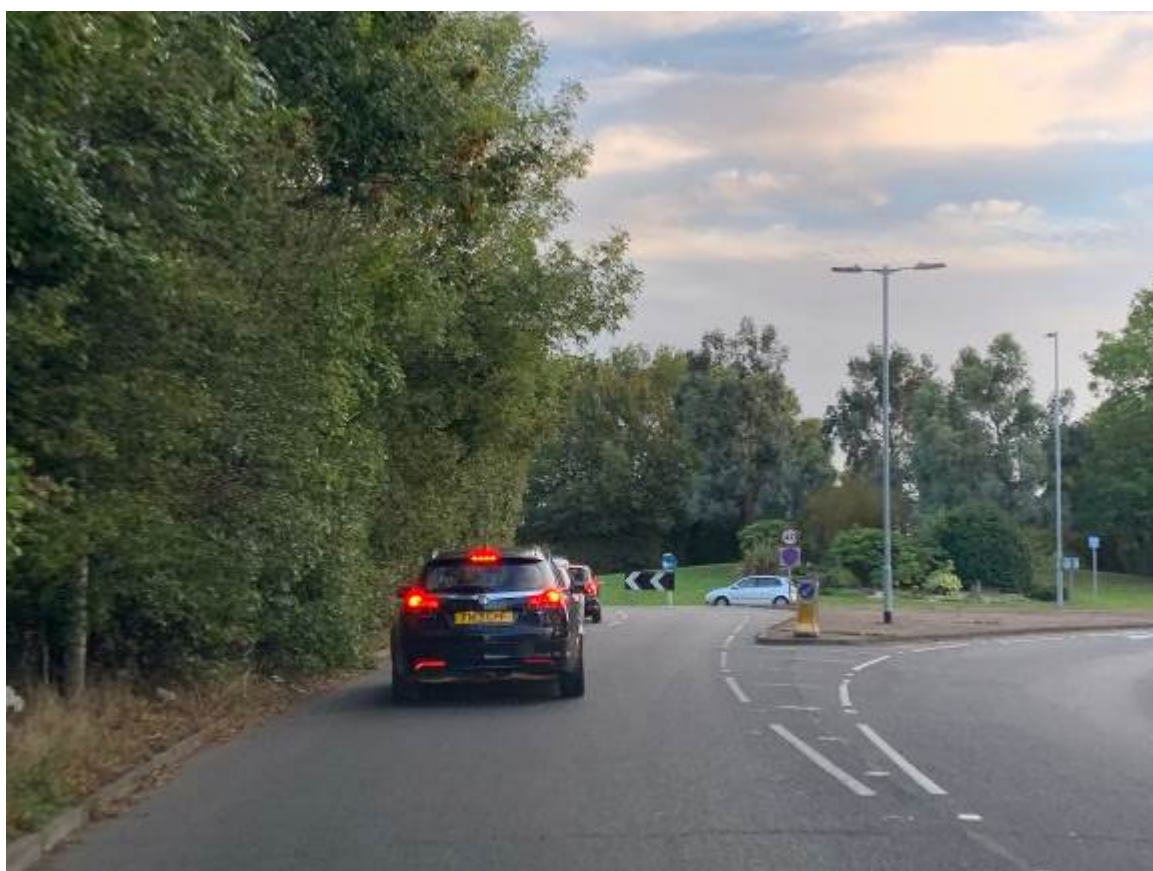
Image 4 – Southbound approach to junction.

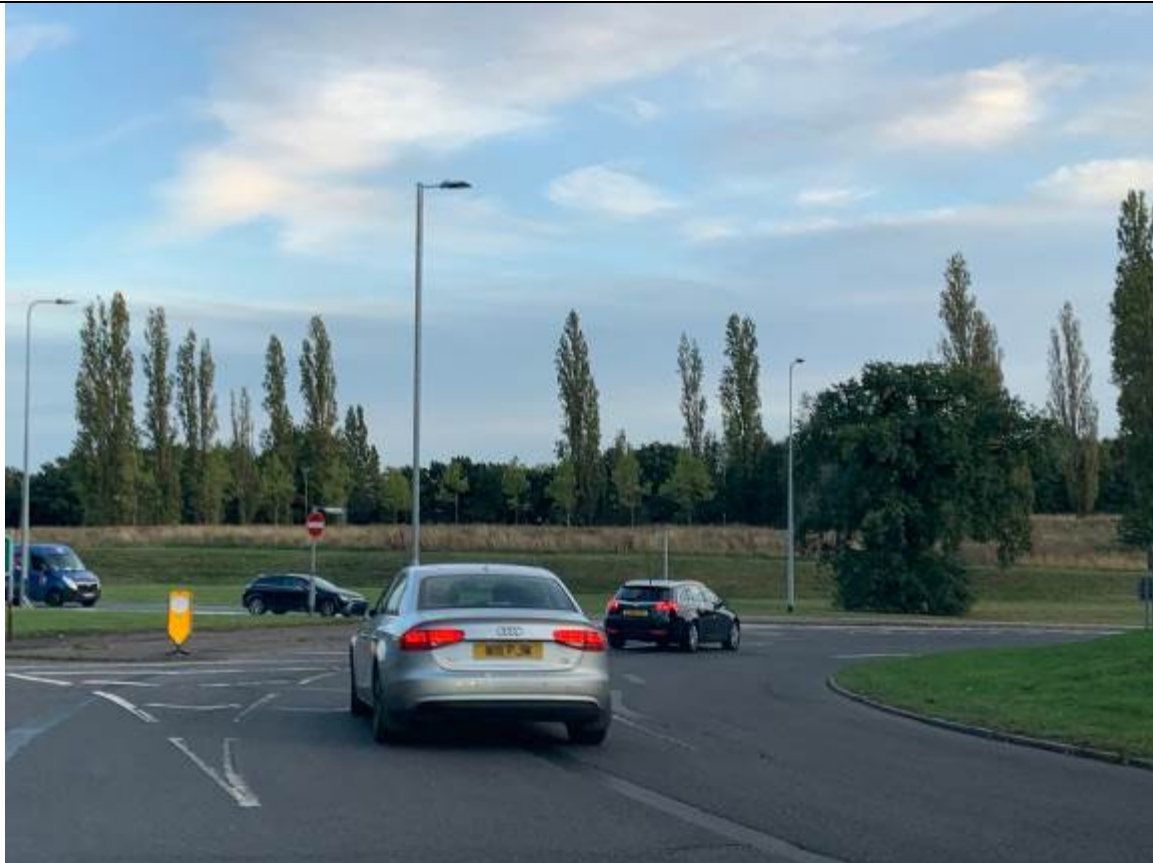
Image 5 – Southbound on roundabout circulatory

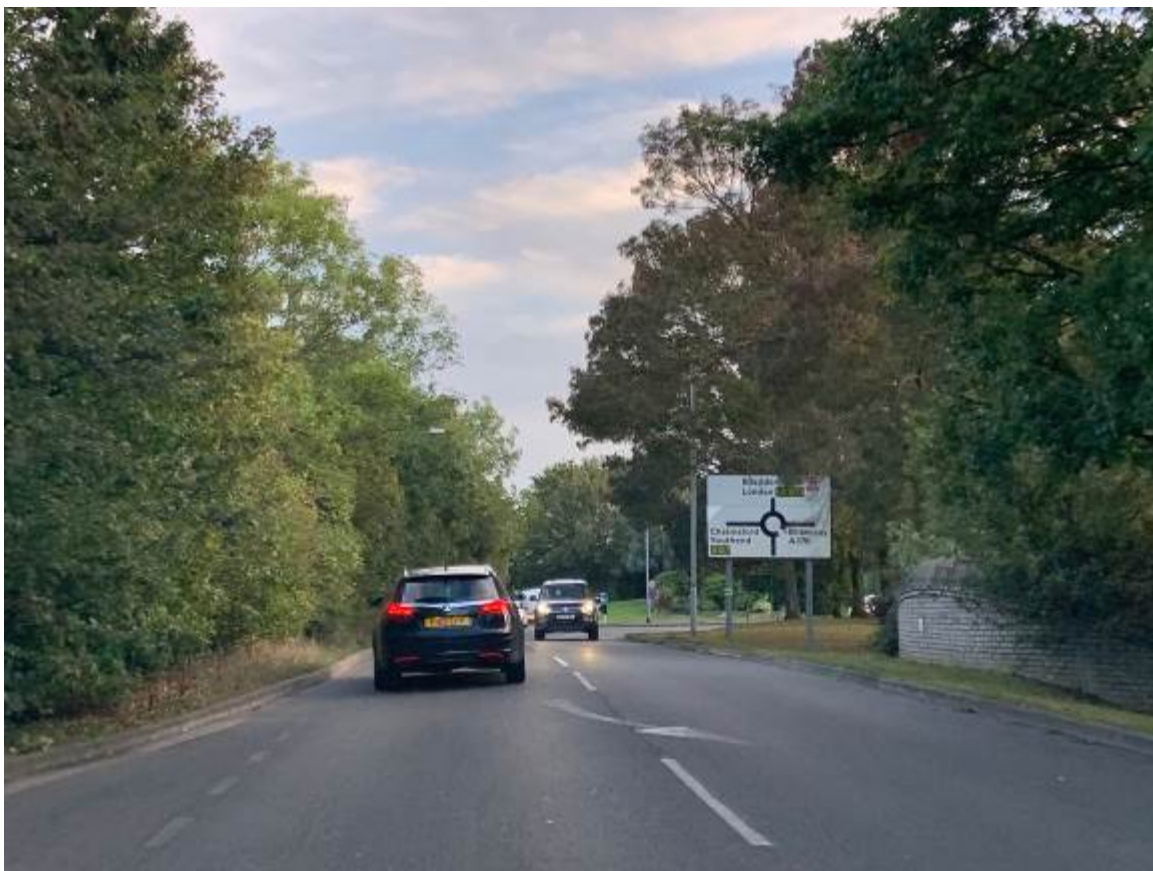
Image 6 – Map type ADS on southbound approach to junction.

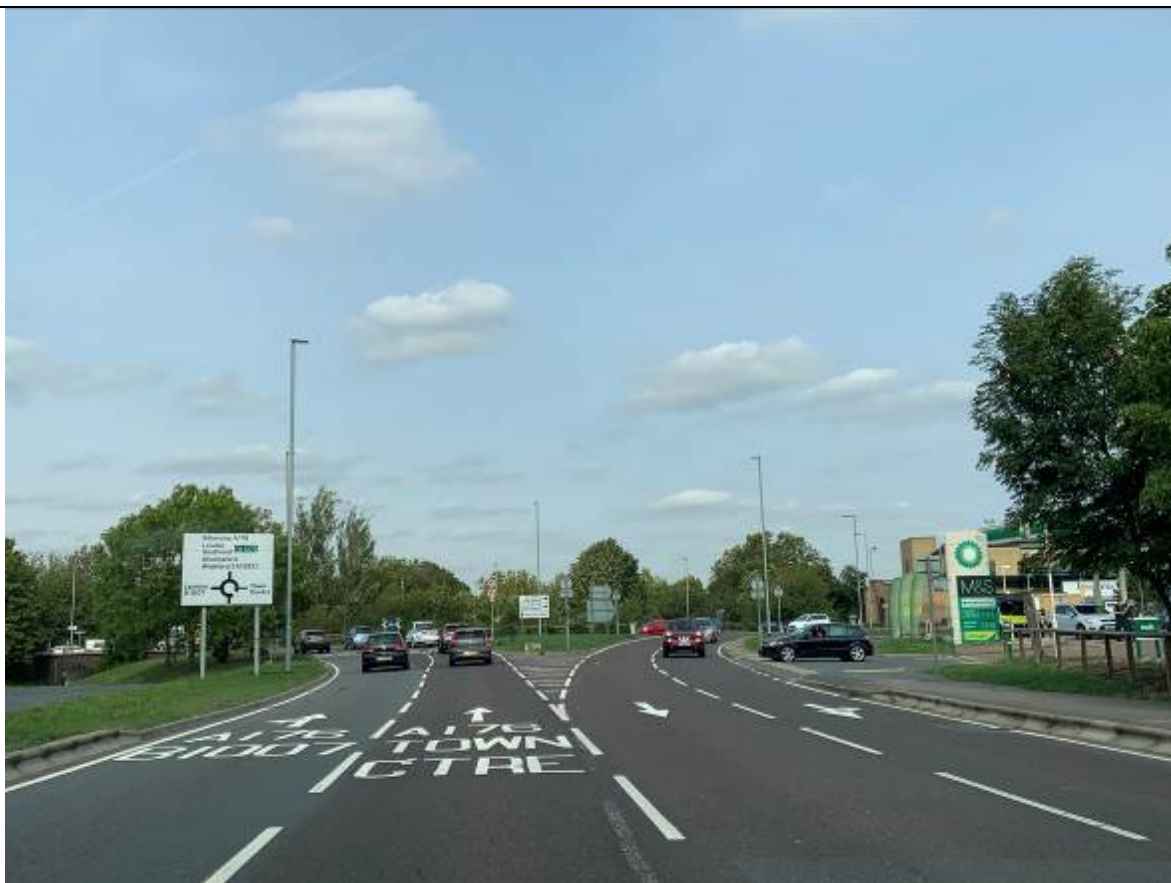
Image 1 – Northbound approach to junction/vehicle access

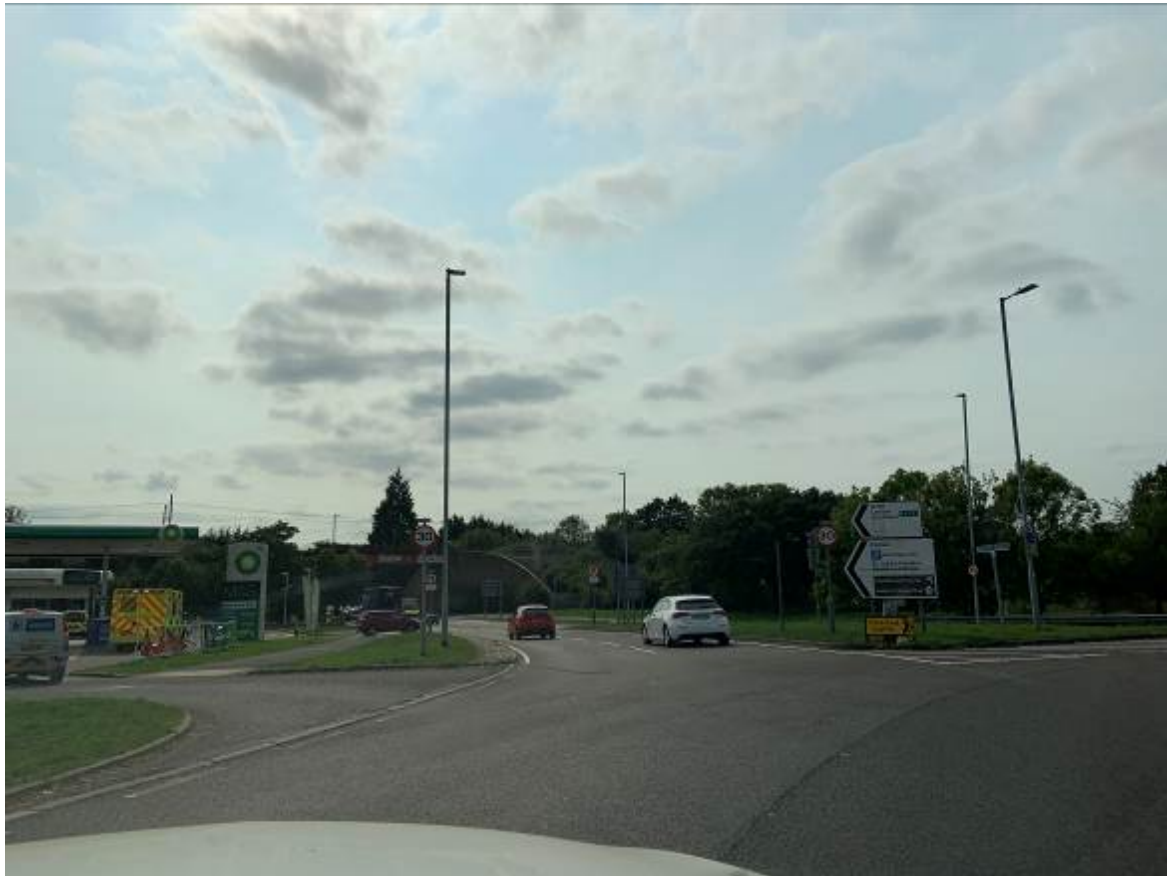
Image 2 – Southbound approach to junction / vehicle access (Leaving Roundacre junction)

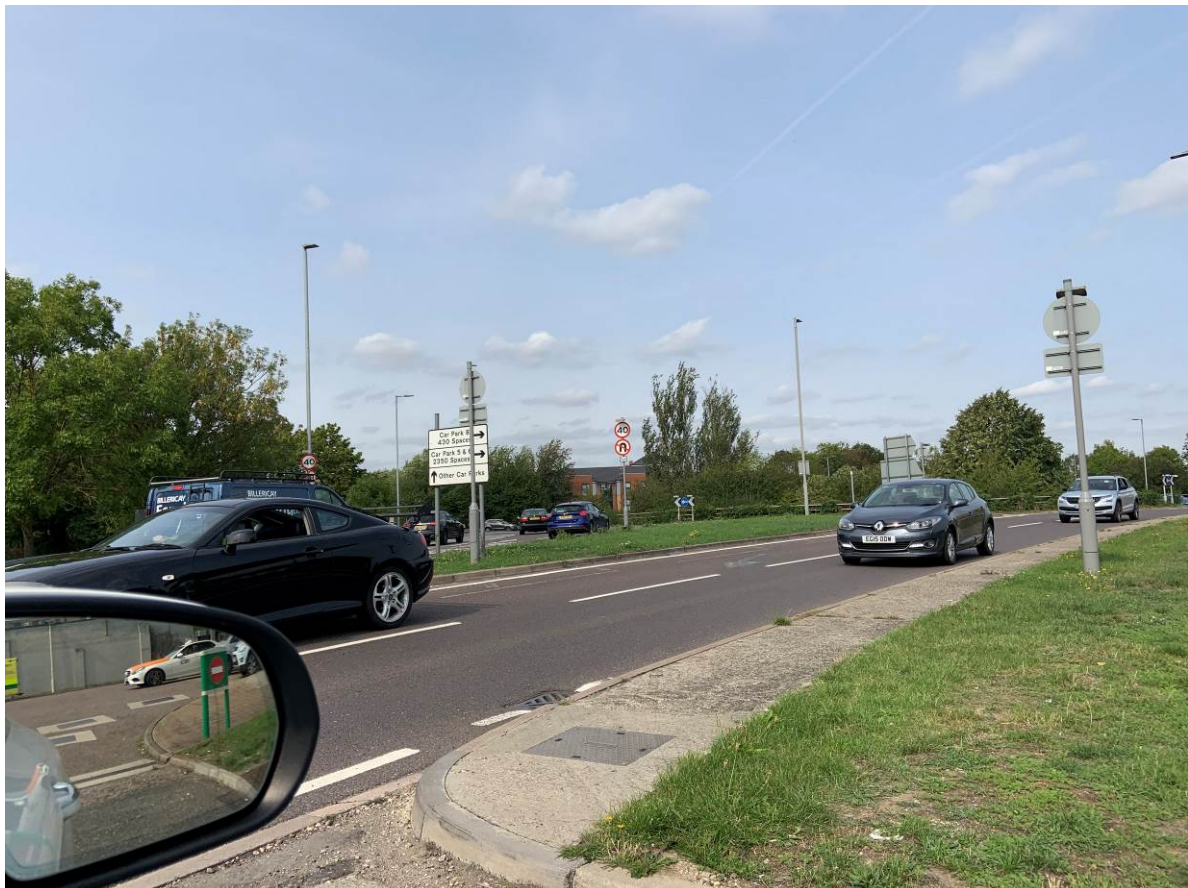
Image 3 – Visibility to right when attempting to join A176 from the junction / vehicle access

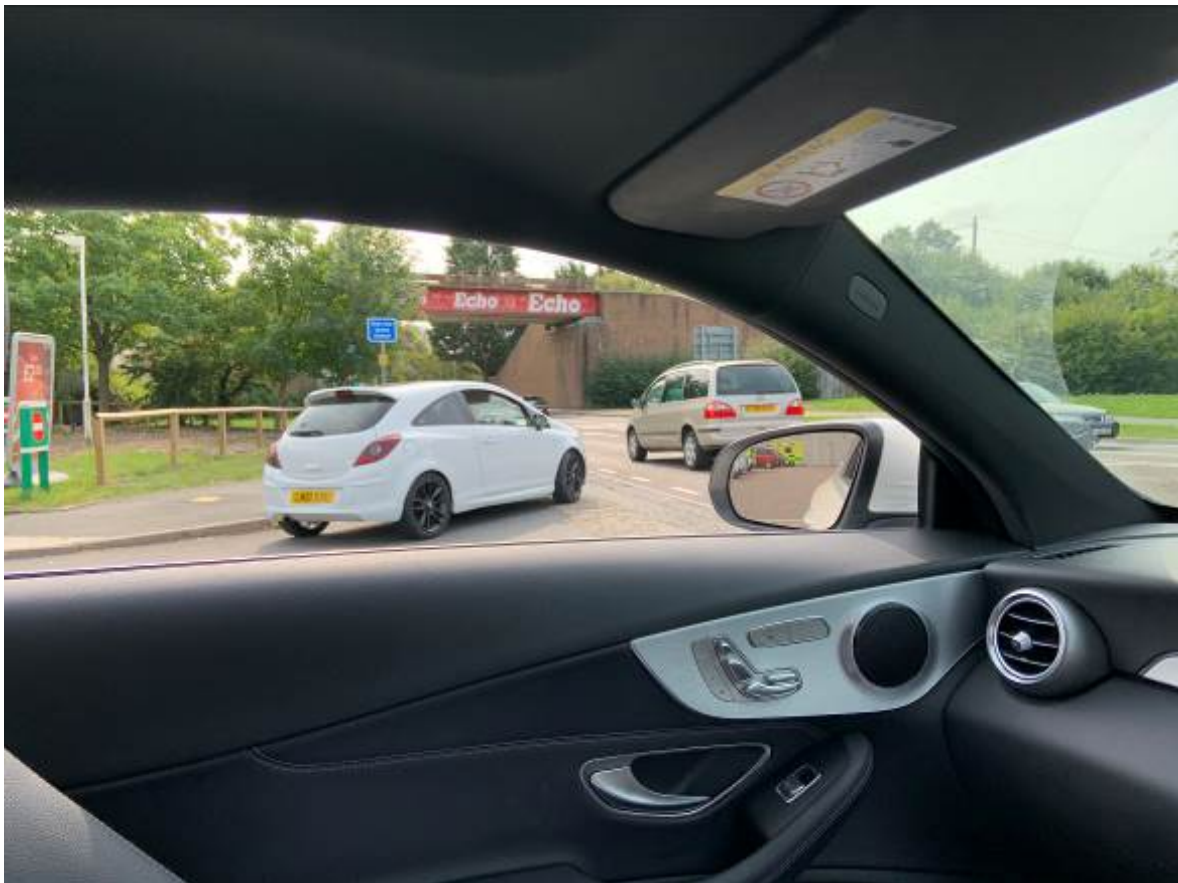
Image 4 – Visibility to left when attempting to join A176 from the junction / vehicle access

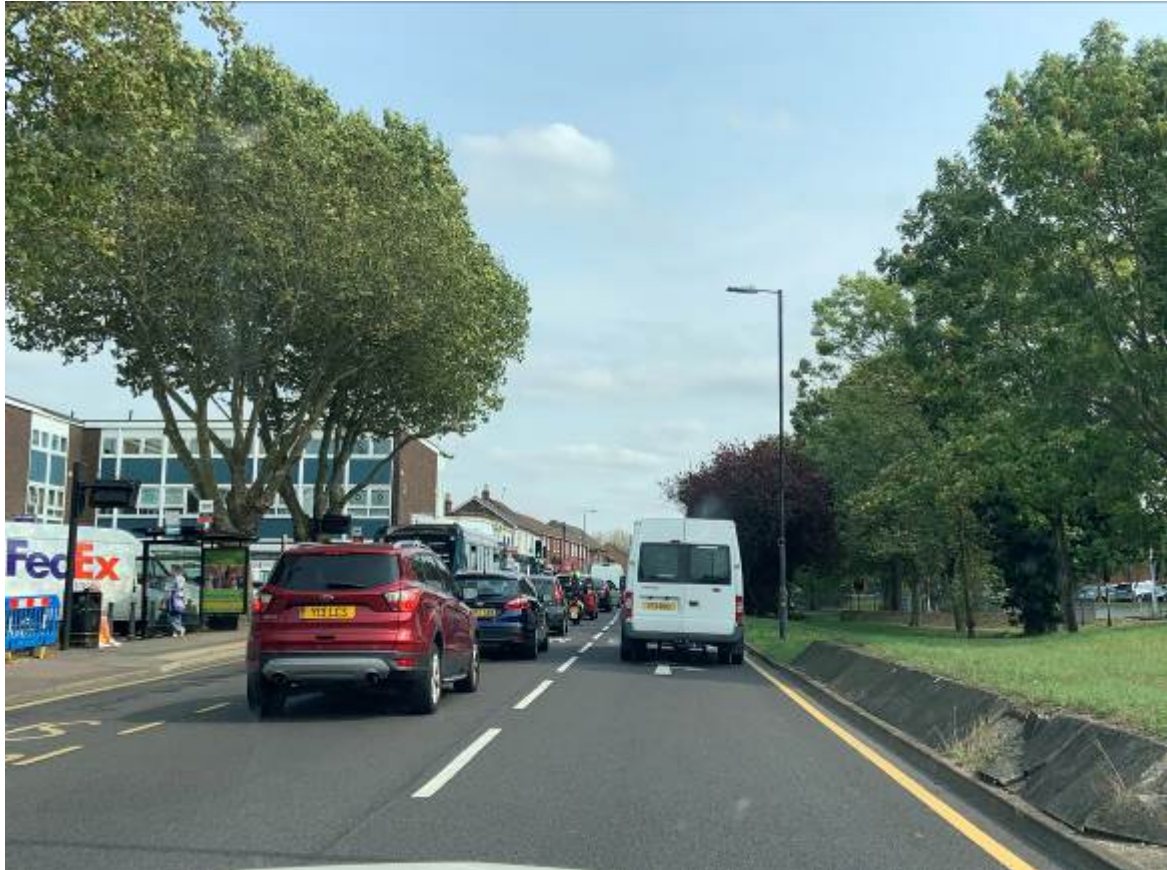
Image 1 – Eastbound approach to traffic signals when leaving nearby roundabout

Remedial Measures
<p>1) It is recommended that the existing overgrown vegetation (Trees) that are partially obscuring the offside signal head should be completely removed.</p> <p>2) Provide a 'Traffic signals ahead' warning sign to the offside of the carriageway on the eastbound approach, visible to road users as they leave the nearby roundabout junction.</p> <p>3) Dependant on estimated costs, provide additional high mounted traffic signal head(s) to increase conspicuity of the traffic signals for approaching motorists.</p>

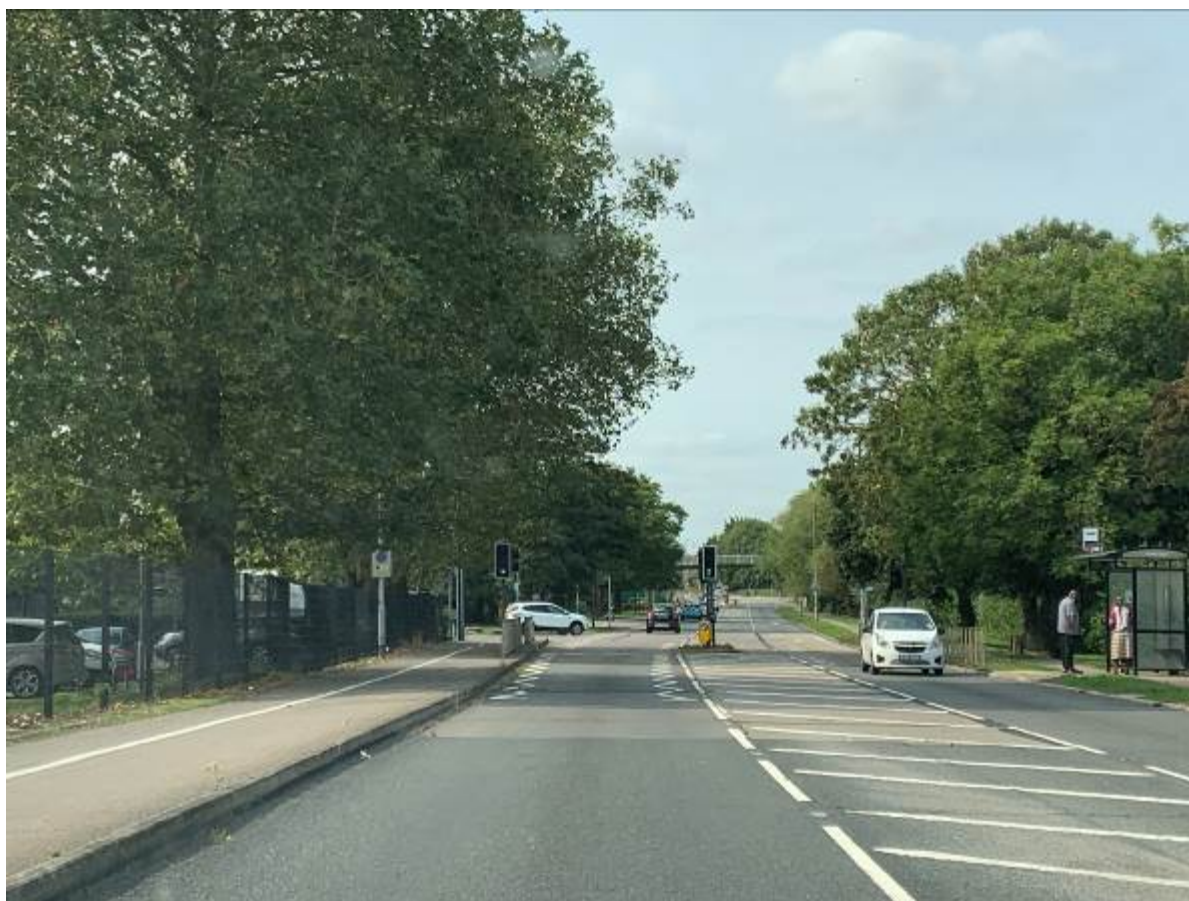
Image 1 – Westbound approach junction

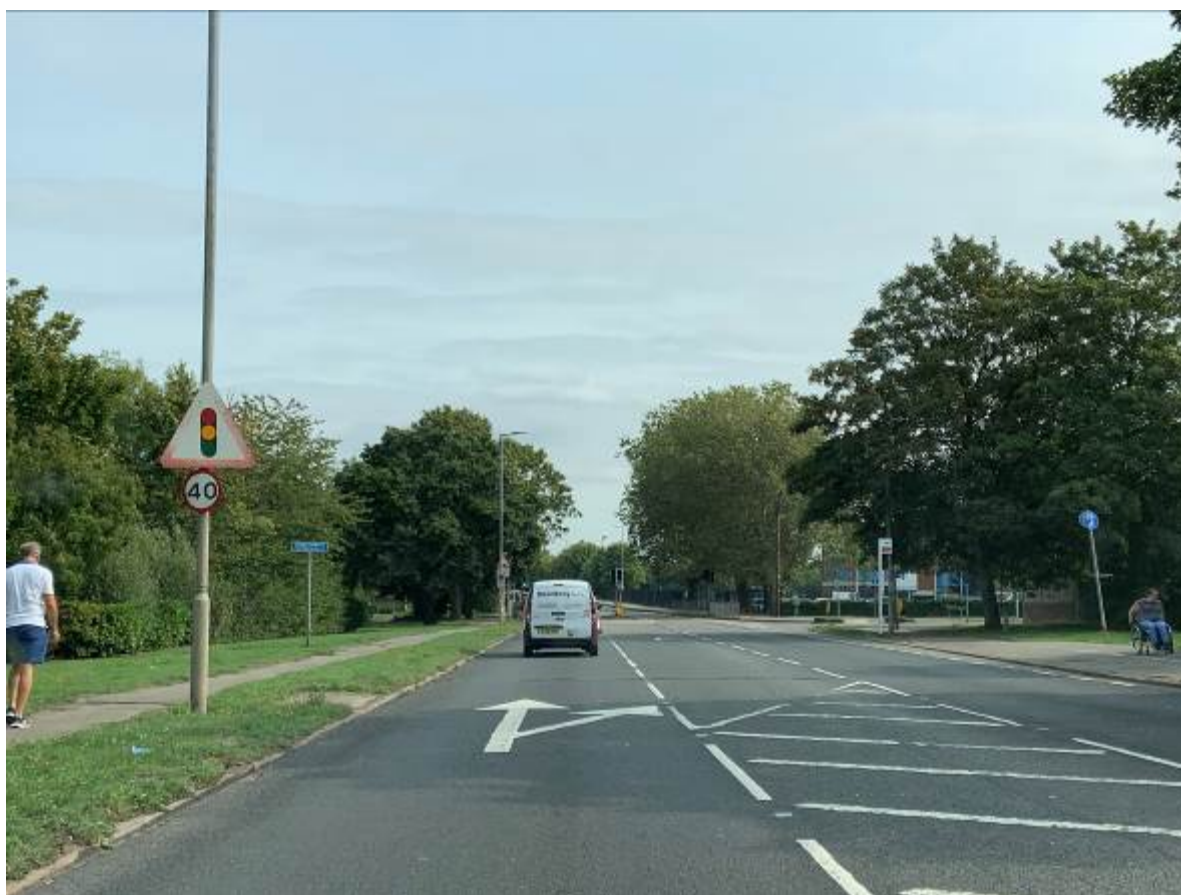
Image 2 – Eastbound approach junction

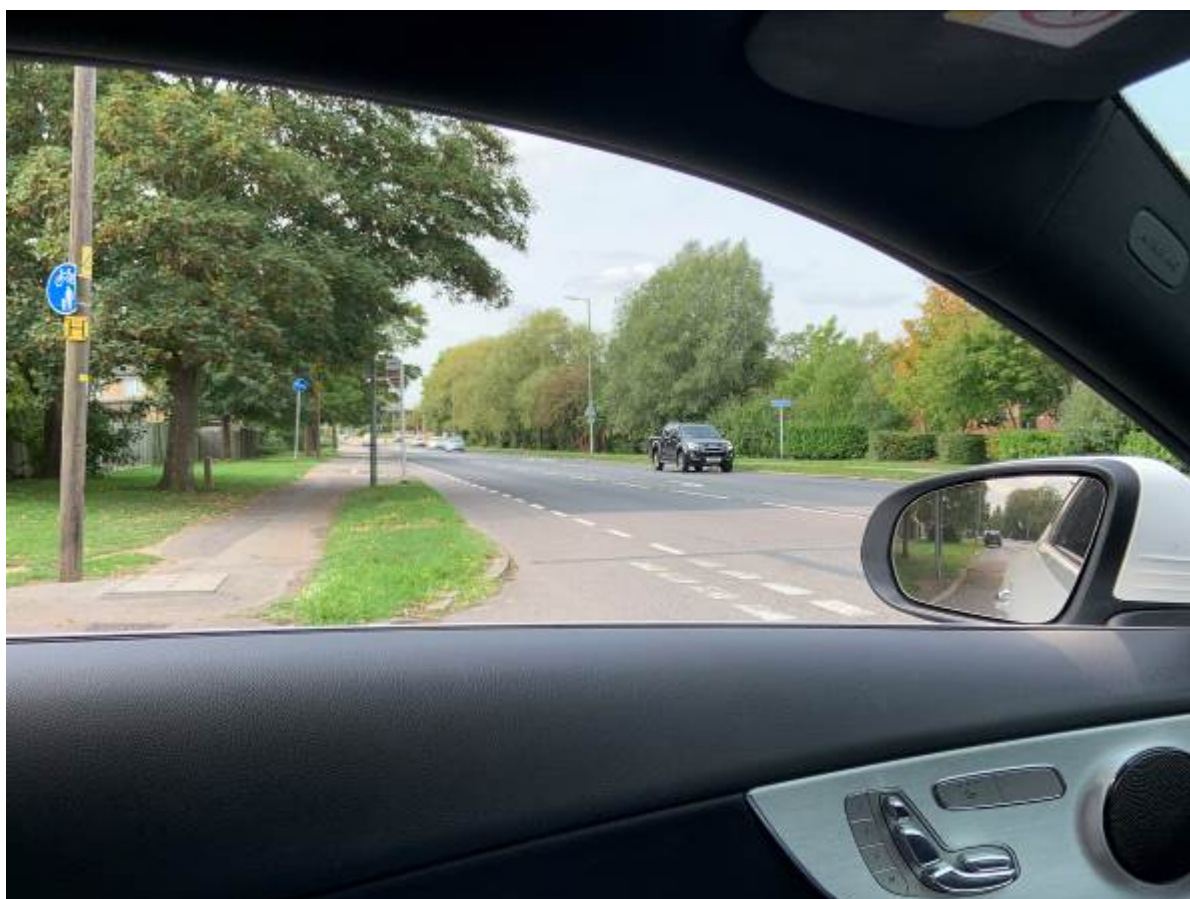
Image 3 – Visibility to left when attempting to join B148 St Nicholas Lane from Leinster Road

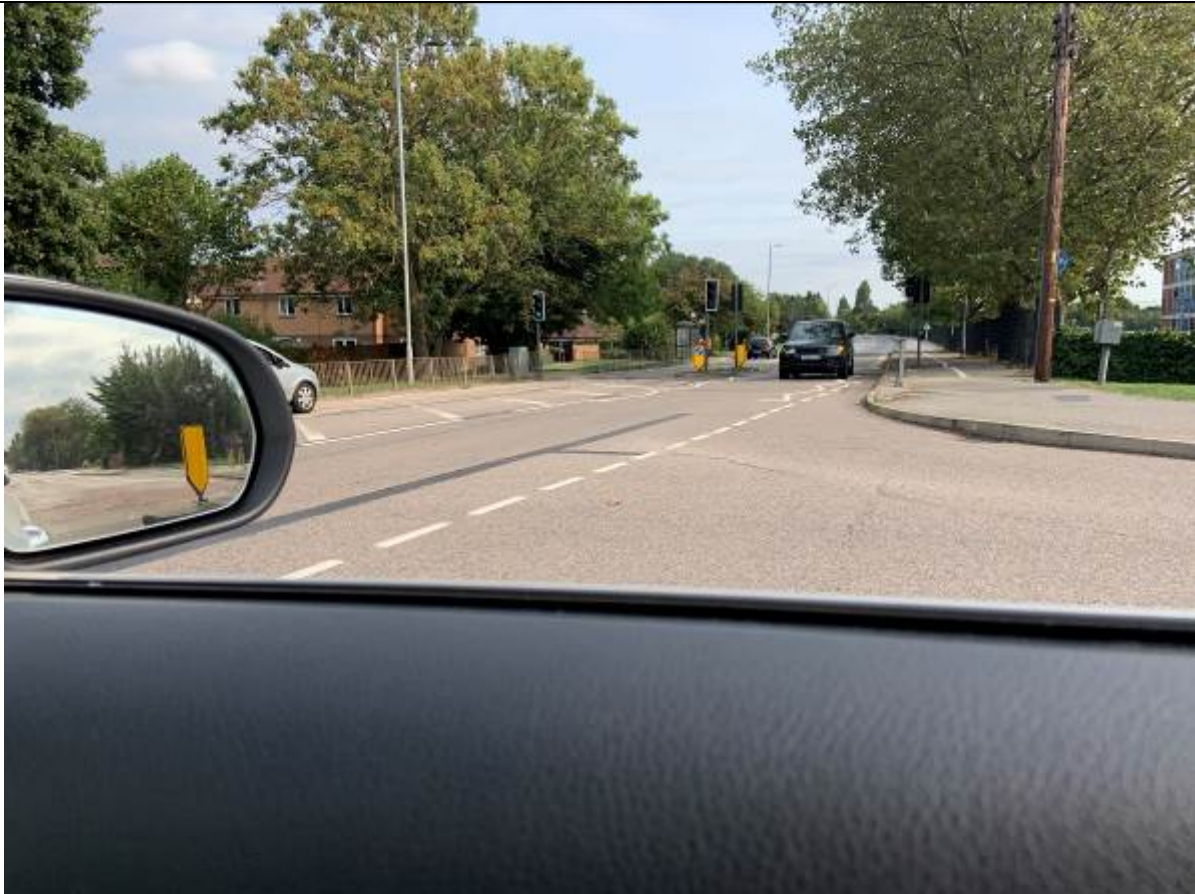
Image 4 – Visibility to right when attempting to join B148 St Nicholas Lane from Leinster Road

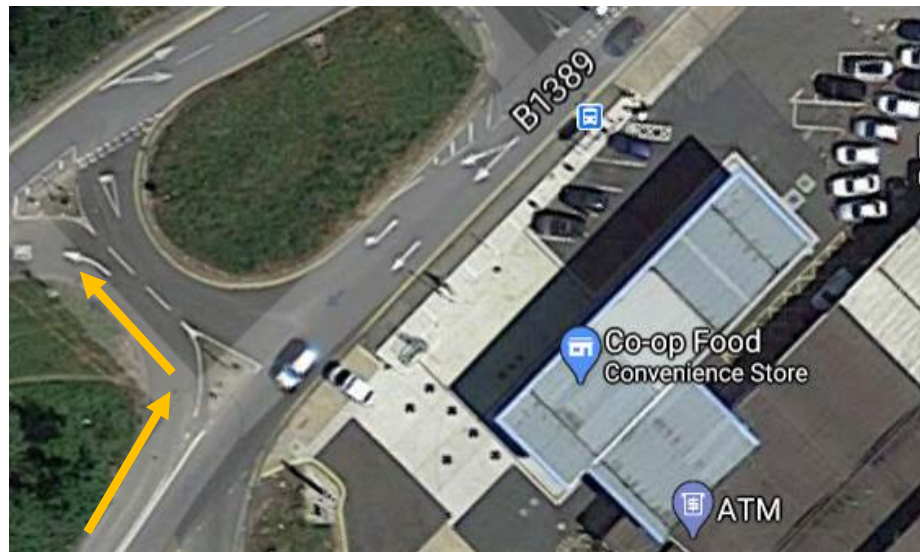
Road Markings	<p>At the collision location, B1389 Hatfield Road is one way south east bound. In the vicinity of the collision site, as road users travel south west the carriageway is divided in to 2 lanes, one straight ahead and one right turn.</p> <p>The straight ahead manoeuvre is for road users wishing to access either</p>

the A12 NB or SB on slips. The right turn lane is for road users wishing to access the B1389 in an easterly direction (as per image below).

Direction arrow road markings are provided, but the lane separation road marking is worn out. No markings are provided on the exit from the petrol station (refer to blue arrow in image above).

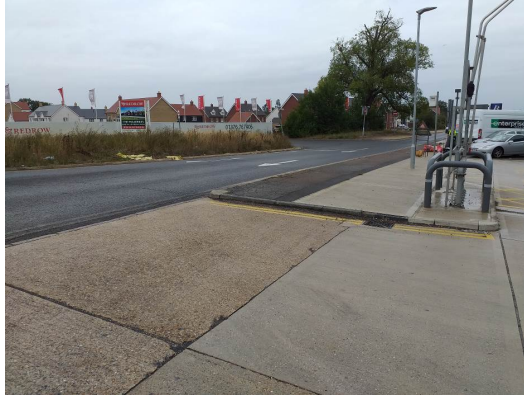
Image 1: Services exit to Hatfield Road

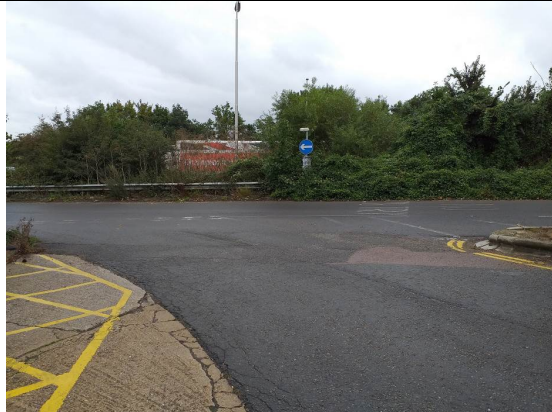
Image 2: Services exit to A12 Slip Road (Slip 1)

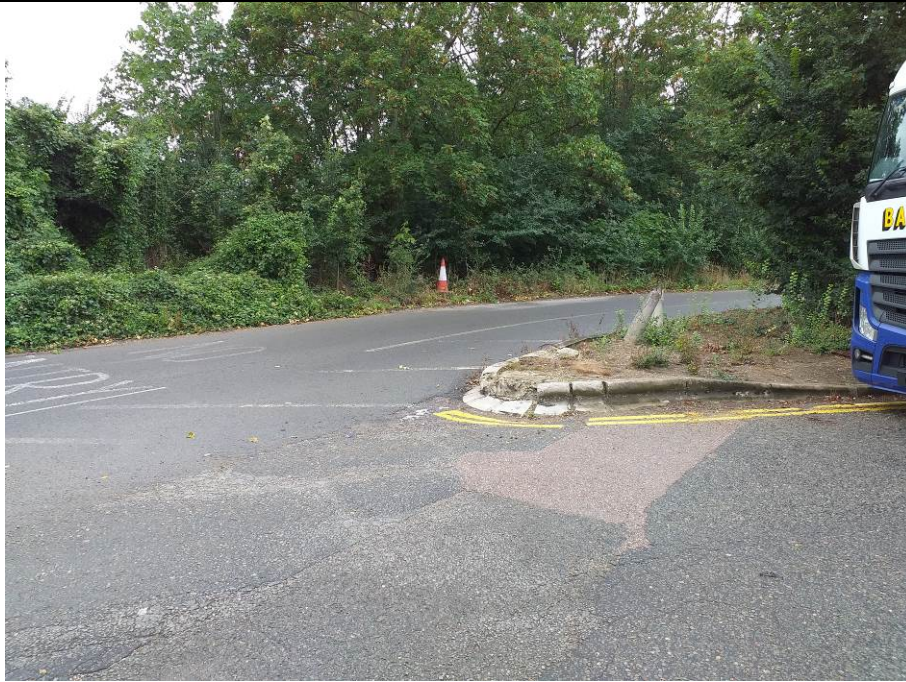
Image 3:
Services exit to A12 Slip Road (Looking right)

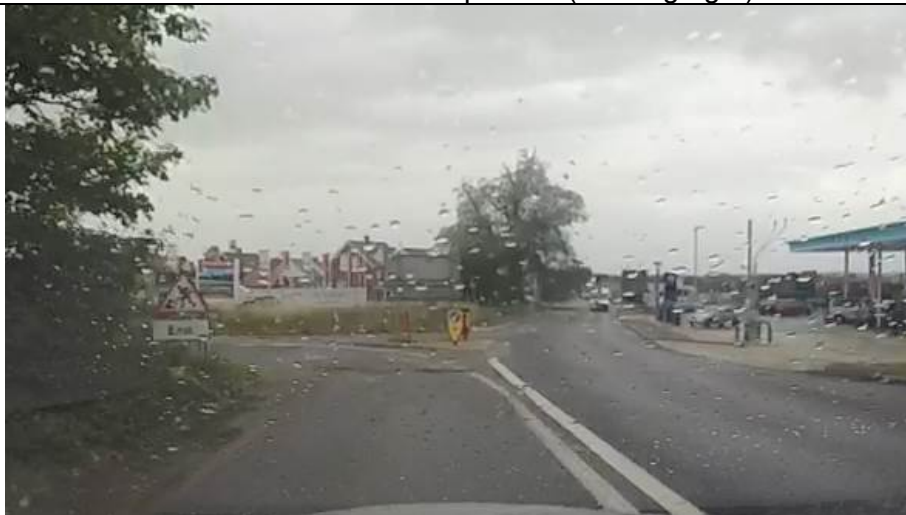
Image 4: South West approach to B1389 one way section

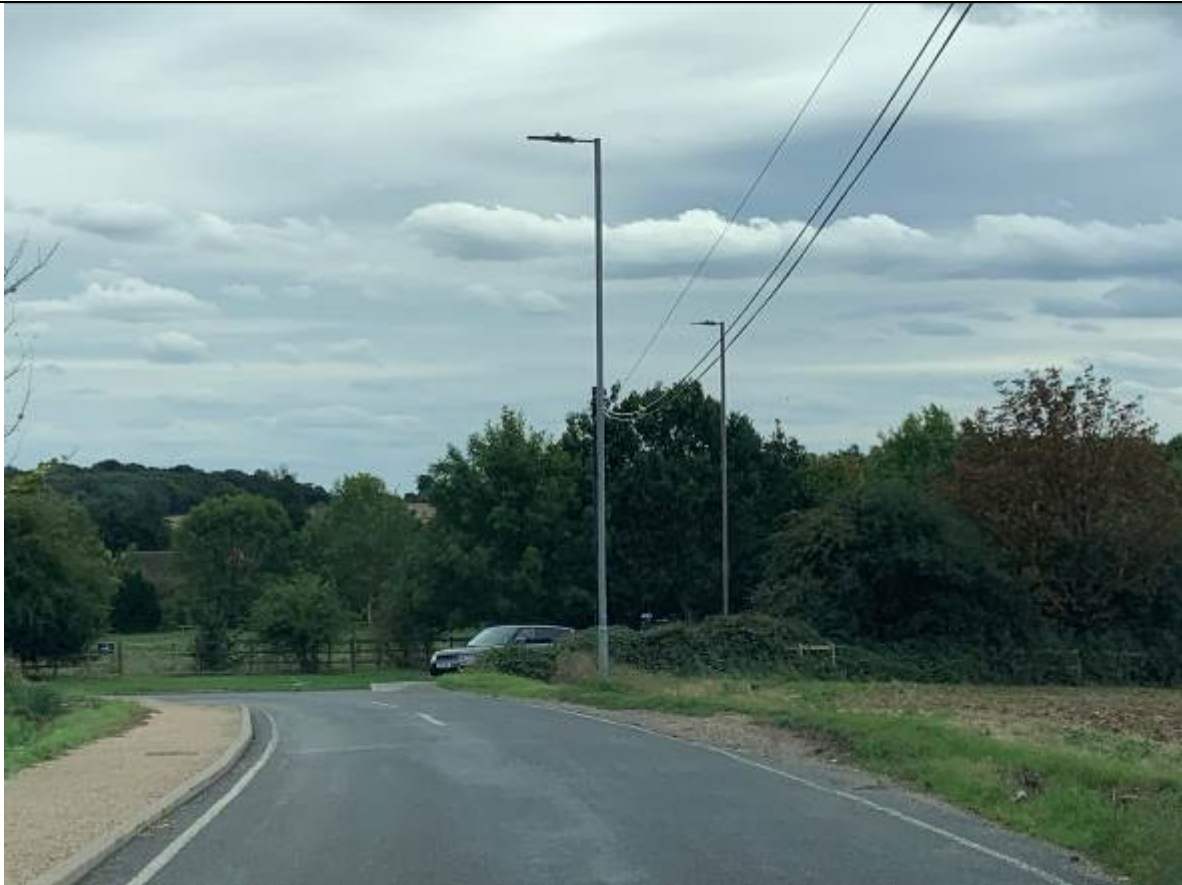
Image 1 – Trueloves Lane approach to junction

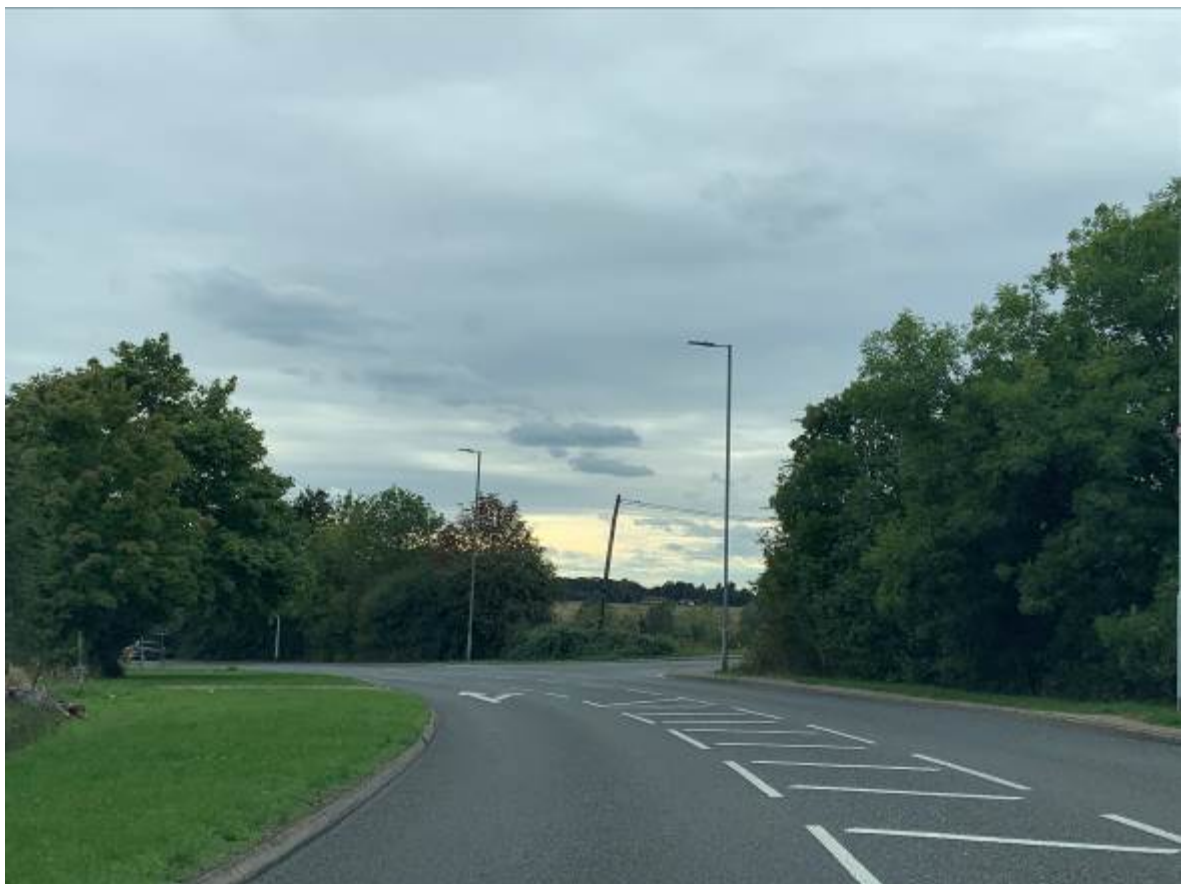
Image 2 – B1002 South-westbound approach to junction

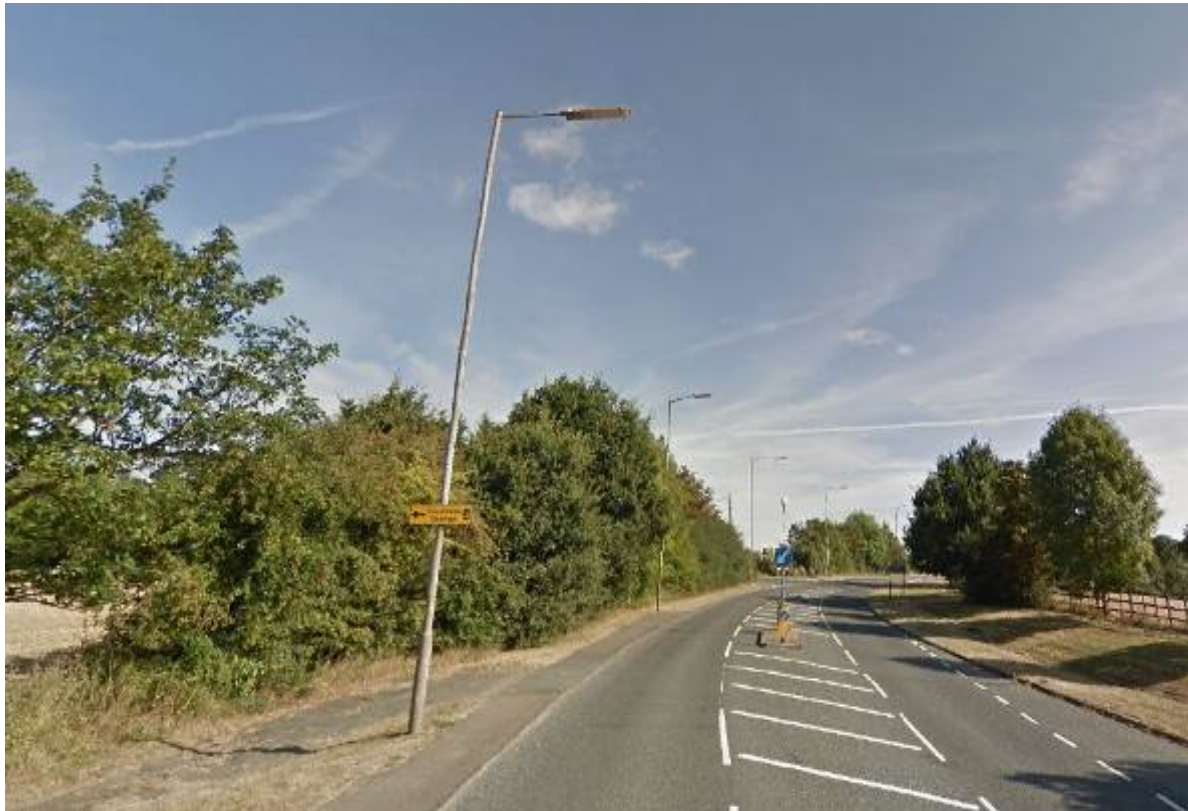
Image 3 – B1002 North-eastbound approach to junction

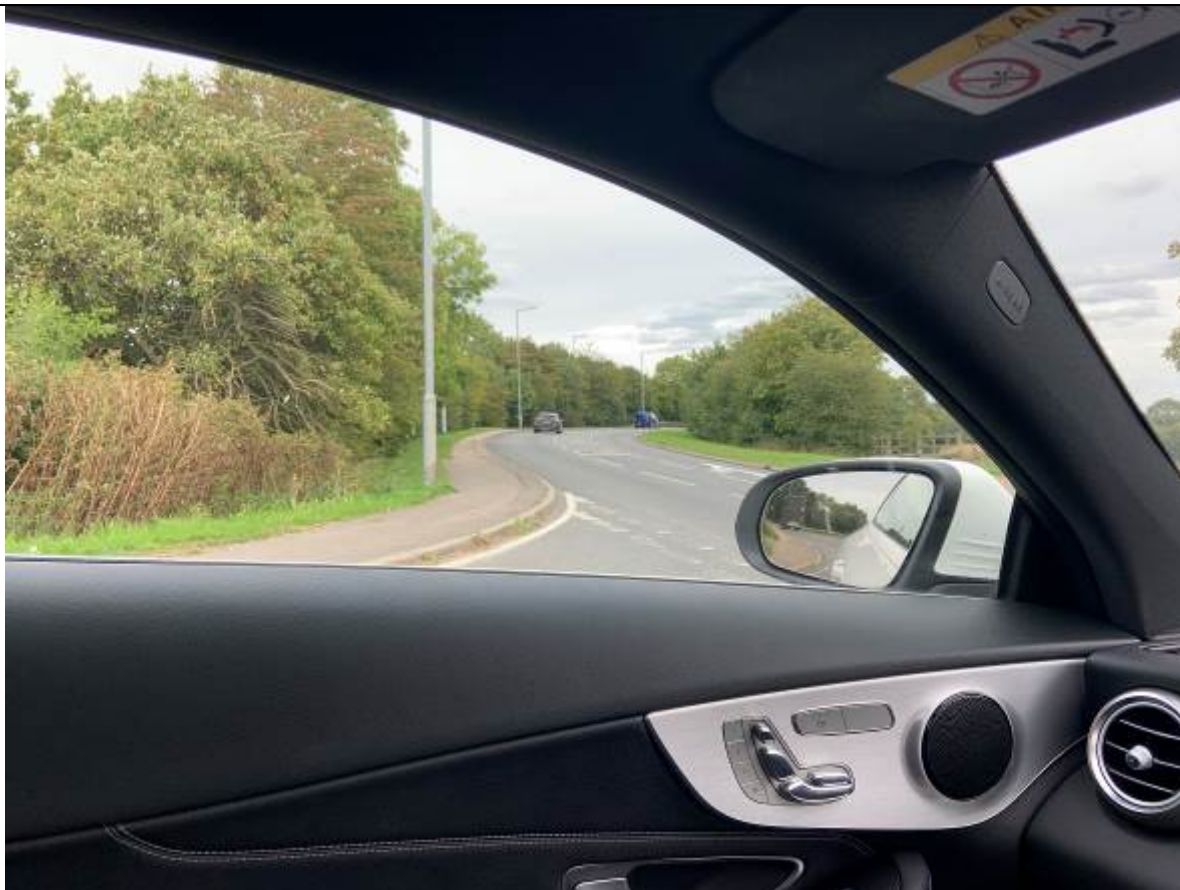
Image 5 – Visibility to left when attempting to join B1002 Roman Road from Trueloves Lane

- 1) It is recommended that the area of overgrown vegetation within the visibility splay to the left of the side road should be substantially cut back, and the small tree within the visibility splay to the right of the side road should be removed.
- 2) Provide additional 40mph speed limit repeater signs on both B1002 Roman Road approaches.
- 3) Provide 'Side road on bend ahead' warning signs on both B1002 Roman Road approaches.
- 4) Provide new flag type destination signs opposite the side road (Trueloves Lane to improve conspicuity for motorists as they approach the junction.
- 5) Refresh worn give way road markings at the junction.

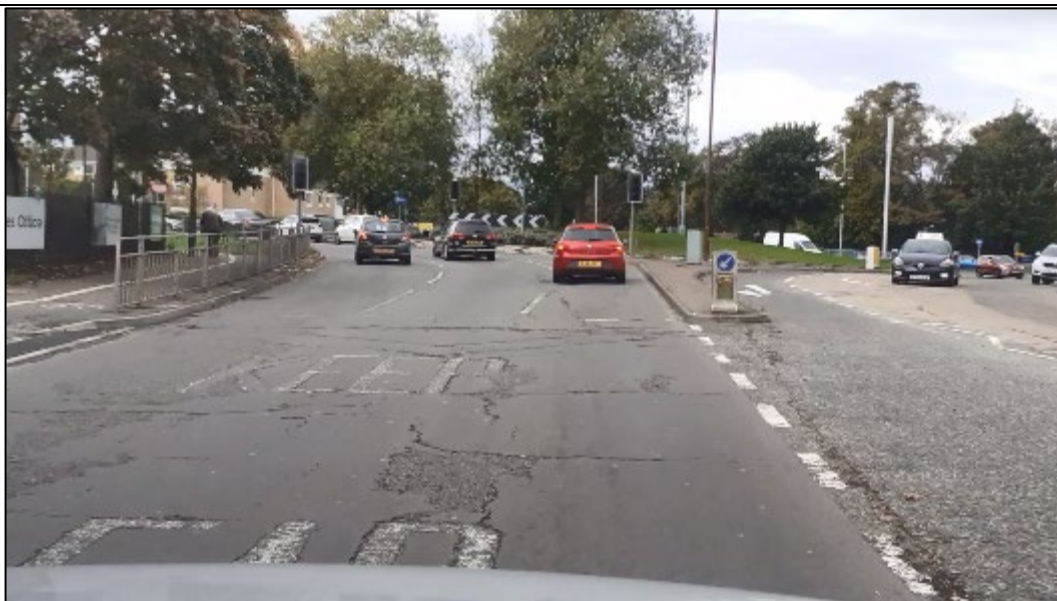
Image 2 – A1114 Princes Road, approach to Give Way lines at roundabout.
Note poor conspicuity of road markings and overhanging trees to nearside.

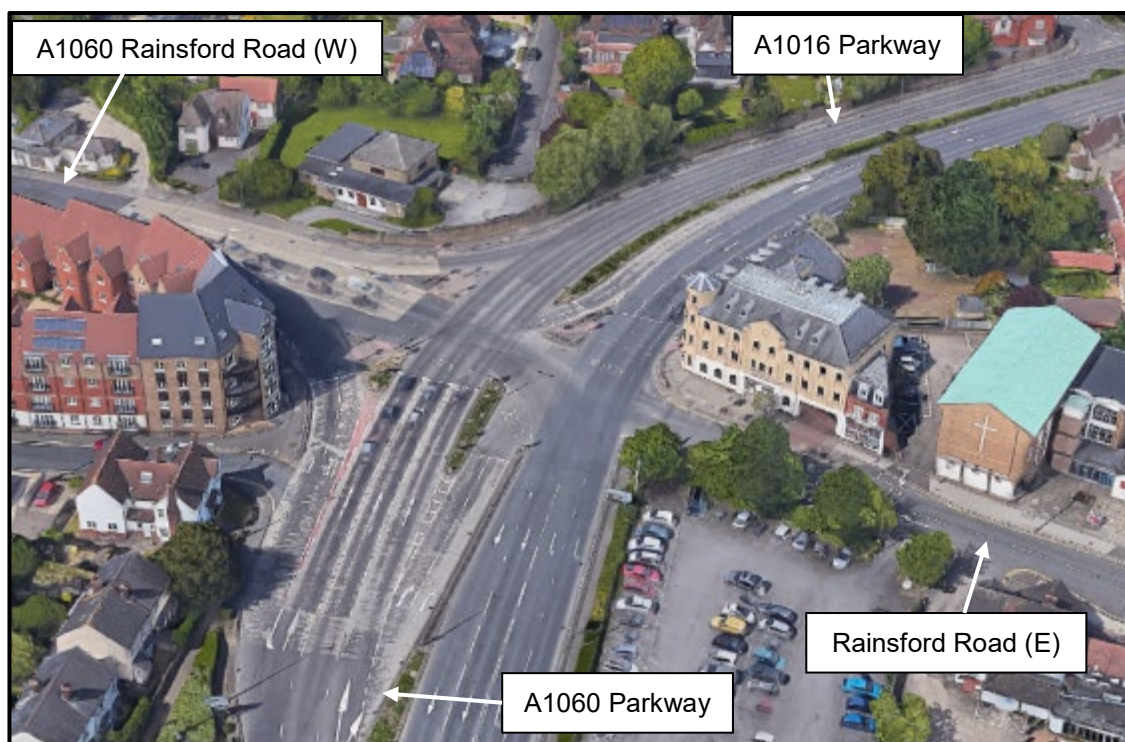
1.0 Site Plan with Collision Plot

Note: worn anti-skid surfacing is evident on Parkway approaches to traffic signals

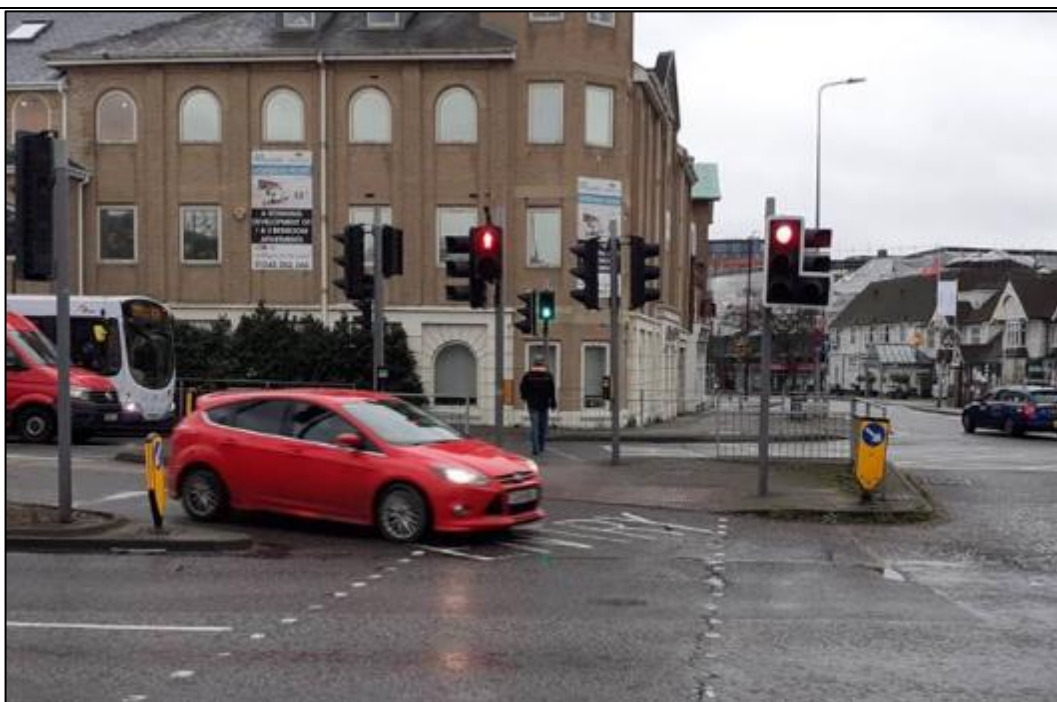
Image 4 – Pedestrian crossing, Parkway (N) - pedestrian signal head 'see-through'
