Location: A127 J/w A176 Northern Roundabout, Basildon
District: Basildon
Collision Investigation Period: 01/01/2017 – 31/12/2019
Site Ranking: N/a

EXECUTIVE SUMMARY

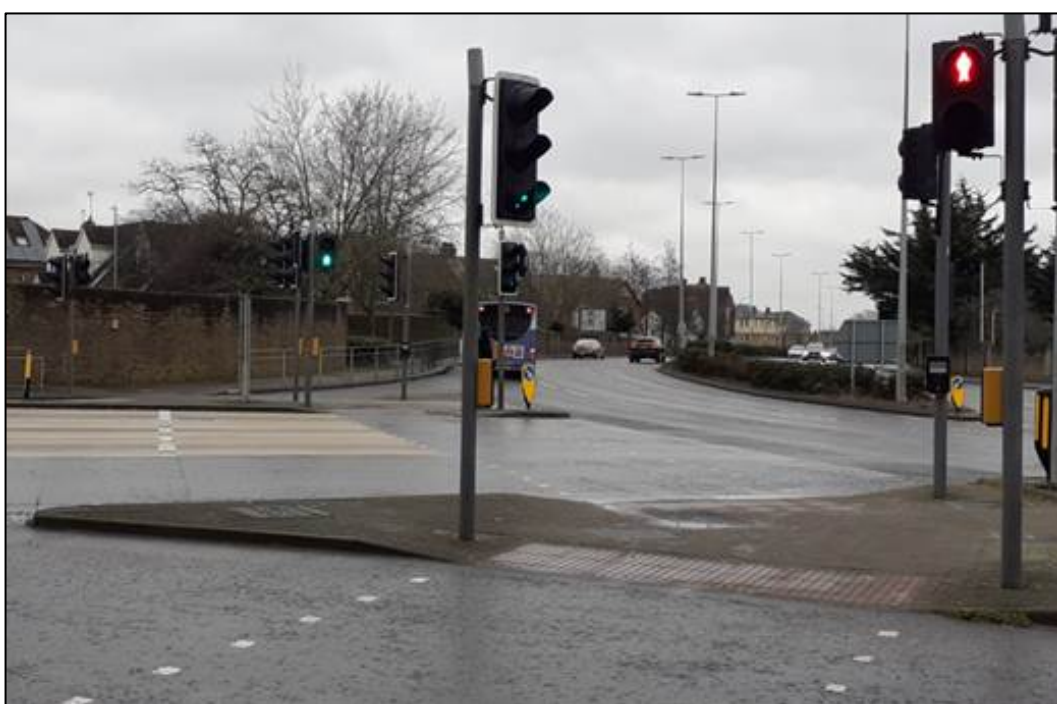
Image 5 – A1060 Rainsford Road (W) – looking south to north –
Pedestrian signal head 'see-through'

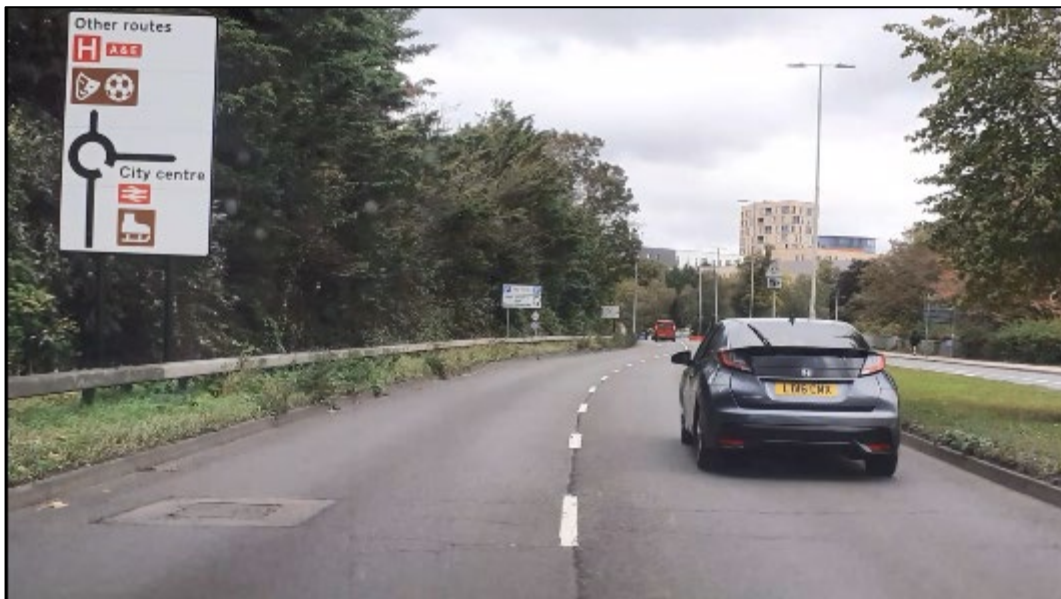
Image 1 – A1060 Parkway westbound approach.
Note faded 'Roundabout Ahead' warning sign in central reservation.

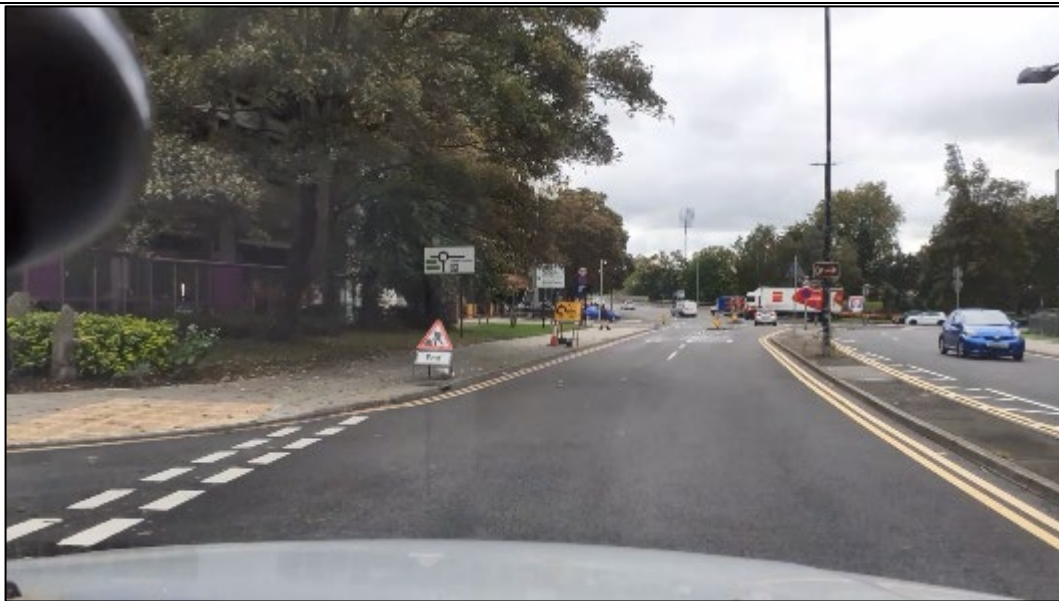
Image 4 – A1099 Victoria Road South, southbound approach
Trees obscuring signs to nearside

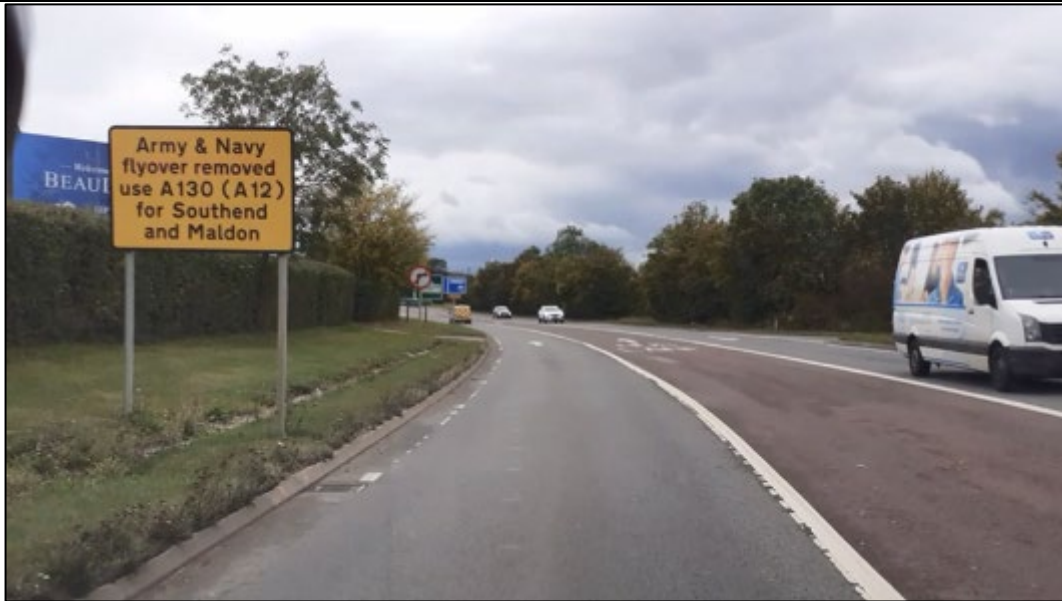
Image 3 – A130 Essex Regiment Way southbound (Little Waltham Road to offside)
Note poor conspicuity of 'No Right Turn' sign against background

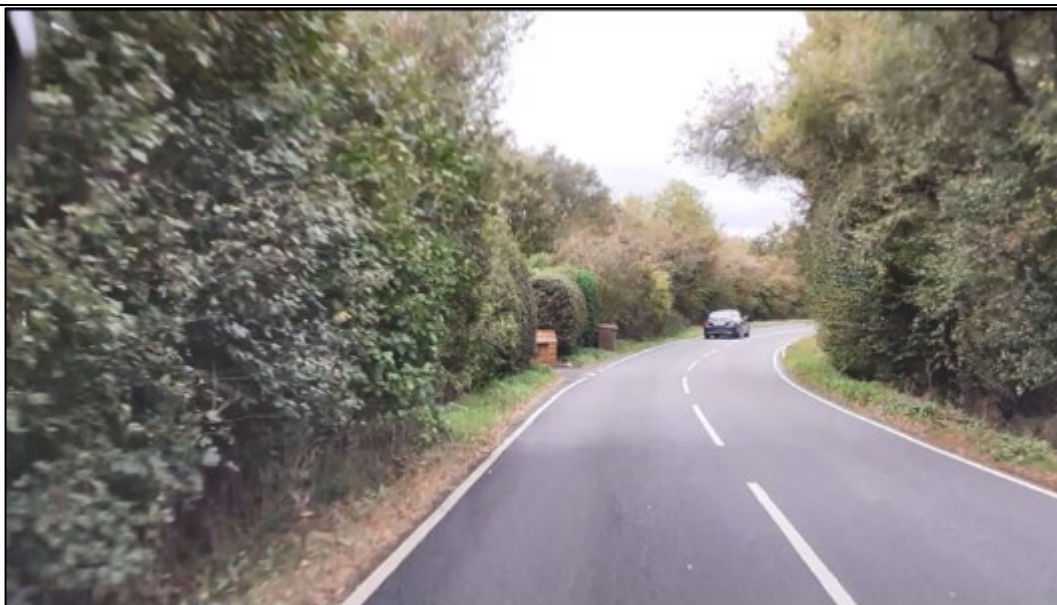
Image 5 – Cranham Road westbound
visibility limited by dense vegetation at both sides of road

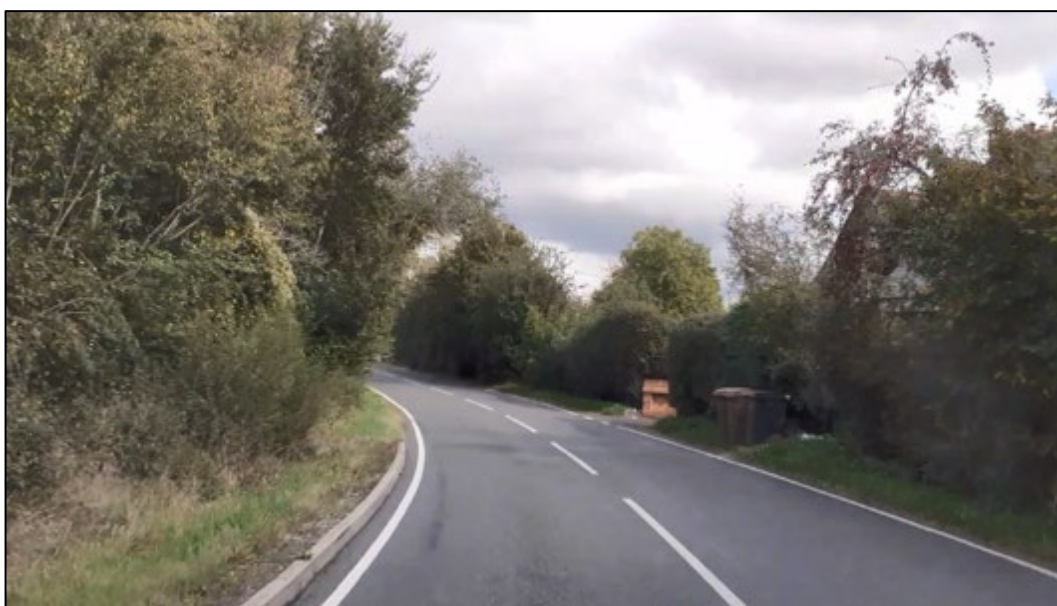
Image 6 – Cranham Road eastbound
(opposing direction to Image 5 above)
Note: locked tyre marks swerving to nearside and restricted forward visibility through bend

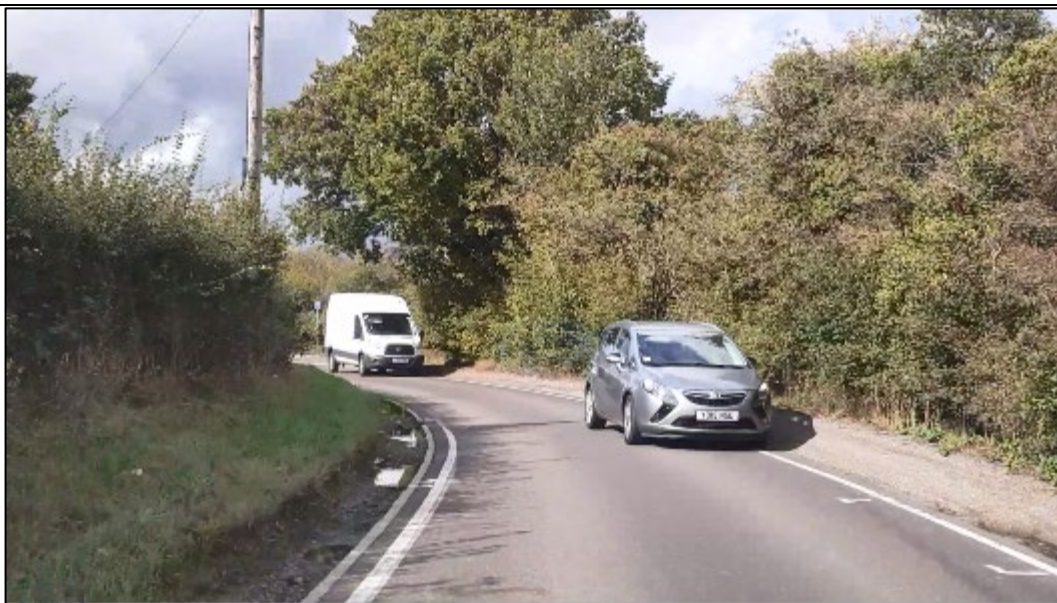
Image 7 – Boreham Road northbound
verge erosion/incursion to both sides and limited forward visibility through narrow bend

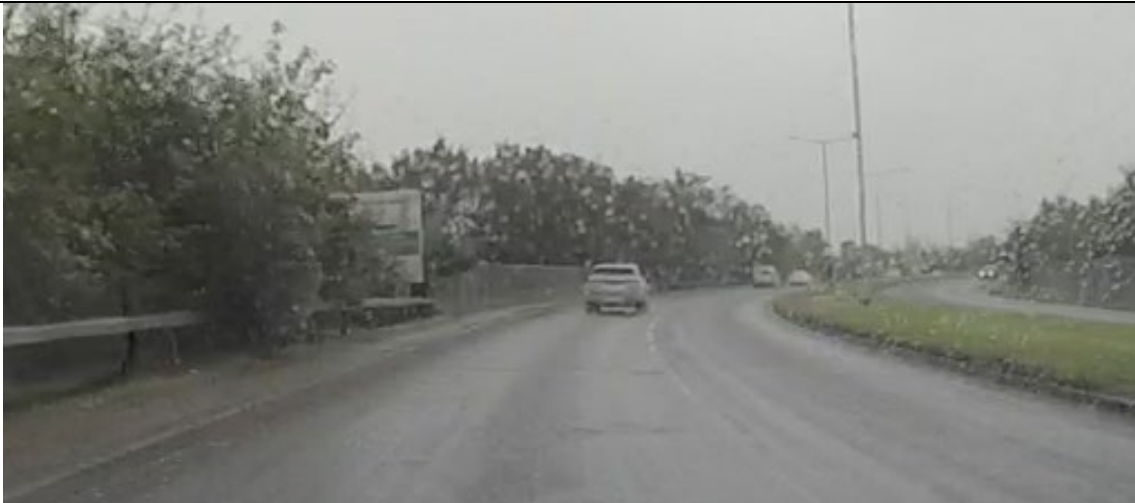
<p>Latest Scrim data from 2020_21 indicates the southbound approach to the cluster location is at SCRIM "Warning Level". However, this is not considered to be a contributory factor in the collisions that have occurred here.</p>
Signing	<p>There is an existing map type advanced directional signs present on the A1124 (southbound). However, this sign is totally obscured by vegetation.</p>

Image 1 – ADS sign obscured by vegetation. (southbound approach)

- 1) It is recommended that visibility to the right is restricted. For aesthetic considerations, it is proposed that vegetation in the form of hedgerow is provided in the central reserve.
- 2) It is recommended that the vegetation obscuring the ADS sign is removed.

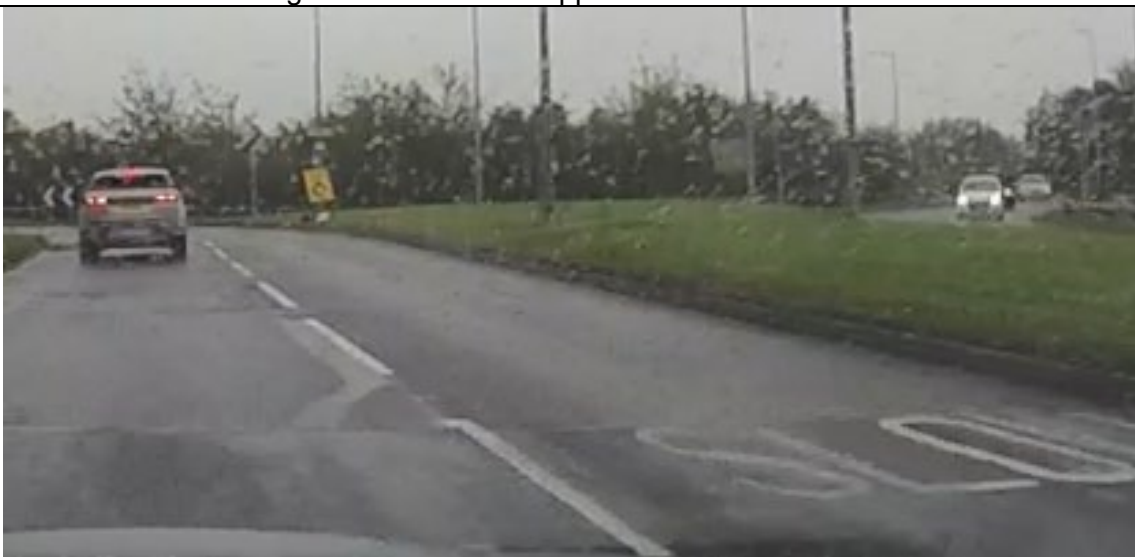
Image 3 – Visibility to the right approx. 55m from give way line.

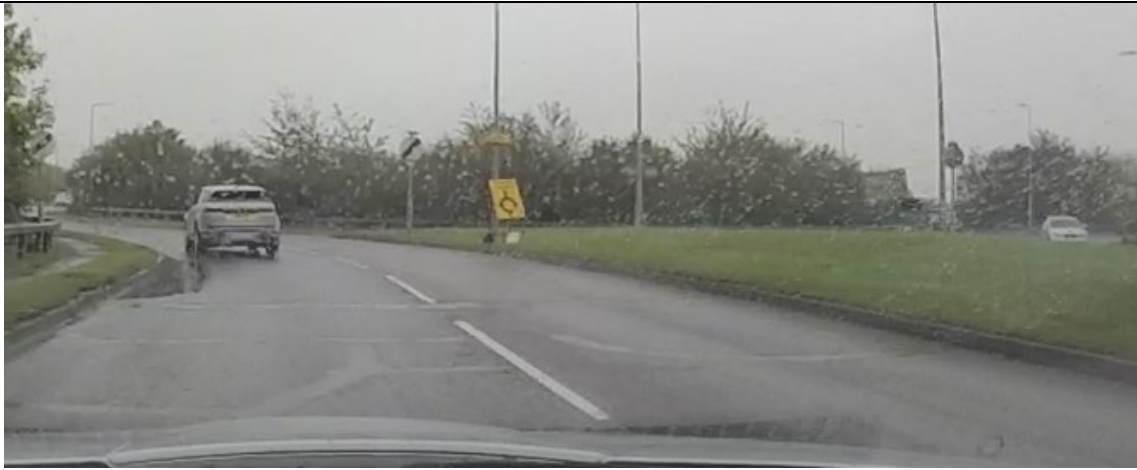
Image 4 – Visibility to the right approx. 40m from give way line.

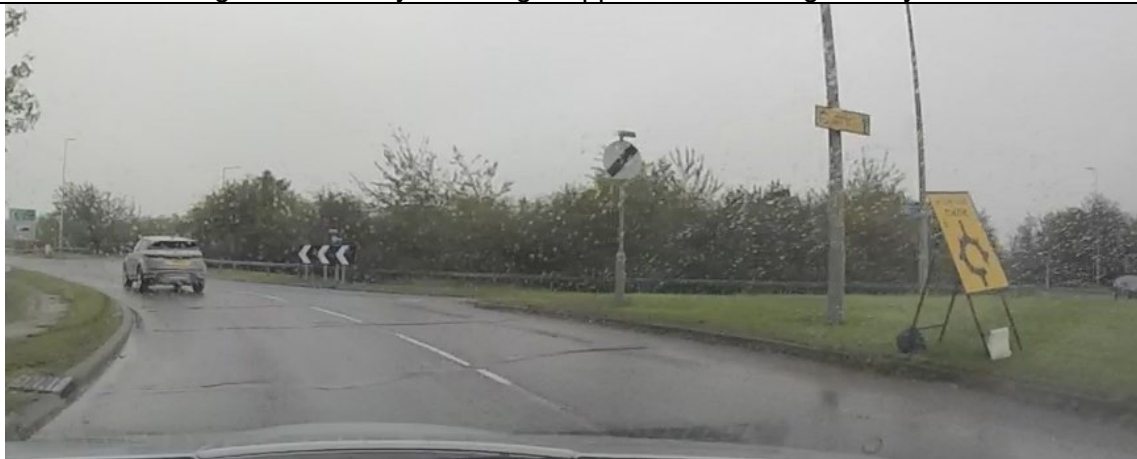
Image 5 – Visibility to the right approaching the give way line

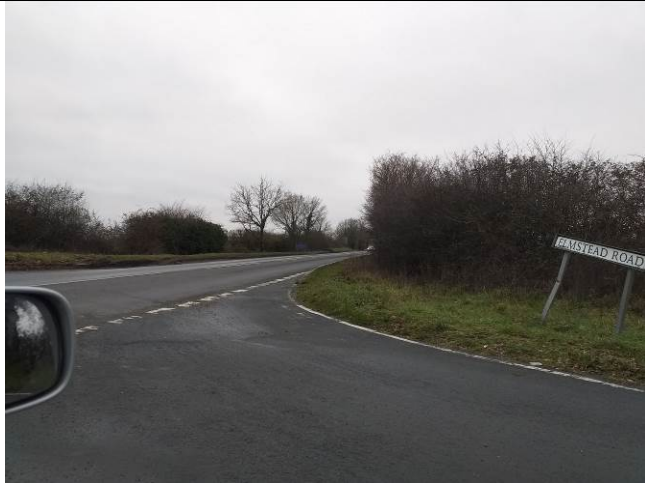
Visibility	Visibility to the right from Elmstead Road (north) is partially obstructed by exiting vegetation (see below)

- Re-apply give way markings and approach centre line;
- Replace existing give way sign with a new 900mm high triangular sign on yellow backing board in nearside verge at junction;
- Remove vegetation on north side of Brightlingsea Road located within the visibility splays;

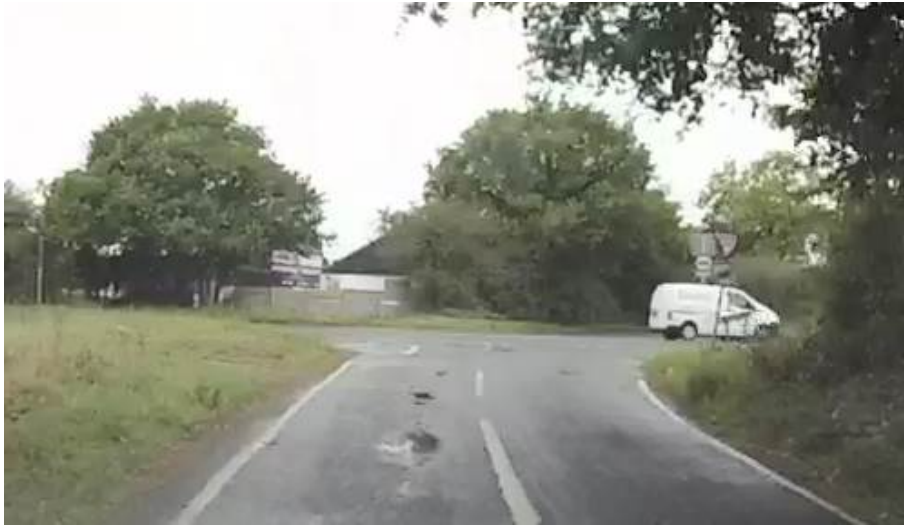
Image 1 – Elmstead Road (north) approach to junction.

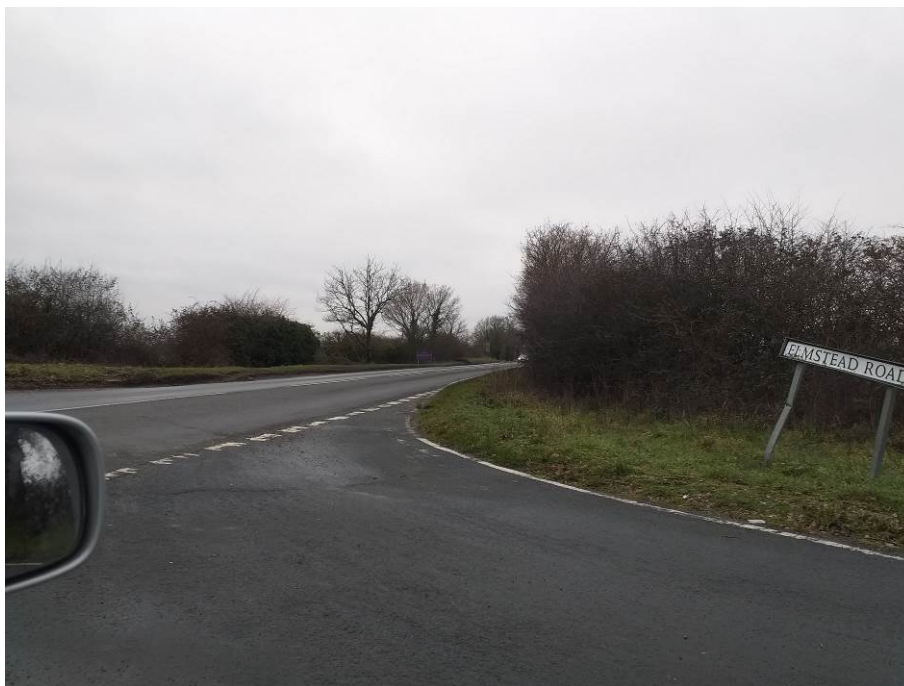
Image 2 – Visibility to the right at Elmstead Road (north) junction

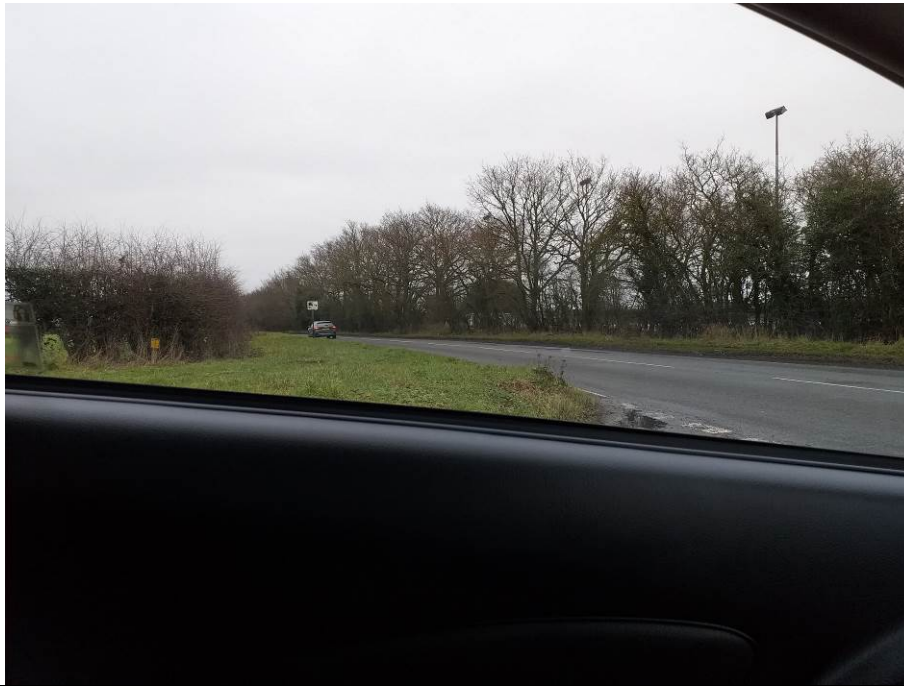
Image 3 – Visibility to the left at Elmstead Road (north) junction.

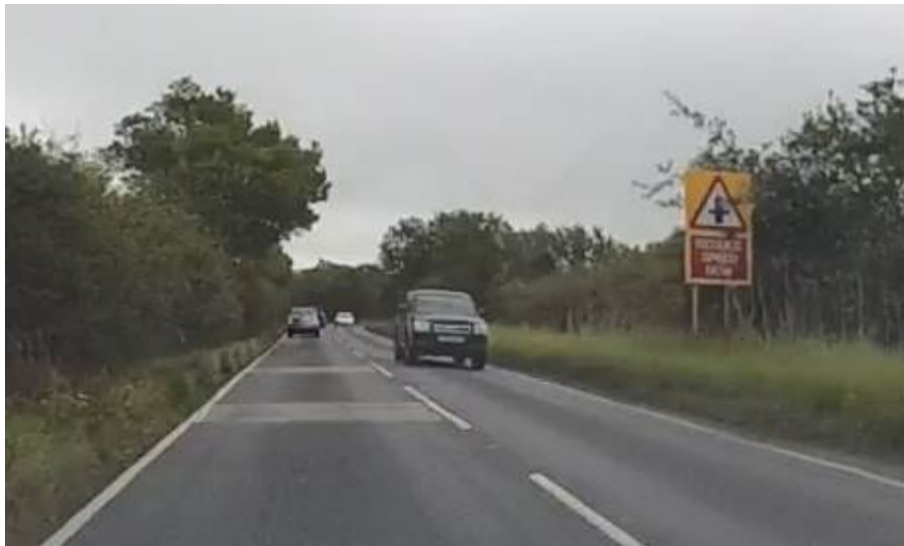
Image 4 – Brightlingsea Road eastbound approach to junction.

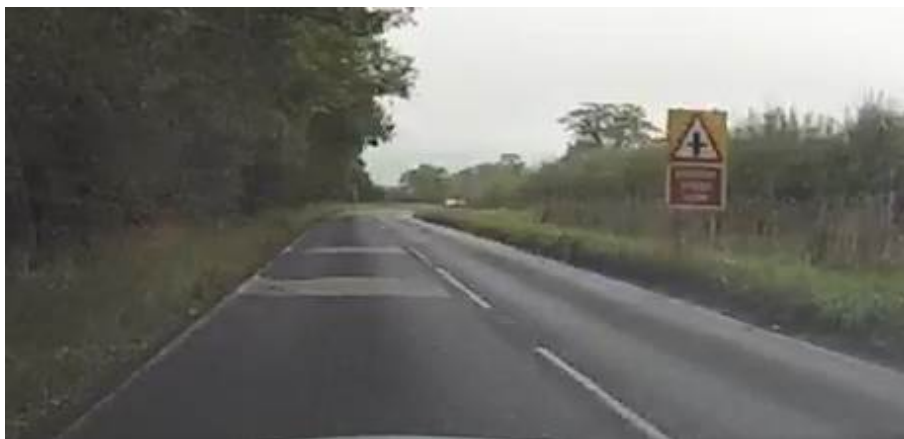
Image 5 – Brightlingsea Road westbound approach to junction

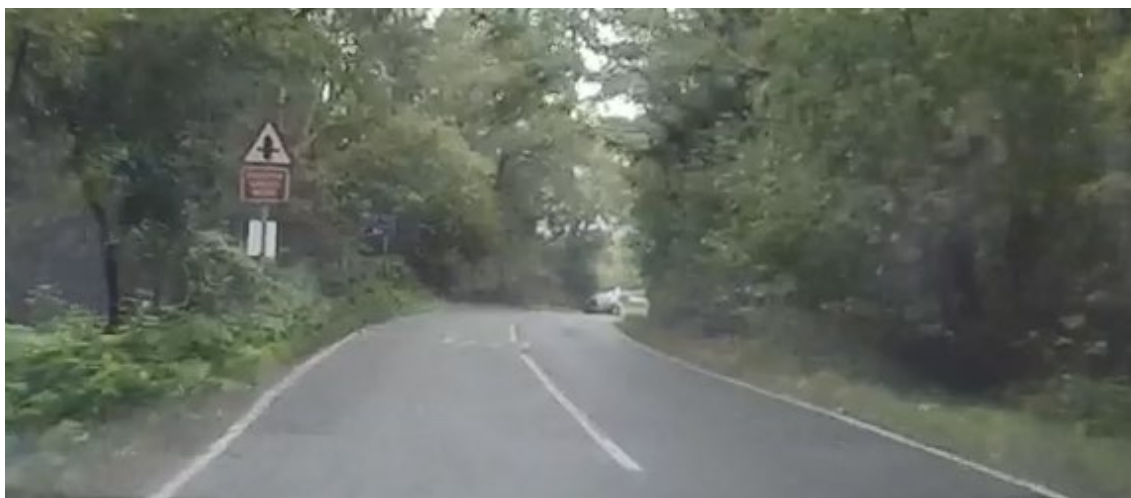
Image 1 – Northbound Fingringhoe Road approach to junction.

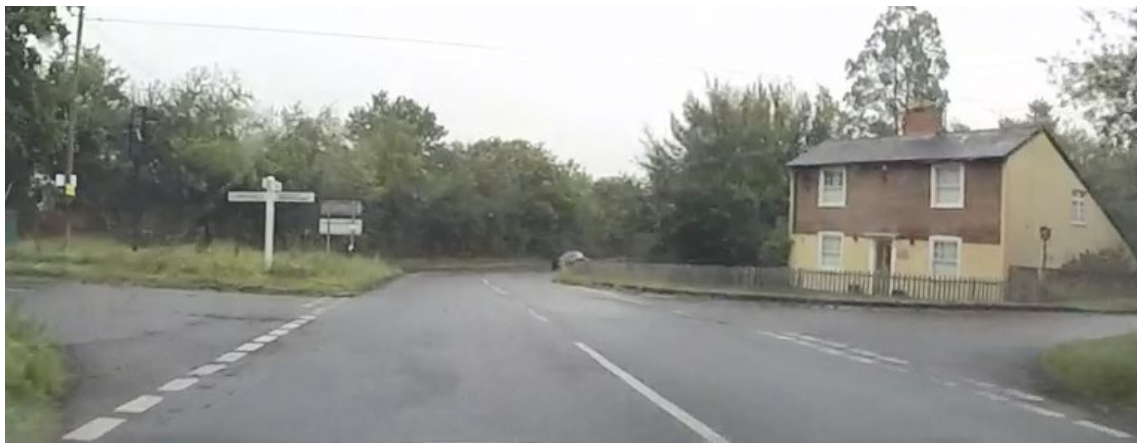
Image 2 – Northbound Fingringhoe Road at junction

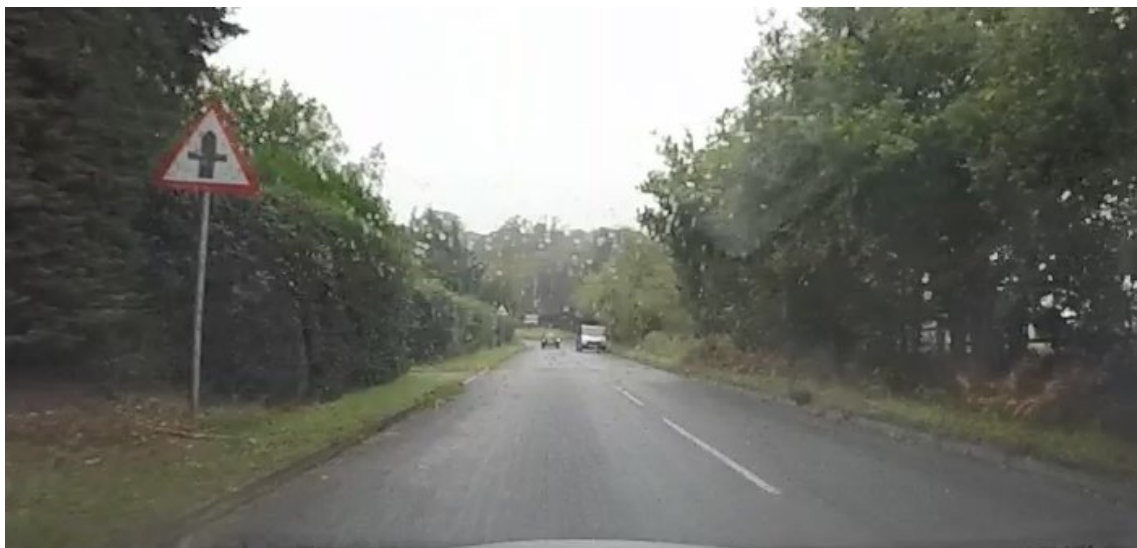
Image 3 – Southbound Fingringhoe Road approach to junction.

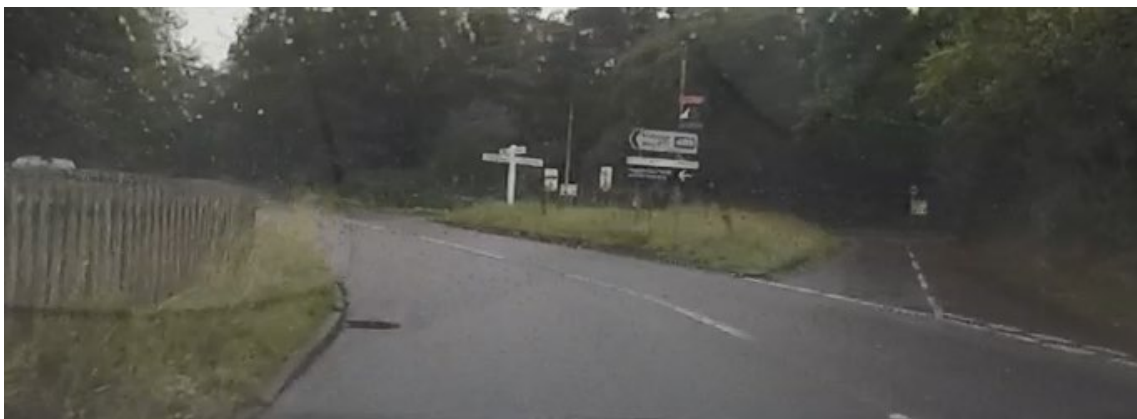
Image 4 – Southbound Fingringhoe Road at junction

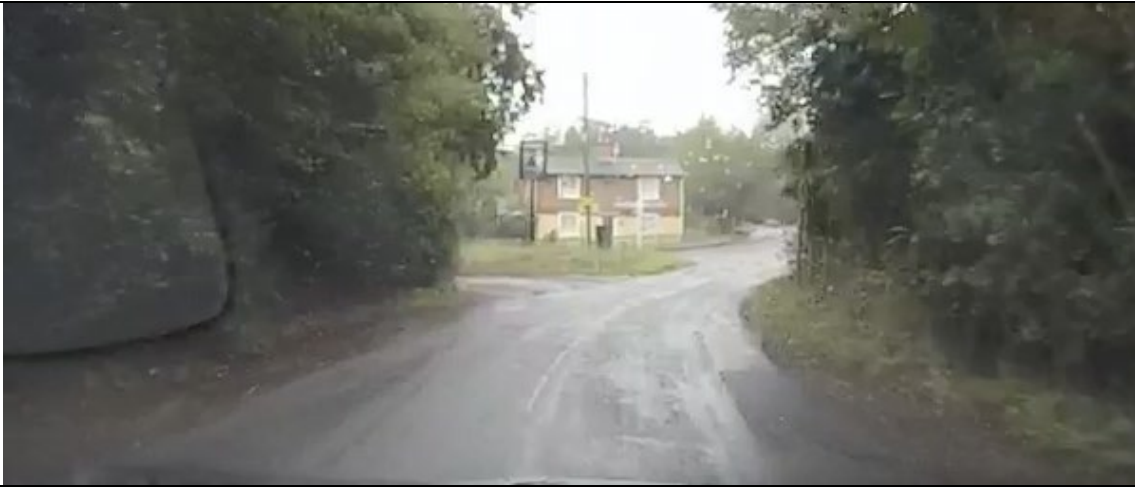
Image 5 – Eastbound Weir Lane approach to junction

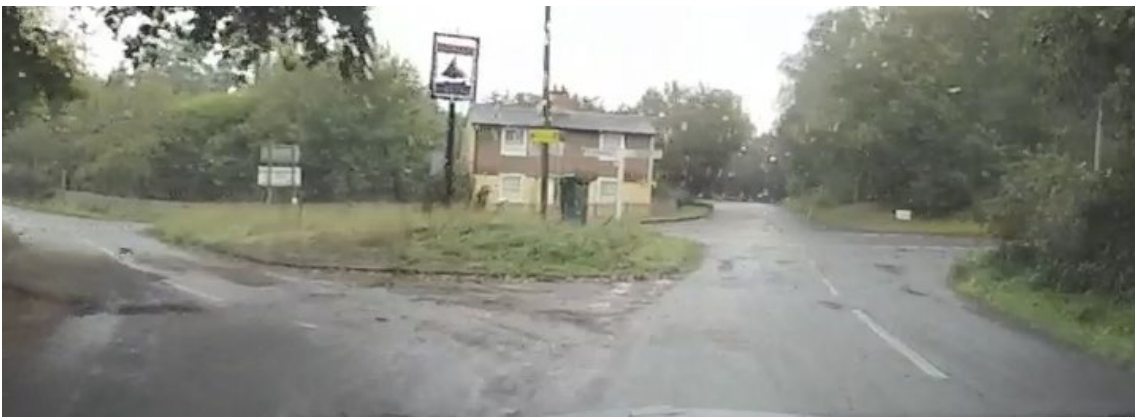
Image 6 – Eastbound Weir Lane at junction

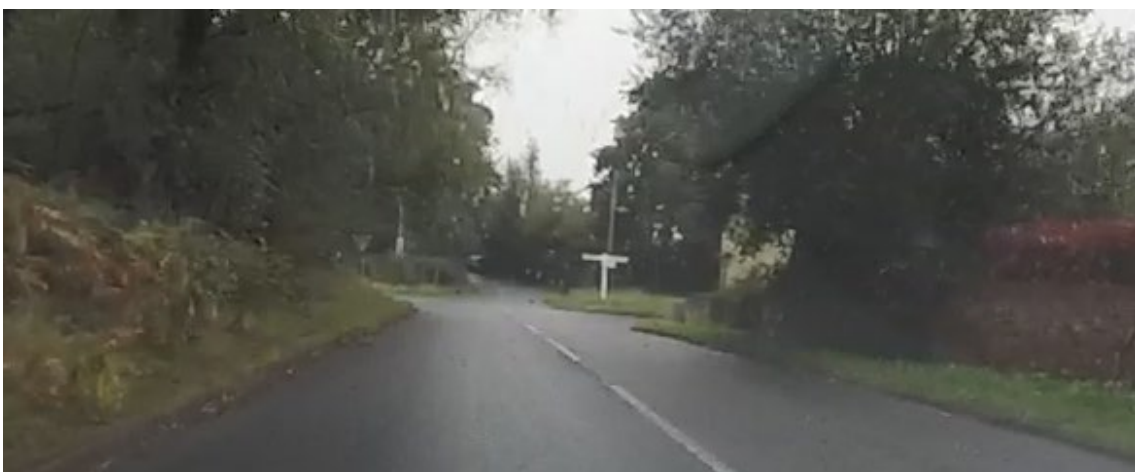
Image 7 – Westbound Rectory Road approach to junction

Re-apply junction give way markings on Rectory Road using “Rainline” or “thick” thermoplastic screed.
 Provide Give Way Triangular Road marking on Rectory Road using “Rainline” or “thick” thermoplastic screed
 Replace existing Give Way sign with similar on yellow backing board on Rectory Road.
 Remove vegetation within Rectory Road visibility splays.

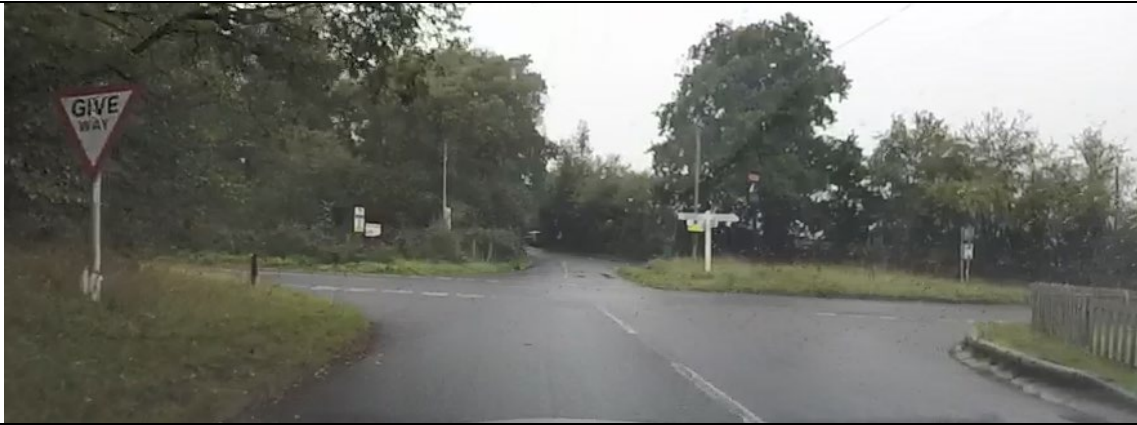
Image 8 – Westbound Rectory Road at junction

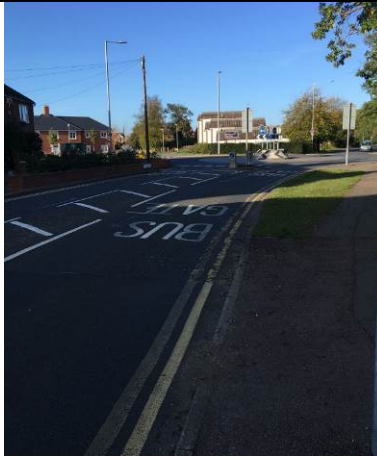
Image 1 – View looking North from the bus gate on Nayland Road

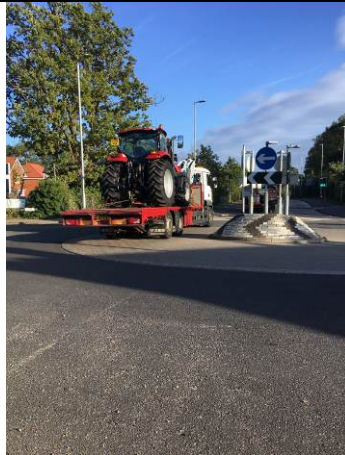
Image 2 – View looking East on Wildeve Avenue (notice articulated vehicle over running the over run area)

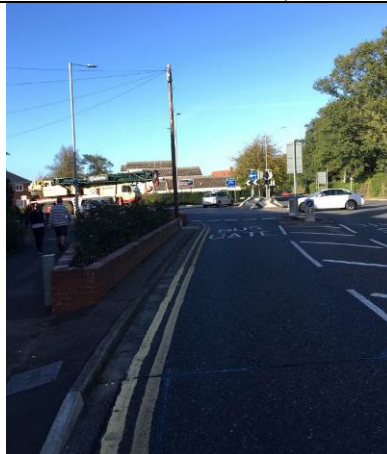
Image 3 – View looking North from the bus gate on Nayland Road

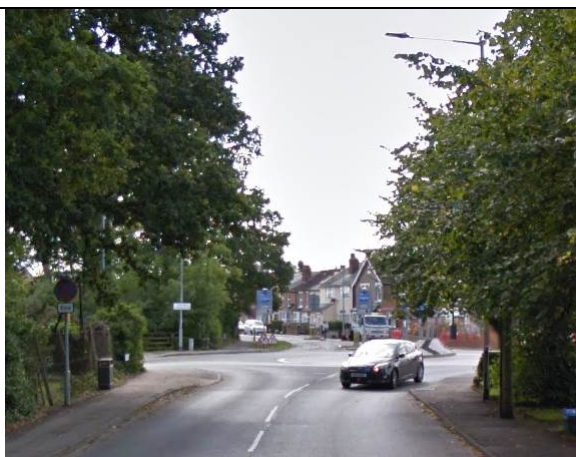
Image 4 – View looking south at the roundabout on Boxted Road

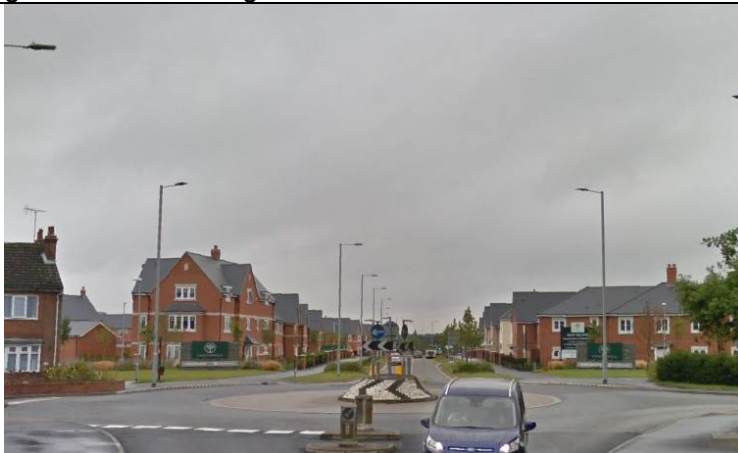
Image 5 – View looking west on Northern Approach Road.

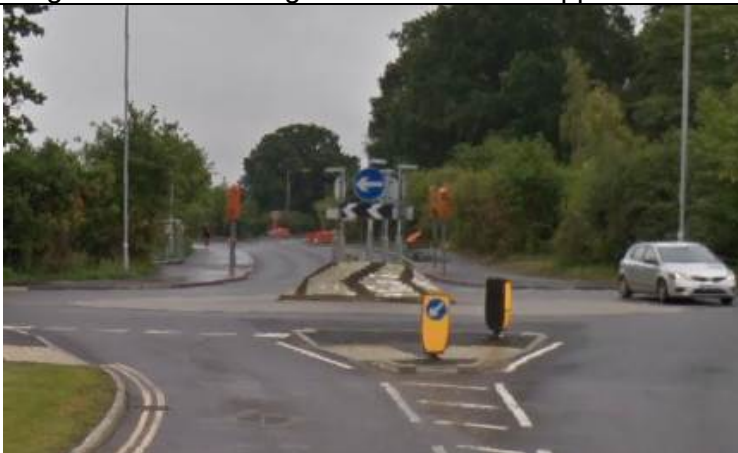
Image 6 – View looking East on Wildeve Avenue
